Acme Coke
11236 S. Torrence Ave.
Chicago IL 60617

Wilputte Oven Inspection

Dated: October 1994

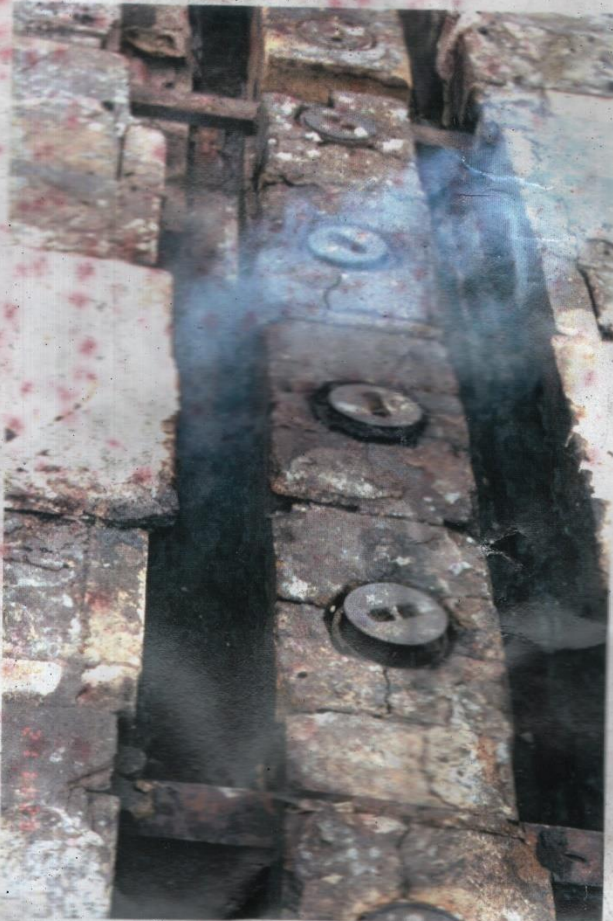
Tie Rod Channel at Charging Holes

NOTE: Gas leaks, broken and cracked top brick and tar deposits in the channel and around the inspection caps.

Charging hole patching and spraying is now in progress and will certainly help in the short term. A more extensive replacement of the charging hole brick shapes down, perhaps as much as five (5) courses and levelling the oven top, will be necessary to control this source of oven to flue leaks. A precast sleeve, grouted in place, is probably the simplest, fastest, and least expensive way to seal the charging holes.
