Acme Coke
11236 S. Torrence Ave.
Chicago IL 60617

Fosbel Refractory Repair data

Dated: 9/17/2001

TRIP REPORT – ACME STEEL SEPTEMBER 2001

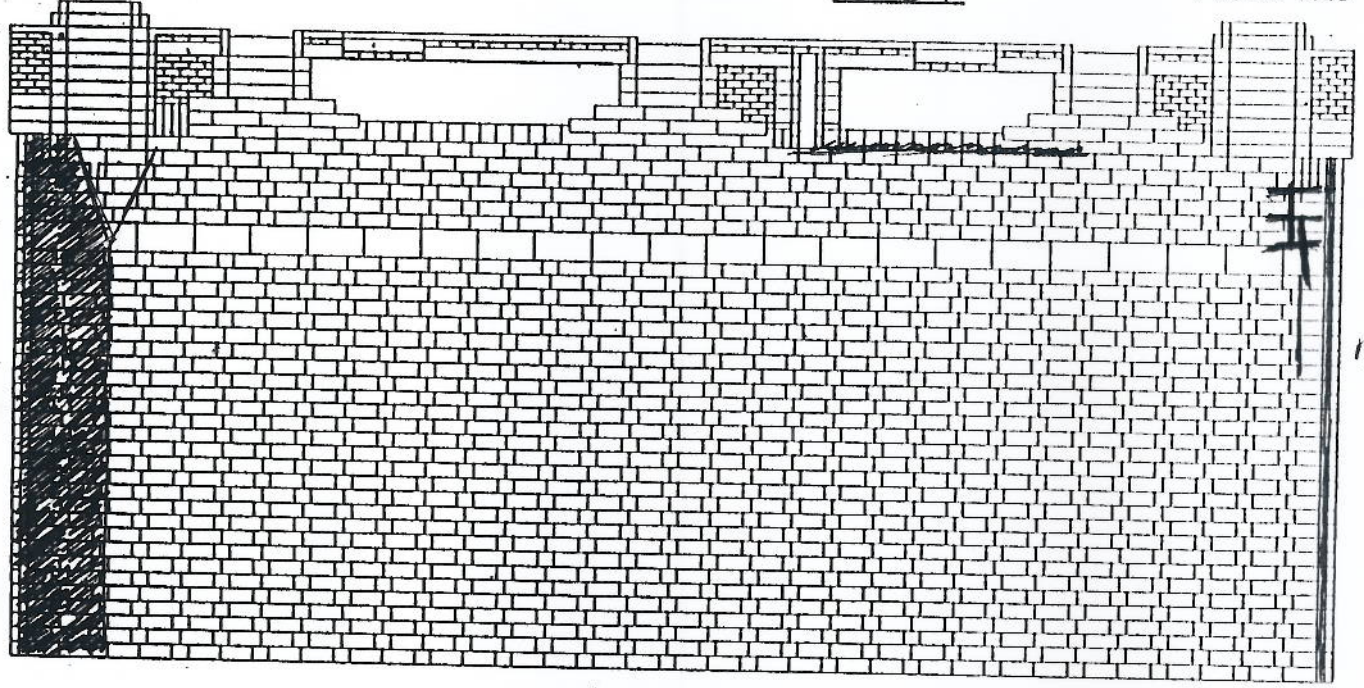
DATE C-21

Oven C-21 Has a lot of Open Joints in The Horizontal Fluss. They were not welded Due To lack of Time.

OVEN NUMBER C-21 START DATE Nov-3 COMPLETED DATE Nov-7

WELDING MATERIAL USED 2225 LBS
