Gas Bleeder Inspection
Dated: 1977

To: J. T. Seaman
From: D. A. Masson
Subject: Chicago Coke Plant
Bleeder Stack
Reference:

1976 INSPECTION OF COKE
GAS BLEEDER STACK

INTERLAKE, INC.
Chicago Plant
Chicago, Illinois

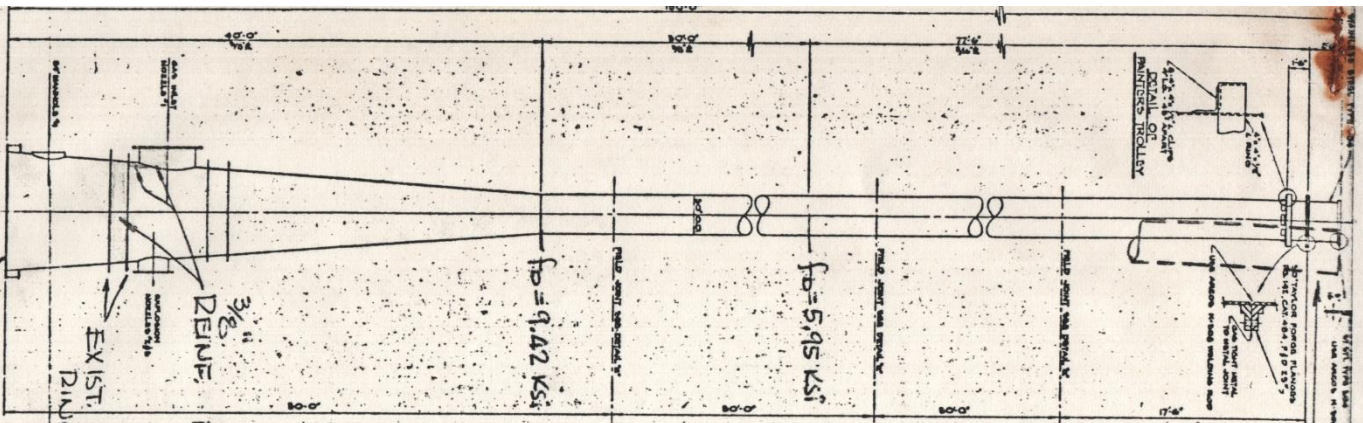
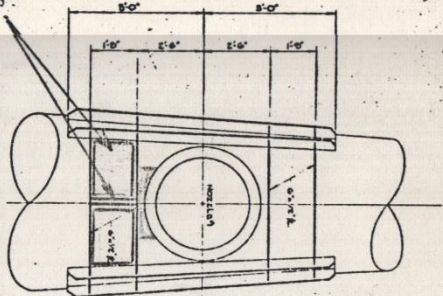
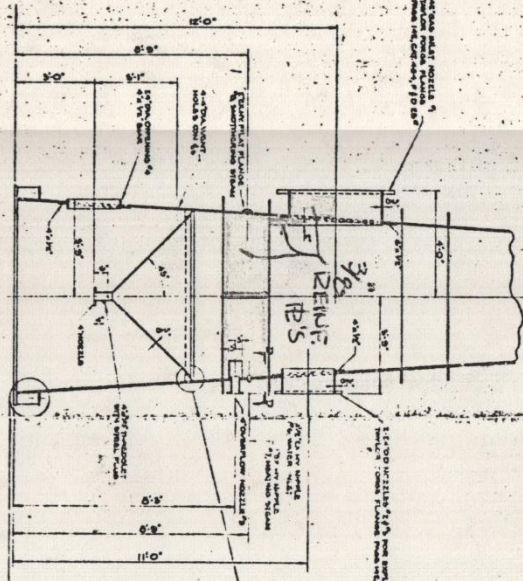
REPAIRS TO BLEEDER STACK

The stack appears to have taken a permanent set of approximately 4-1/2 inches out of plumb. Per observations and calculations made by Mr. D. Juricic, there is no cause for concern over the 4-1/2 inch deflection nor are further repairs (other than those recommended in the report of September 21, 1976) required at this time.

MAX. DEFLECTION DUE TO WIND = 16 1/2"

3/8" REINF. RINGS & STIFFENERS ADDED ALL AROUND

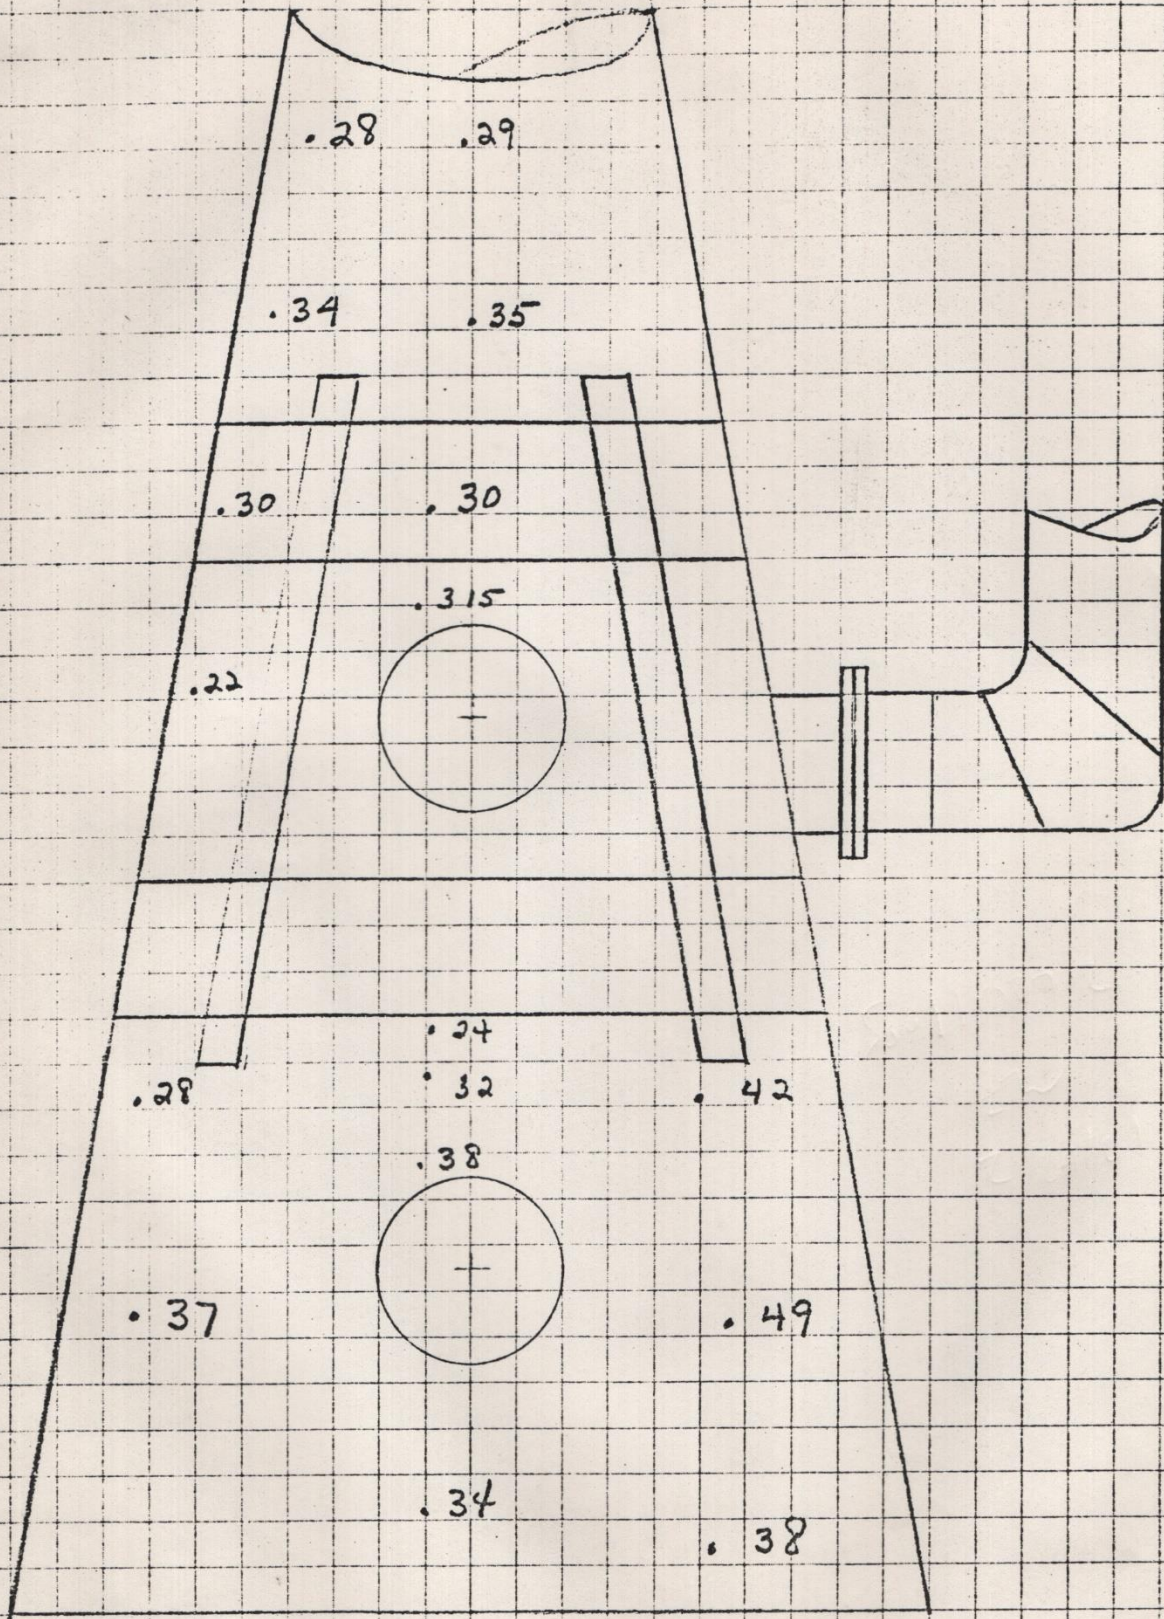
EC 1

- Northeast side: The overall average thickness of the shell plate on the northeast side is 9/32" to 3/8" with thin areas of 3/16" to 1/4". Refer to Sketch EC-1. The thin areas of 3/16 or less should be patched.

DESCRIPTION *Gas Bleeder Stack*
NORTH EAST Side View

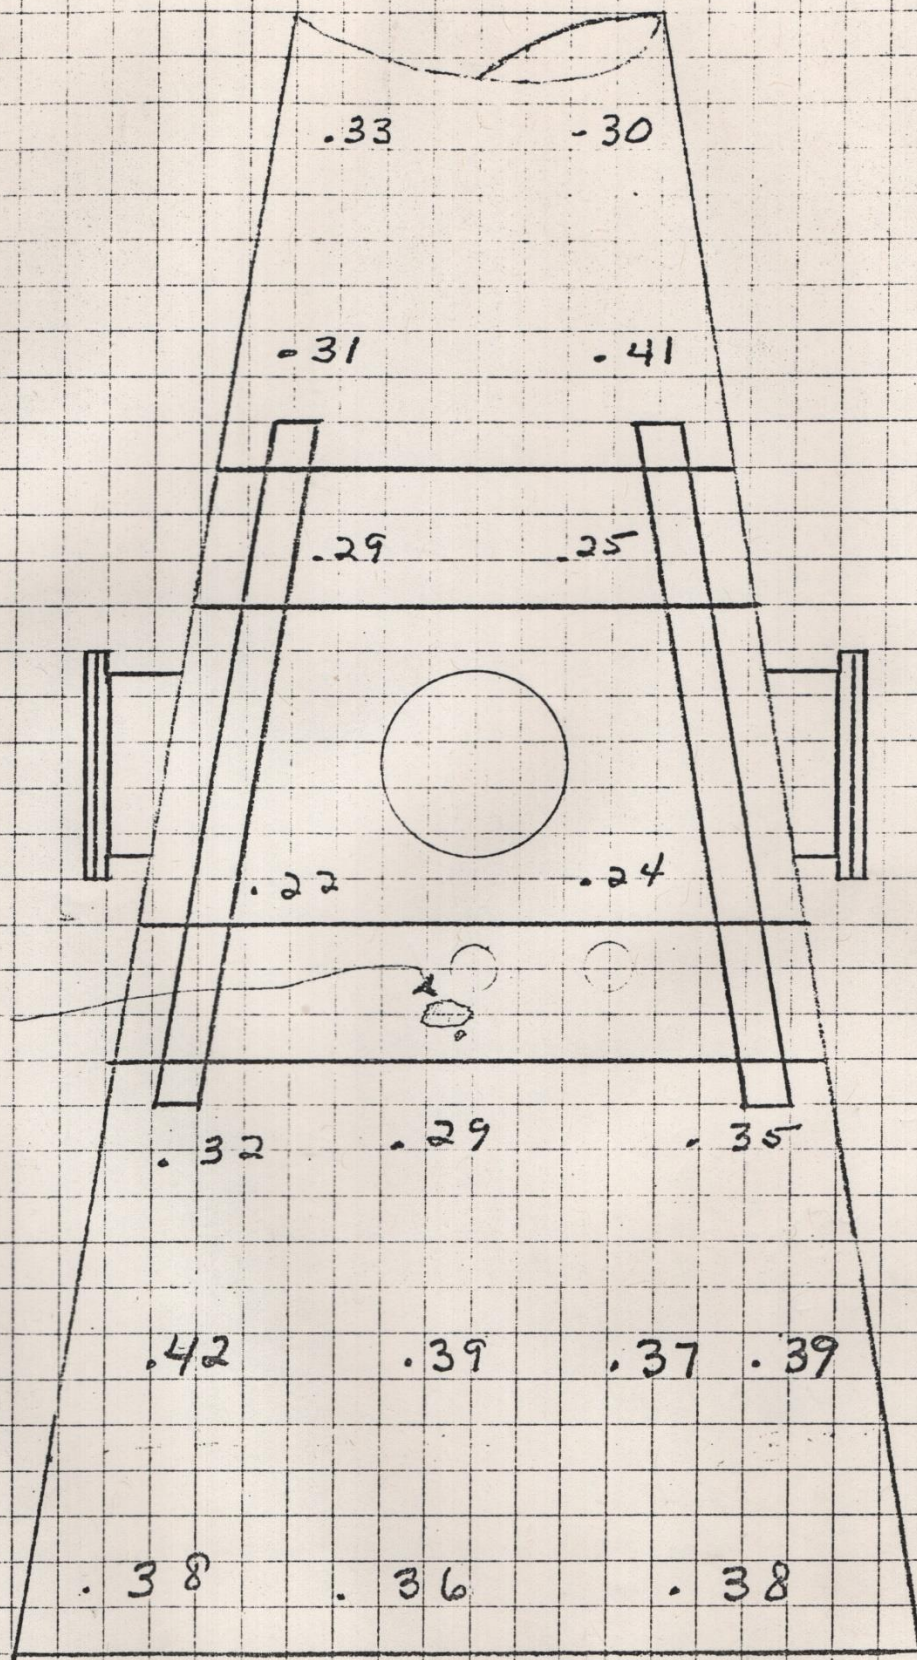
LOCATION
 SKETCH NO. EC 2

- Northwest side: The overall average thickness of the shell plate on the northwest side is 1/4" to 3/8", with thin areas of 0" (100% deterioration) to 3/16". There are two holes 1" x 1" and 3/4" x 1-1/2" in the side of the stack approximately 9'-0" from the ground. The thin areas of shell plate of 3/16 or less should be patched. (Refer to Sketch EC-2).

100% deterioration
 1 hole 1" x 1"
 1 hole 3/4" x 1/2"

DESCRIPTION GAS BLEEDER STACK
 NORTHWEST SIDE VIEW

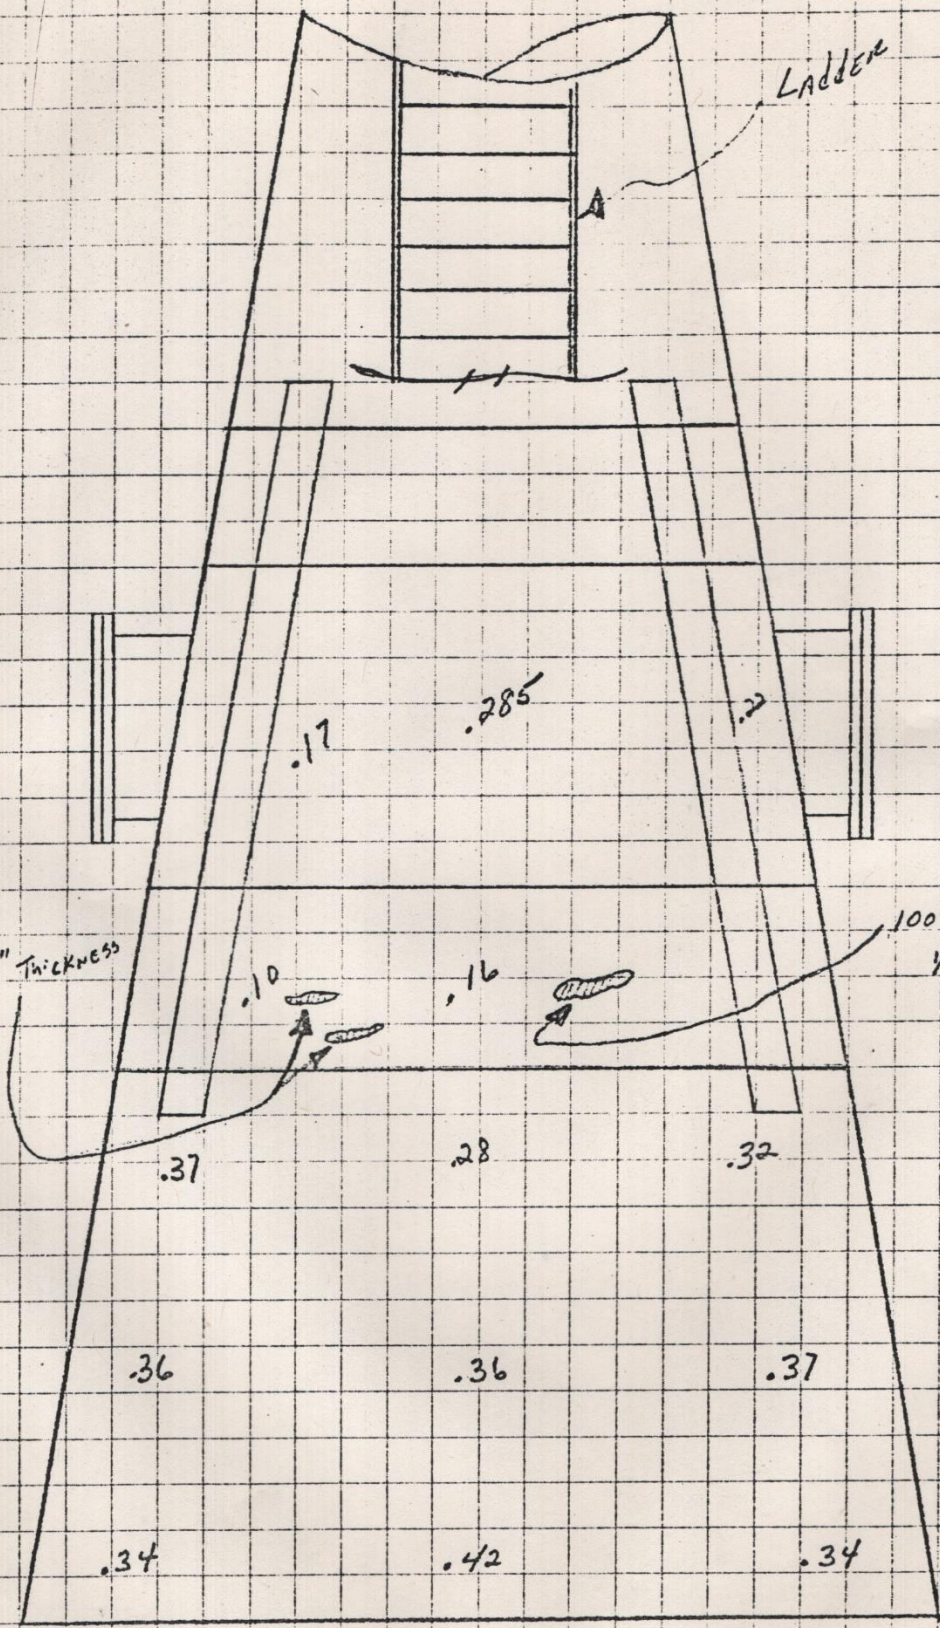
INTERLAKE, INC.
LOCATION
SKETCH NO. E C 3

- Southeast side: The overall average thickness of the shell plate on the southeast side is 1/4" to 3/8" with thin areas of 0" (100% deterioration) to 3/16". There is one hole 1/2" x 2" in the side of the stack approximately 9'-0" from the ground. The thin areas of shell plate of 3/16" or less should be patched. (Refer to Sketch EC-3).

SMALL AREAS
FEATHERED TO 0" THICKNESS

100% DETERRATION
1/2 x 2"

DESCRIPTION GAS BLEEDER STACK
SOUTHEAST SIDE VIEW

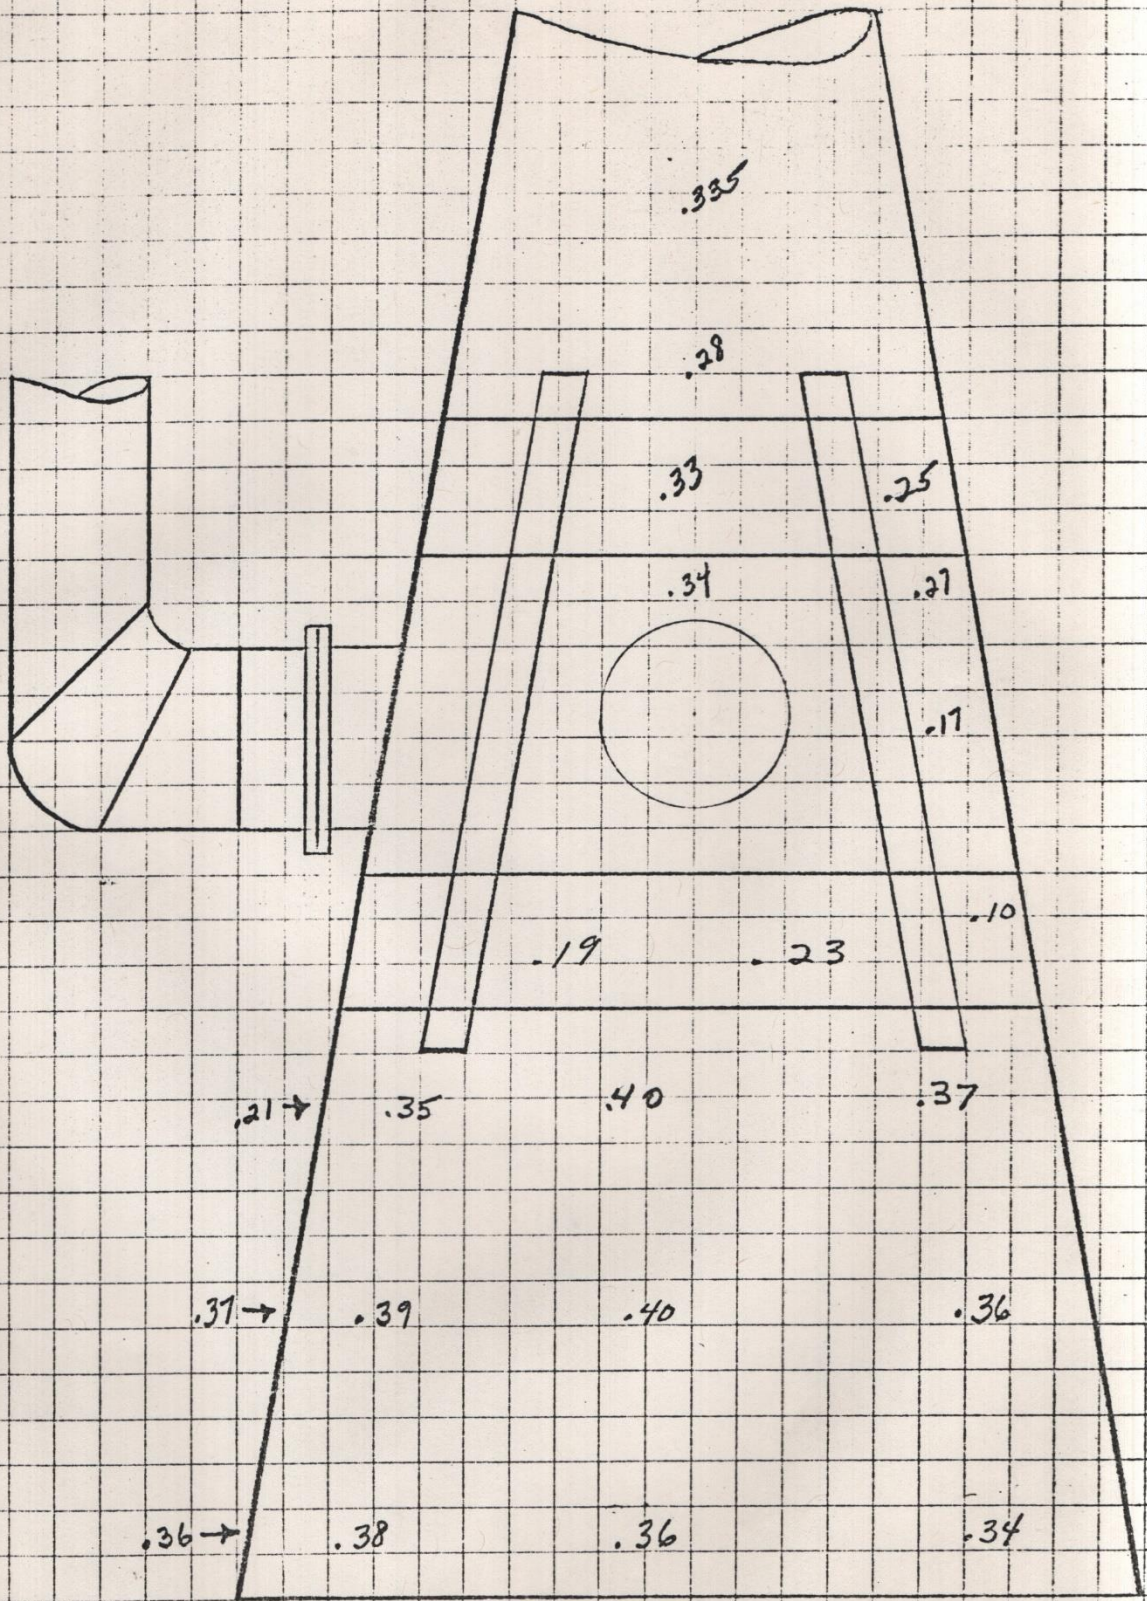
INTERLAKE, INC.
 LOCATION
 SKETCH NO. **EC 4**

- Southwest side: The overall average thickness of the shell plate on the southwest side is 1/4" to 3/8" with thin areas of 1/16" to 3/16". The thin areas of shell plate of 3/16" or less should be patched.

DESCRIPTION **GAS BLEEDER STACK**
Southwest Side view
