**ACME STEEL COMPANY**  
 DATE: 12-13-96 Last Edit: Jan. 10, 1997

ACME STEEL - CHICAGO  
 COKE PLANT  
 PUSHING EMISSION DUCT  
 SECTION, DETAILS, & GENERAL INSPECTION FINDINGS  
 1996 INSPECTION

JOB No. 05-7672-01 SHT. No. 2

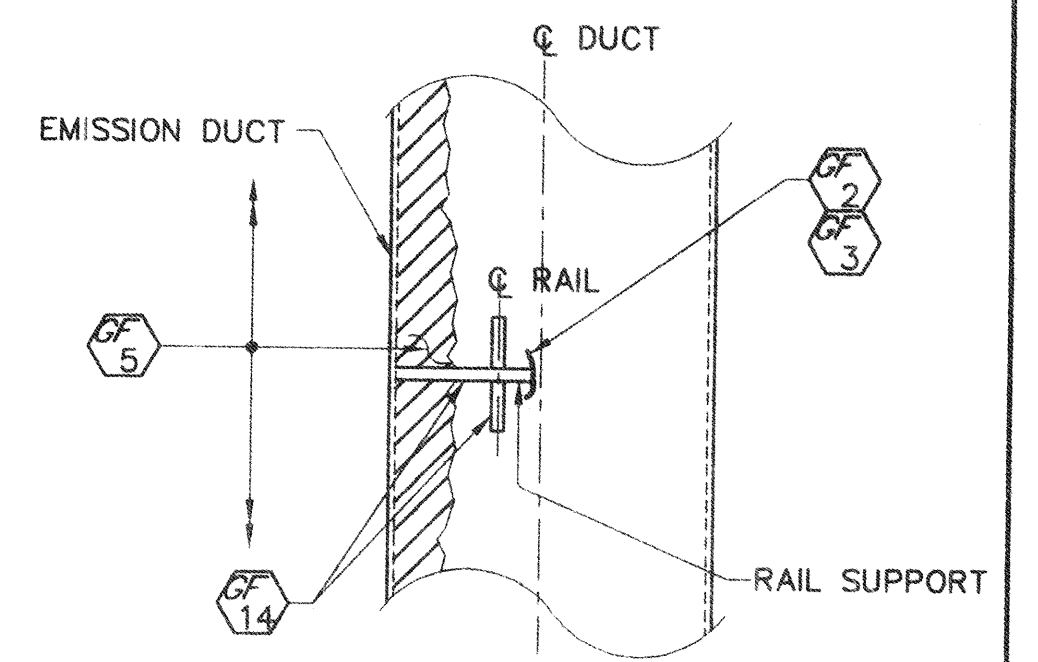
DETAIL 1 (LOOKING DOWN)

- GF 2 THE SHELL R IS TYPICALLY CRACKED BY 3" - 8" AT THE TOE OF THE MAIN RAIL SUPPORTS. (REFER TO SECTION "A-A" & DETAIL 1.)
- GF 3 THE SHELL R IS TYPICALLY CRACKED BY 1" - 2" AT THE TOE OF THE INTERMEDIATE RAIL SUPPORTS. (REFER TO SECTION "A-A" & DETAIL 1.)

- GF 14 THE STIFFENER R'S THROUGHOUT ARE HEAVILY RUST LAYERED AND RUSTED THIN TO 1/8" ±. (REFER TO SECTION "A-A" & DETAIL 1.)

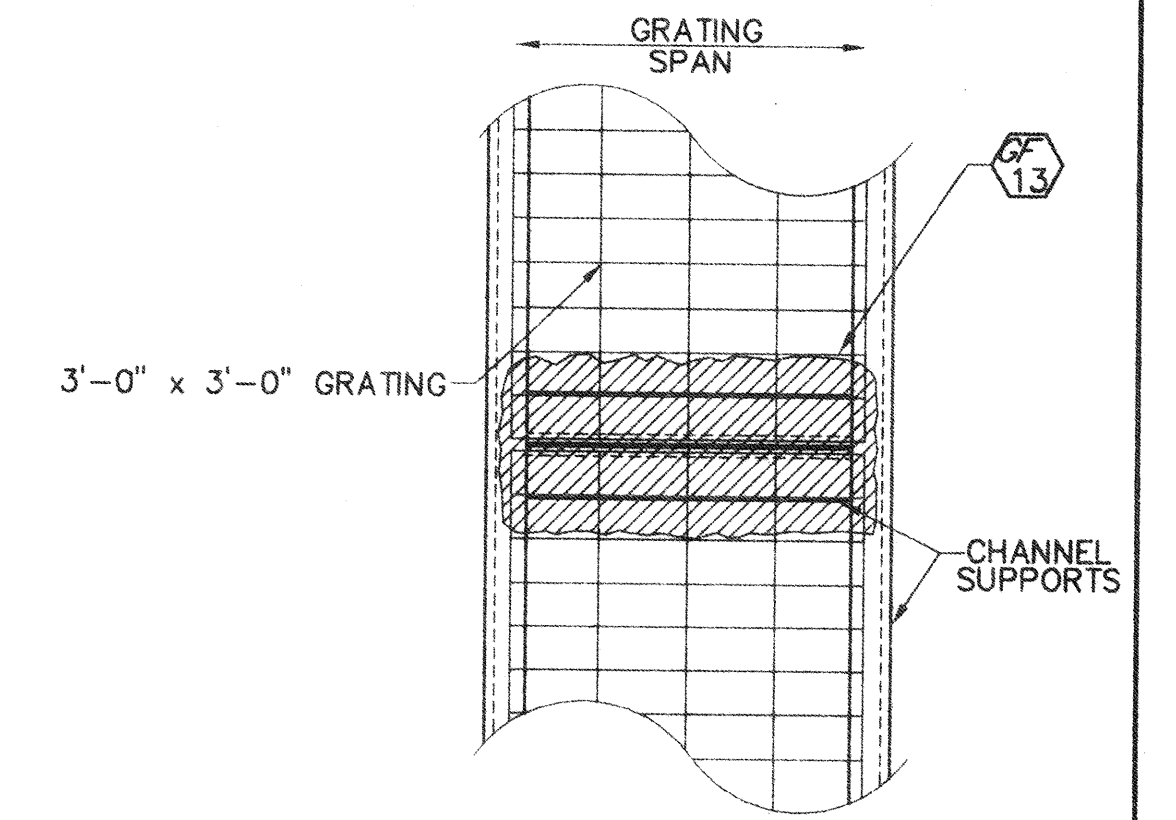
DETAIL 2 (LOOKING DOWN)

- GF 11 THE 8 ± SOUTHERN MOST WALKWAY SUPPORTS OVER THE COKE WHARF WERE FOUND TO BE HEAVILY RUST LAYERED AND RUSTED THIN. (REFER TO DWG. 7672-1 & SECTION "A-A".)
- GF 12 SEVEN (7) KICK R'S WERE FOUND TO BE EXTREMELY LOOSE. (REFER TO DWG. 7672-1 & SECTION "A-A".)
- GF 13 THE GRATING IS RUSTED THIN AND THRU IN A 4" WIDE x 3'-0" ACROSS AREA. THIS WAS FOUND TO BE TYPICAL AT ALL GRATING SPLICES ABOVE BATTERY No. 2 AND THE SIX (6) SOUTH SPLICES ABOVE BATTERY No. 1. (REFER TO DWG. 7672-1, SECTION "A-A", & DETAIL 2.)

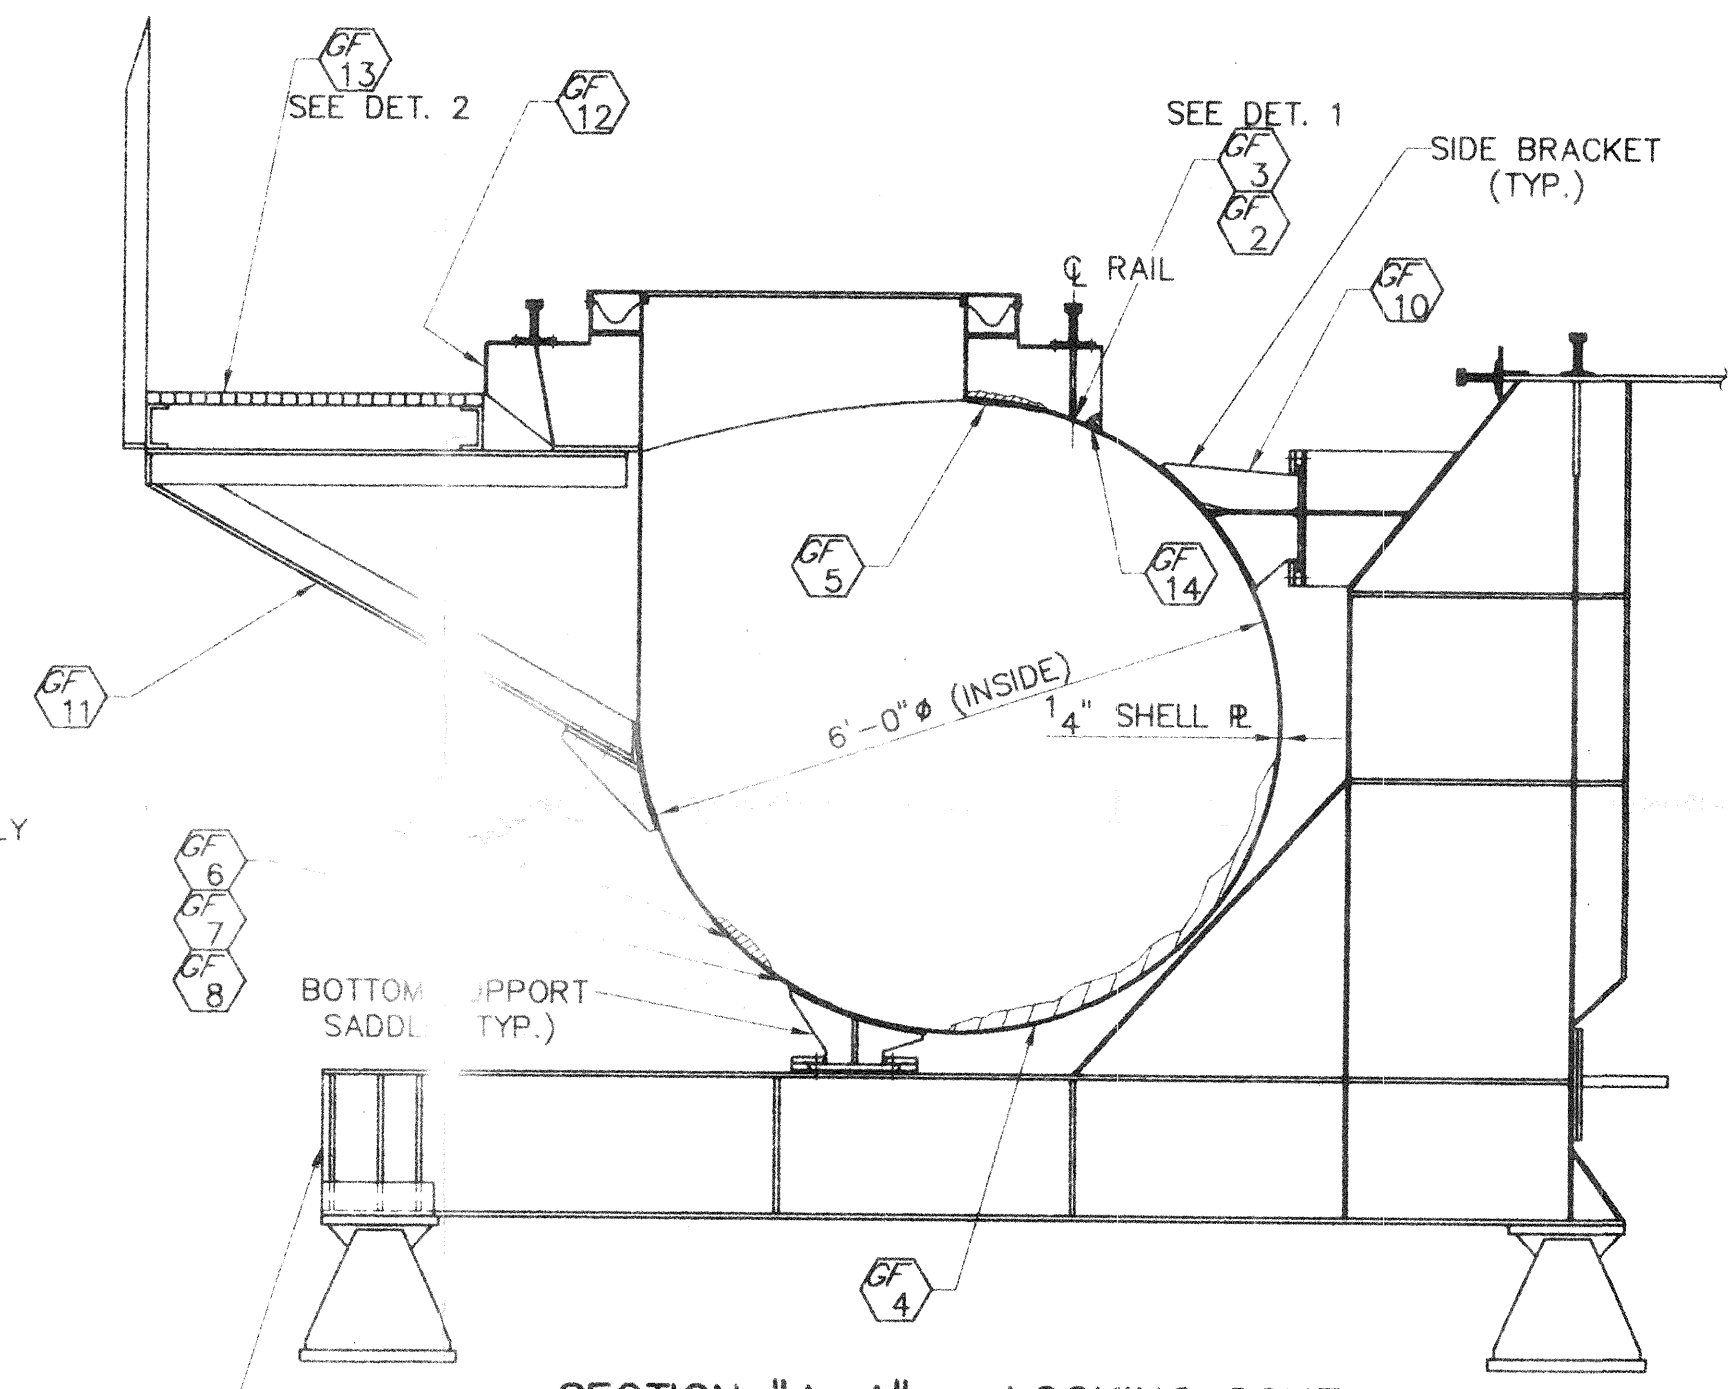
- GF 1 AN 18" x 100'-0" ± LONG AREA OF SHELL R OVER THE COKE WHARF IS BUCKLED AND RUSTED THIN. (DENTS EASILY WITH A HAMMER AND ULTRASONIC THICKNESS READINGS TAKEN RANGE FROM .11 TO .19.) THREE (3) RUSTED THROUGH AREAS WERE ALSO FOUND AT THIS LOCATION. (REFER TO DWG. 7672-1, SECTION "A-A", & THE SUMMARY CHART.)

- GF 4 THE LOWER WEST SIDE 90° AREA OF THE SHELL R WAS INACCESSIBLE FOR INSPECTION. THESE AREAS DISPLAY RUST PITTING AND SLIGHT GOUGING THROUGHOUT. (REFER TO SECTION "A-A".)

- GF 5 A 6" WIDE AREA OF SHELL R IS HEAVILY RUST LAYERED THROUGHOUT SUPPORTS No. 1 THROUGH 10 AND SPORADICALLY FROM SUPPORTS No. 10 THROUGH 15. THE AREA IS SUSPECTED OF BEING THIN. (REFER TO DWG. 7672-1, SECTION "A-A", & DETAIL 1.)

- GF 6 AT TEN (10) OF TWENTY-NINE (29) SADDLES THE SHELL R WAS FOUND TO BE RUSTED THIN AND THRU OR CRACKS WERE FOUND AT THE TOE OF THE CONNECTION WELD. (REFER TO DWG. 7672-1, SECTION "A-A" & THE SUMMARY CHART.)

- GF 7 AT TWENTY-FIVE (25) OF TWENTY-NINE (29) SADDLES THE DUCT BUCKLES IN AT VARIOUS DEPTHS, SUBSEQUENTLY IT IS ASSUMED THAT THE DUCT HAS DROPPED IN ELEVATION. (REFER TO SECTION "A-A", THE SECTIONAL PLAN VIEW, & THE SUMMARY CHART.)

- GF 8 ULTRASONIC THICKNESS READINGS (RANGING FROM .11 TO .25) WERE TAKEN ADJACENT TO THE SADDLES. AT FOURTEEN (14) LOCATIONS 36% TO 56% SECTION LOSS WAS EVIDENT. THE REMAINDER OF THE AREAS EXPERIENCED 16% TO 32% SECTION LOSS. (REFER TO SECTION "A-A", THE SECTIONAL PLAN VIEW, & THE SUMMARY CHART.)
