HKC Emission System Repairs
Dated: 1997

Subject: **ACME STEEL - CHICAGO PLANT**
Coke Batteries No. 1 and No. 2
Pushing Emissions Central System
Emissions Duct and Support Structure
Inspection Services

PROJECT NO. 05-7672-01
Acme P.O. X19098196

In reference to the above subject we are submitting this letter report to present the results of the Pushing Emissions Duct inspection. The inspection was conducted on December 16 and 17 of 1996, in cooperation with the Acme Coke Plant Maintenance Department.

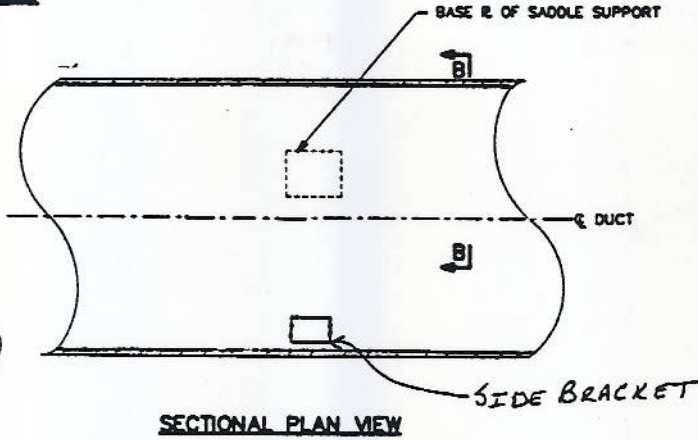
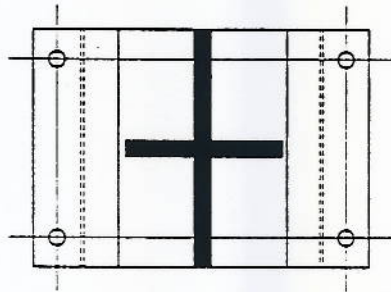
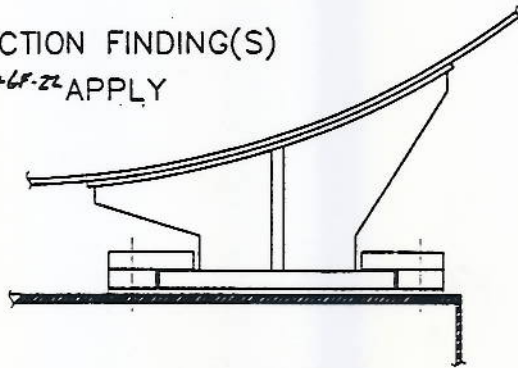
SADDLE LINE |

U.T. READINGS
.19 TO .23
(TYPICALLY
~10 TAKEN
@ EACH
SUPPORT)

NO NOTICEABLE
BUCKLE IN MAIN

GENERAL INSPECTION FINDING(S)
GF-19, GF-21, + GF-22 APPLY

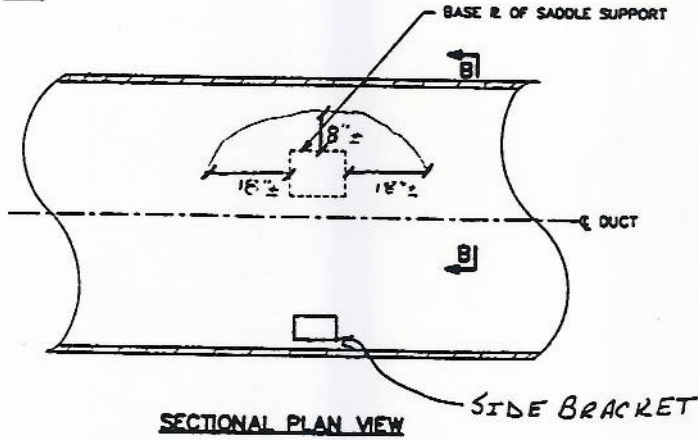
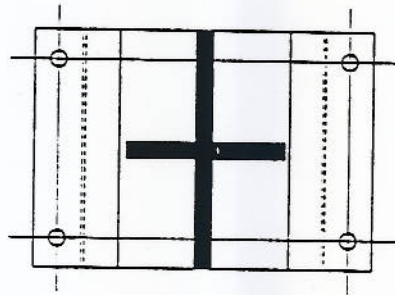
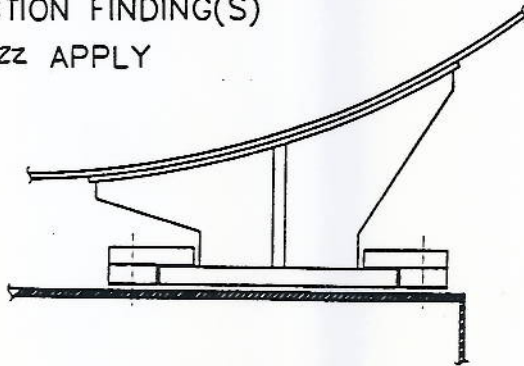
SADDLE LINE 1.5
(INACCESSIBLE)

1" ± DEEP
BUCKLE

(SUPPORT WAS INACCESSIBLE DUE TO ITS LOCATION - DEPTH AND AREA OF BUCKLE WERE ESTIMATED FROM GRADE)

GENERAL INSPECTION FINDING(S)

GF-99 THRU GF-22 APPLY

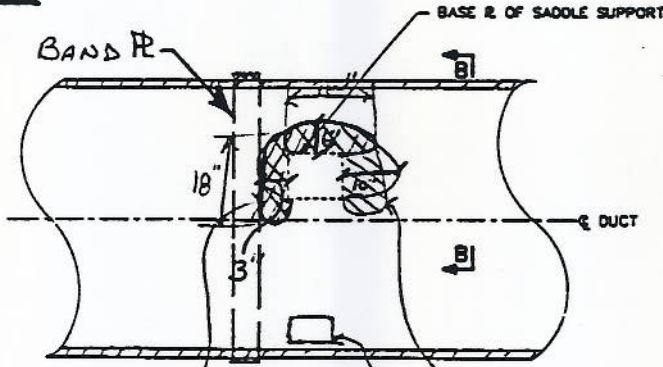
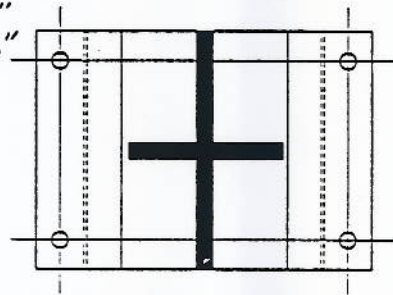
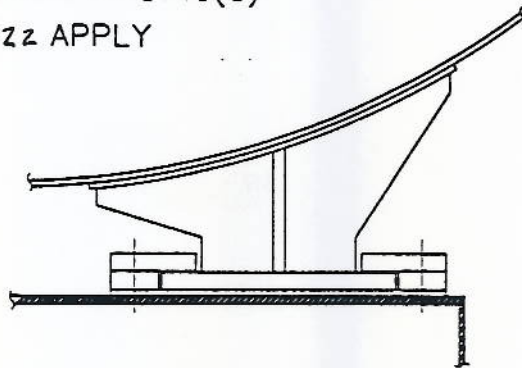
SADDLE LINE 2

UT READINGS
.19 TO .24
(U.N.O.)

1/4" DEEP MAX
BUCKLE

U.T. READINGS
.15 TO .19
SIDE BRACKET

RIT
Z AREAS
18" x 13"
6" x 16"

GENERAL INSPECTION FINDING(S)

GF-19 THRU GF-22 APPLY

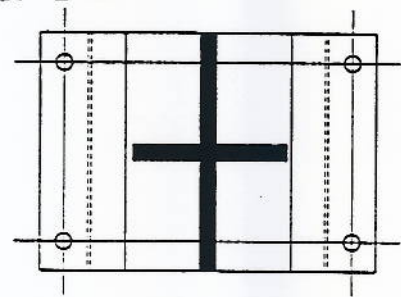
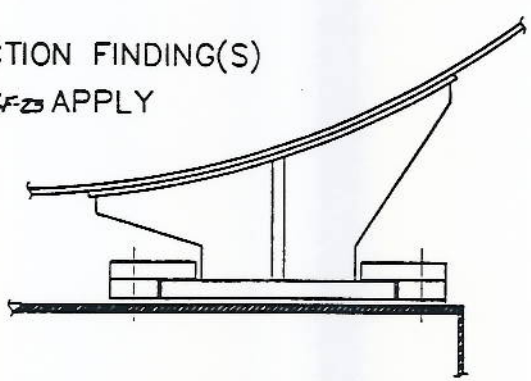
SADDLE LINE 2.5

2 1/2" DEEP M. BUCKLE

DENTS EASILY WHEN STRUCK

RIT
3" @ 3 SIDES OF SADDLE

INDENT IS CONTINUOUS FROM AROUND SADDLE LINE 3.5 TO ~8'-0" OF SADDLE LINE 2. (ENTIRE AREA ^{OF INDENT} IS RUSTED THROUGH)

GENERAL INSPECTION FINDING(S)
GF-19, GF-20, GF-21, + GF-23 APPLY

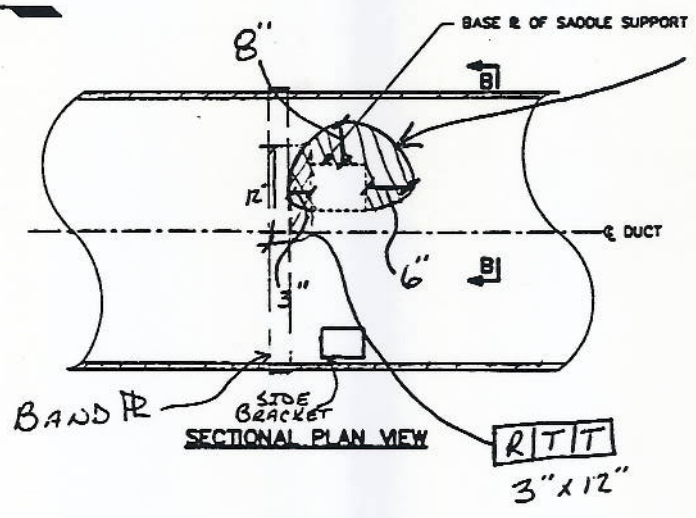
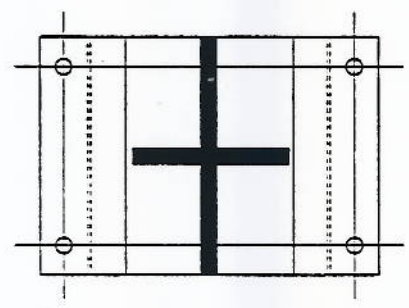
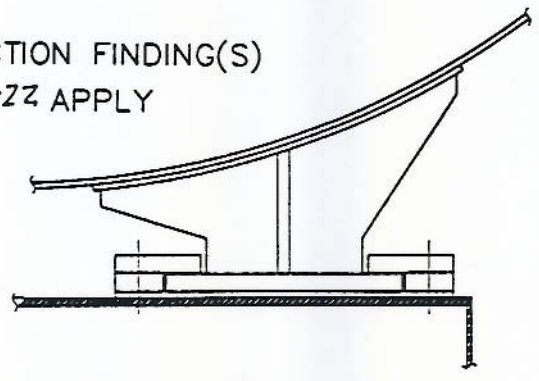
SADDLE LINE 3

U.T. READINGS
-19 TO -21
(U.N.O.)

U.T. READINGS
.11 TO .16

1 1/2" DEEP MAX
BUCKLE

INDENT IS CONTINUOUS
FROM AROUND SADDLE LINES TO
~8'-0" N. OF SADDLE
LINE 2.
ENTIRE AREA OF INDENT IS
RUSTED THIN &/OR THROUGH,

GENERAL INSPECTION FINDING(S)
GF-19 THROUGH GF-22 APPLY

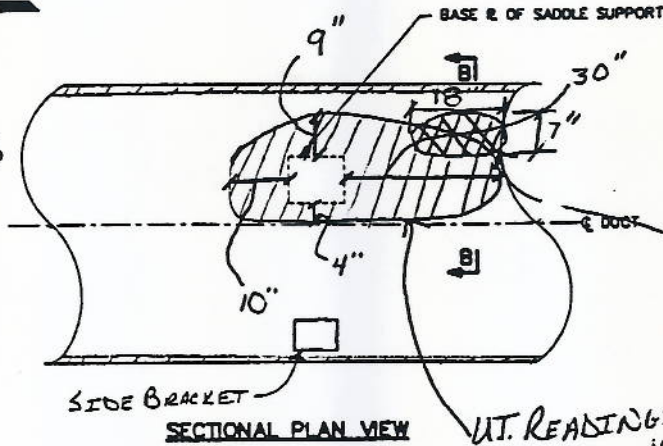
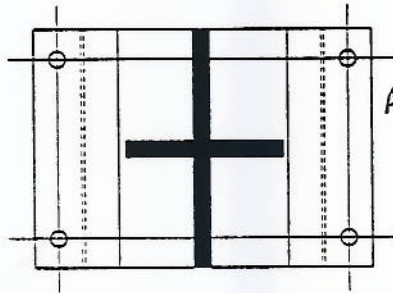
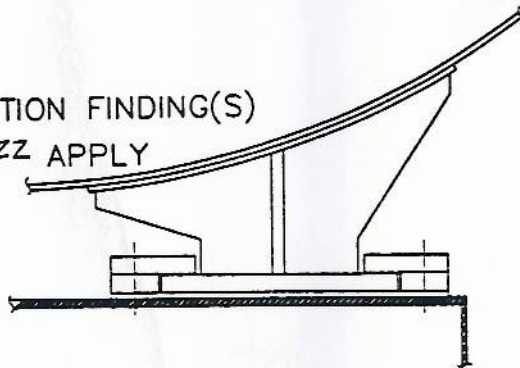
U.T. READINGS
.20 TO .24
(U.N.O.)

RT 4/CR T
18" x 7"

U.T. READINGS
.13 TO .19

2' Z" DEEP MAX
BUCKLE

INDENT IS CONTINUOUS FROM
AROUND SADDLE LINE 3.5 TO ~8'-0"
OF SADDLE LINE Z.
(ENTIRE AREA OF INDENT IS
RUSTED THIN & /OR THROUGH)

GENERAL INSPECTION FINDING(S)
6F-19 THRU 6F-22 APPLY

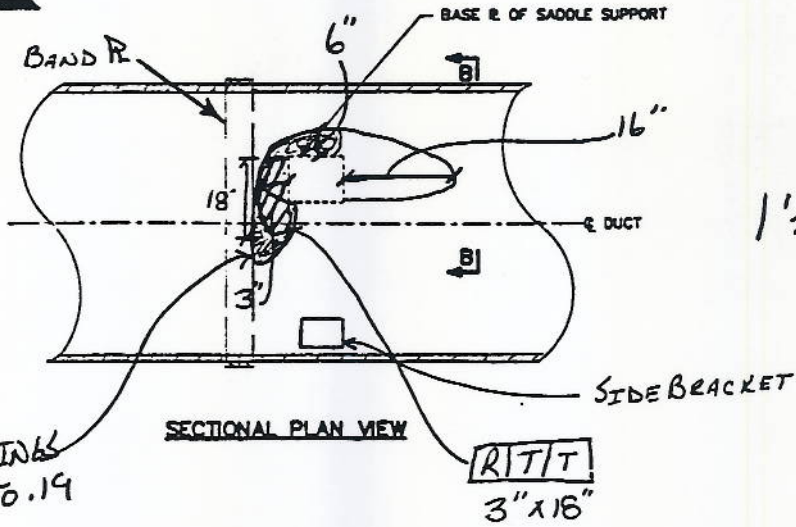
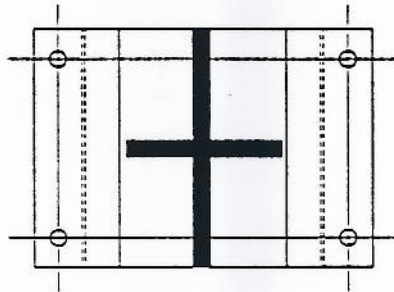
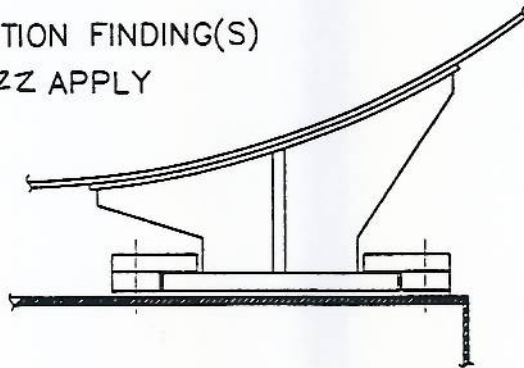
SADDLE LINE 4

UT READINGS
.21 TO .24
(U.N.O.)

1 1/2" DEEP MAX
BUCKLE

UT READINGS
.13 TO .19

RIT
3" x 18"

GENERAL INSPECTION FINDING(S)
GF-19 THRU GF-22 APPLY

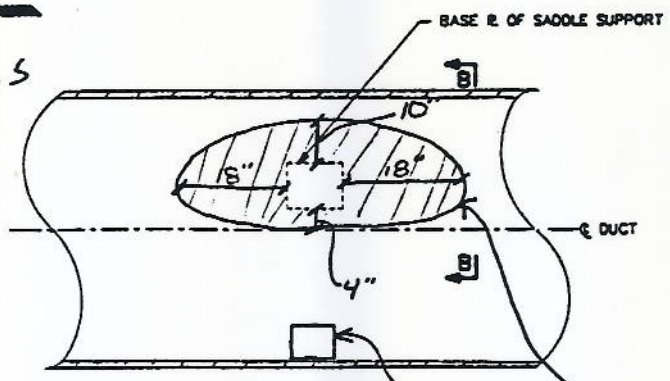
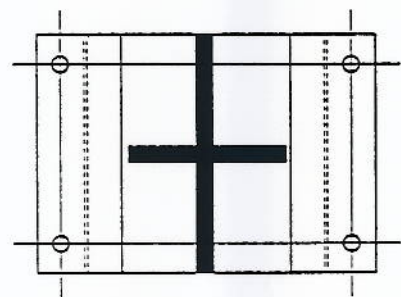
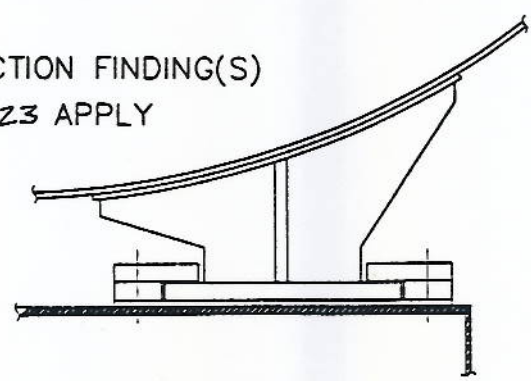
SADDLE LINE 4.5

U.T. READINGS
.20 TO .24
(U.N.O)

2" DEEP MAX
BUCKLE

U.T. READINGS
.13 TO .19

GENERAL INSPECTION FINDING(S)
GF-19 THRU GF-23 APPLY
