Pinion Wall Inspection

Subject: **Acme - Chicago Coke**  
Coke Plant - Battery  
South Pinion Wall  
Floor Steel & Concrete Dock  
1998 Inspection

**Project No. 05-8126**  
ACME P.O. No. 7000000-880  
CSMP ID No. 10-2-1146

SUBJECT ACME STEEL - CHICAGO COKE PLANT  
 SOUTH PINION WALL #1 BATTERY  
 ALLEYWAY FLOOR STEEL & CONG. DECK

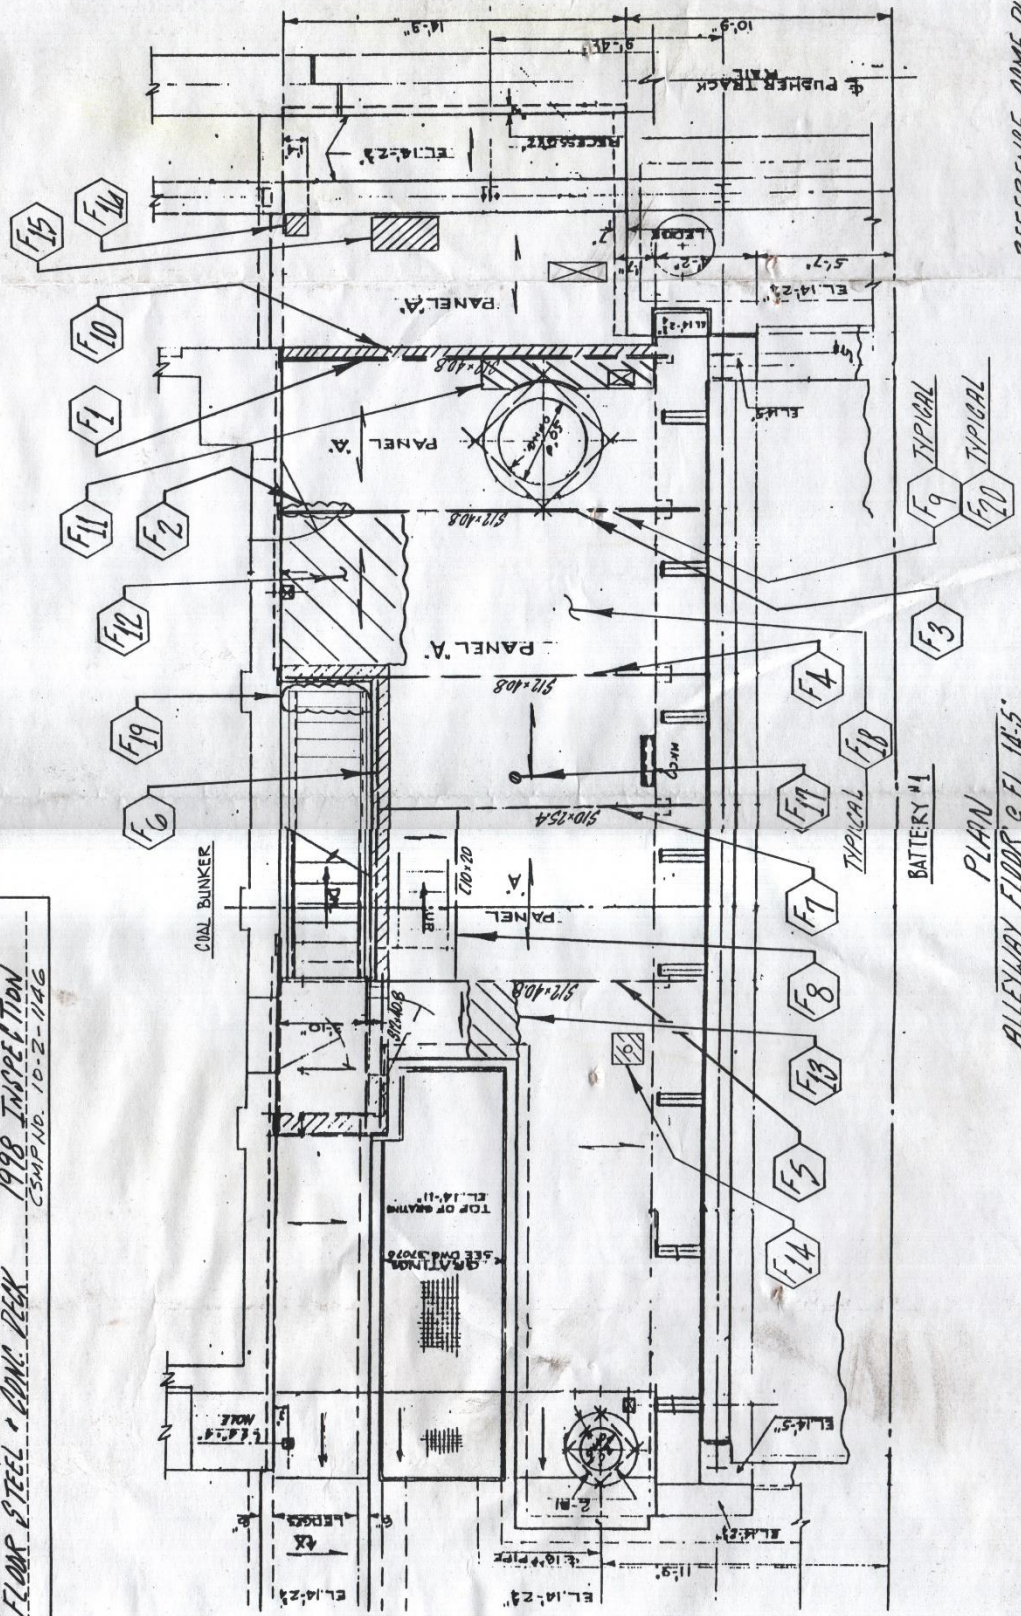
BATTERY #1  
 PLAN  
 ALLEYWAY FLOOR @ EL. 14.5

F1) The S12 is heavily rust layered and rusted thin and through throughout.

F2) The S12 and related seat assembly is rusted thin and through at the south end 24".

F3) The remainder of the S12 bottom flange exhibits approximately 50% section loss.

- F4) Ultrasonic thickness testing was conducted on the S12 web ranging from .47" to .48", indicating 0% section loss (.428" [7/16"] original thickness). The top and bottom flanges exhibit only slight section loss.

- F5) Ultrasonic thickness testing was conducted on the S12 web ranging from .46" to .47", indicating 0% section loss (.428" [7/16"] original thickness). The top and bottom flanges exhibit only slight section loss.

- F6) Ultrasonic thickness testing was conducted on the S12 web ranging from .45" to .47", indicating 0% section loss (.428" [7/16"] original thickness). The top and bottom flanges exhibit only slight section loss.

- F7) Ultrasonic thickness testing was conducted on the S10 web ranging from .25" to .27", indicating 13% to 20% section loss (.311" [5/16"] original thickness). The top and bottom flanges exhibit only slight section loss.

- F8) Ultrasonic thickness testing was conducted on the C10 web ranging from .46" to .47", indicating 0% section loss (.428" [7/16"] original thickness). The top and bottom flanges exhibit only slight section loss.

- F10) 17'-0" long by 3'-0" wide area by 3" deep with exposed rusted thin and through rebar.
- F11) 6'-6" long x 2'-6" wide area by 3" deep with exposed rusted thin and through rebar.
- F12) 6'-0" long by 6'-0" wide area by 3" deep with exposed rusted thin and through rebar.
- F13) 3'-0" long by 2'-0" wide area by 3"± deep with exposed rusted thin and through rebar.
- F14) 18" long by 18" wide area by 3"± deep with exposed rusted thin and through rebar.
- F15) 5'-0" long by 4'-0" wide area by 3"± deep with exposed rusted thin and through rebar.
- F16) 2'-0" long by 2'-0" wide area by 3" deep.
- F17) 2" diameter hole through concrete deck.

- F18) The underside of the concrete deck is sporadically cracked throughout.
- R18/P4) Monitor deficient area of concrete on a monthly basis with the intent of removing and replacing the concrete slab "in-kind" in the next twelve (12) months. Refer also to Finding "F17".

R1/P3) Replace the deficient S12 "in-kind" as required.

P3) Replace the S12 and seat assembly "in-kind" as required.

- P4)** Monitor deficient area of concrete on a monthly basis with the intent of removing and replacing the concrete slab "in-kind" in the next twelve (12) months. Refer also to Finding "F18".
