COG Line Failure

To: Mr. J. T. Seaman
From: V. Beaucaire
Subject: Investigation of Coke Oven Gas Line Failure
at Chicago "A" Furnace
Reference: D3-002-001

Subject: Investigation of COG Line Failure in Chicago "A" Furnace

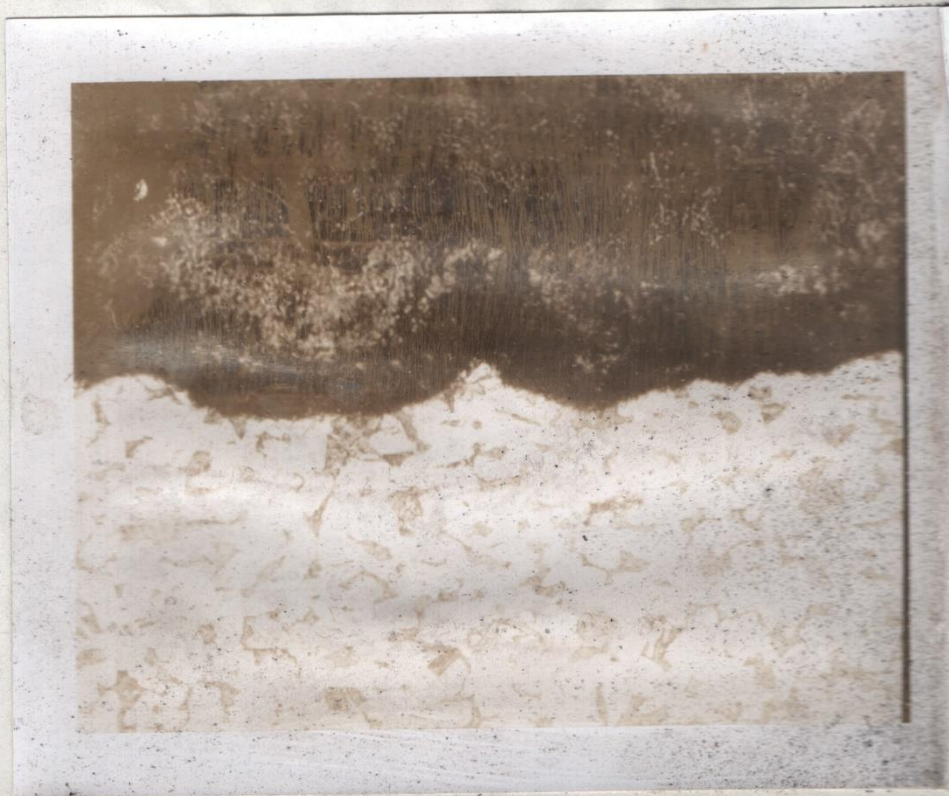
1. Pipe line was made of carbon steel 0.22% carbon, $R_B \approx 80$.
2. Corrosion usually was uniform corrosion. Some locations ended up only half its original thickness left. (Figure 1)

Figure 1. Uniform Corrosion on COG Line ($\times 200$)

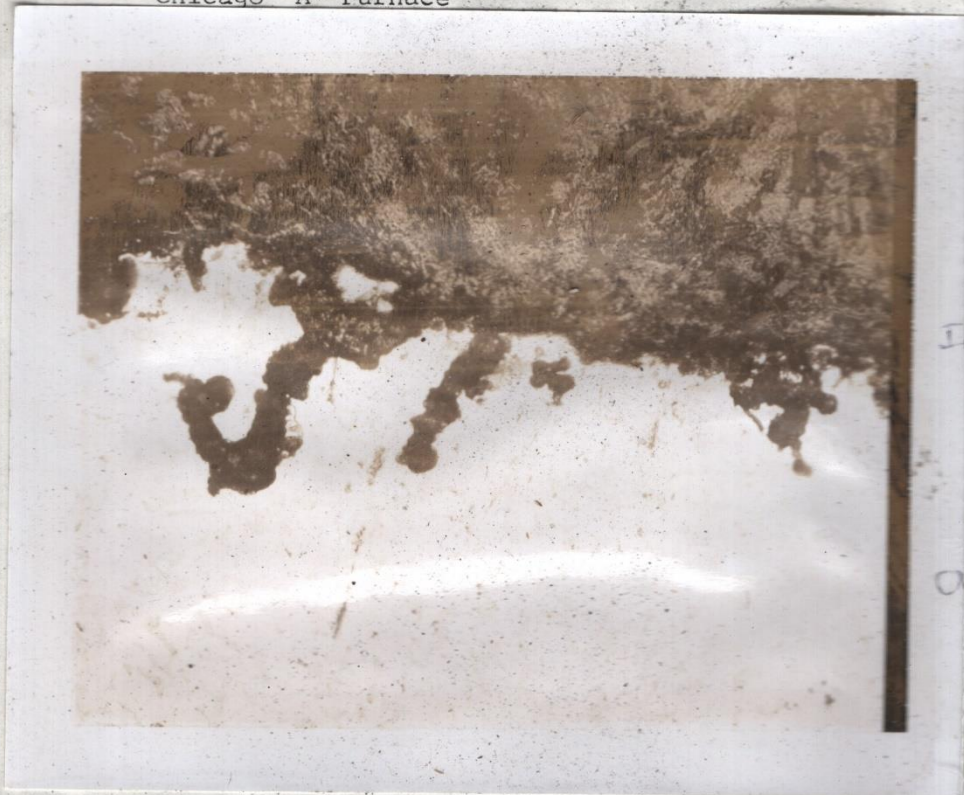
3. Only few corrosion pits were found. This was the major reason of failure. However, mild steel are not too sensitive to pit. Maybe these two reasons are why that pipe could last for 12 years. (Figure 2 and 3).

Figure 2. Pit Corrosion on COG Line, 200X

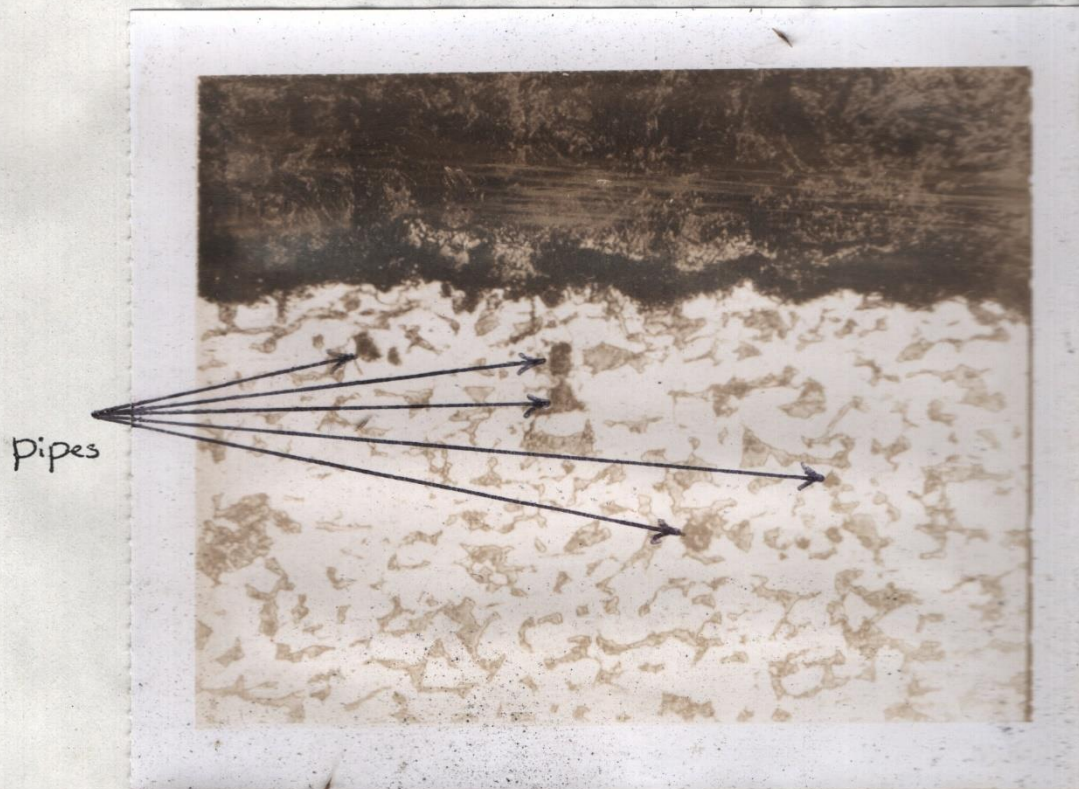
Figure 3. Another Example of Pit Corrosion on COG Line, 200 X. There are also some corrosion pipes away from surface.

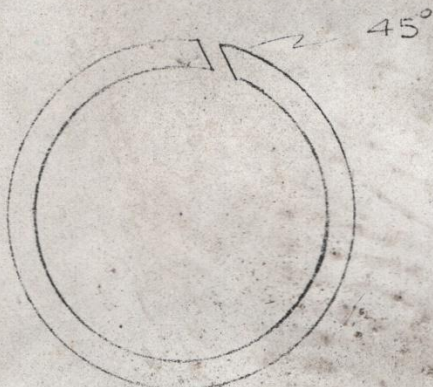
4. The cleavage is 45° to its radial direction, since 45° to the tension direction has the highest shear stress^s (Figure 4). In addition, the longitudinal direction of cleavage was coincident with the grain structure of seamless pipe. (Figure 5).

Figure 4. Cross Section of COG Line

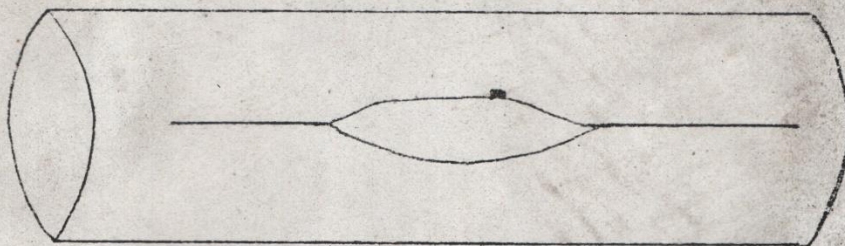
5. The origin of failure was almost in the center of burst.

Figure 5. Burst of COG Line
