OSHA Overhead Crane Inspections
Dated: 1983

1983 OSHA STRUCTURAL INSPECTION
OF THE
MAINTENANCE SHOP OVERHEAD CRANE
AND
SUPPORT SYSTEM
AT THE
COKE PLANT

1983 OSHA Structural Inspection
Maintenance Shop Overhead Crane & Support System
at the Coke Plant
April, 1983

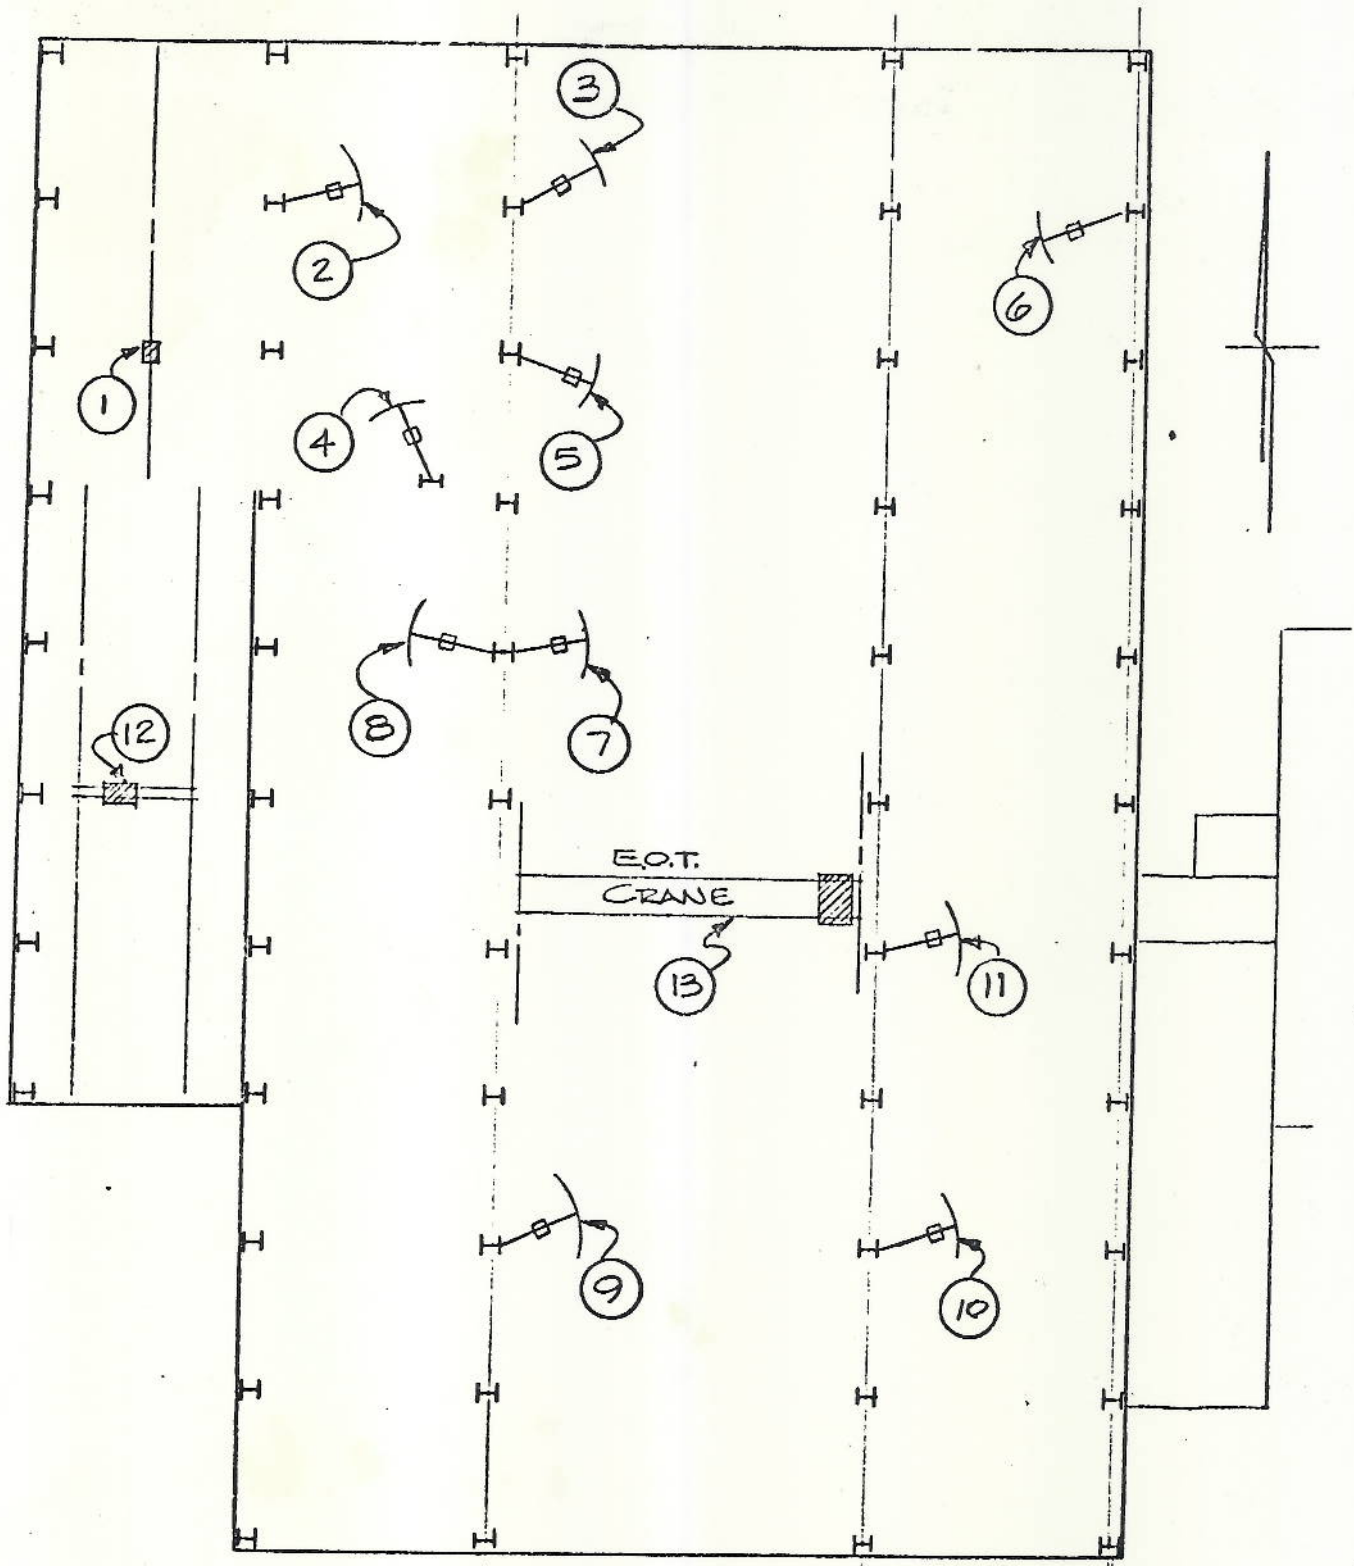
Dwg. No.
C-55-I

Annual Structural Inspection
Chicago Coke Plant Machine Shop
Overhead & Jib Cranes Arrangement

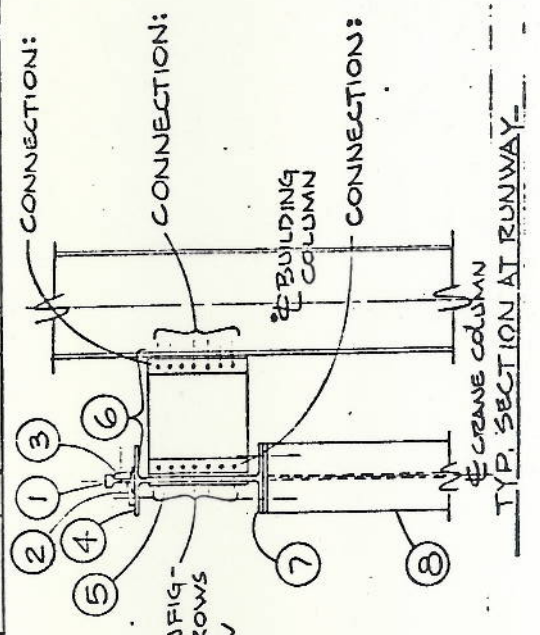
CRANE RUNWAY
SUPPORT INSPECTION
CRANE: **EAST**
RUNWAY SYSTEM
DATE: _____ PAGE No. _____

①	②	③	④	⑤	⑥	⑦	⑧	CRANE COLUMN FOUNDATION	REPAIR REQ'D
SOUTH To NORTH	CRANE RAIL	RAIL CLIPS	RAIL SPLICE BAR BOLTS	CRANE GIRDER	GIRDER SPICE	GIRDER TO COL. DIAPHRAGM	GIRDER TO CRANE COL. SEAT CONNECTION	CRANE COLUMN	CRANE COLUMN FOUNDATION	REPAIR REQ'D
col. 1		2L RI								
col. 2		3L RI								
col. 3										
col. 4		3L RI								
col. 5										
col. 6		3L RI								
col. 7										
col. 8		4L RI								
col. 9		2L RI								
col. 10										
11

**NOTE: CRANE
GIRDERS AND
COLUMNS IN
Good Condition**

REPAIRS	REPAIRS REQ'D.	CONDITION	RECOMMENDED ACTION
R1		LOOSE BOLTS	TIGHTEN BOLTS
R2		MISSING OR SHEARED BOLTS & LOOSE, MISSING, OR SHEARED RIVETS	REPLACE WITH HIGH STRENGTH BOLTS
R3		MISSING OR SHEARED SPLICE BAR BOLTS	REPLACE WITH PROPERLY SIZED SPLICE BAR BOLTS

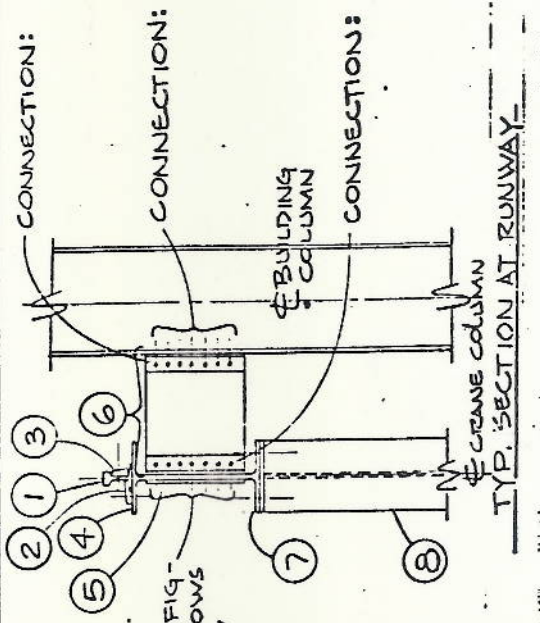
CRANE RUNWAY SUPPORT INSPECTION
CRANE: **WEST**
RUNWAY SYSTEM
DATE: _____ PAGE NO. _____

①	②	③	④	⑤	⑥	⑦	⑧	CRANE COLUMN FOUNDATION	CRANE COLUMN
	CRANE RAIL	RAIL CLIPS	RAIL SPICE BAR BOLTS	CRANE GIRDER	GIRDER SPICE	GIRDER TO COL. DIAPHRAGM	GIRDER TO CRANE COL. SEAT CONNECTION	CRANE COLUMN	CRANE COLUMN FOUNDATION	CRANE COLUMN
SOUTH To NORTH										
col. 1										
col. 2		2L								
col. 3			2L							
col. 4		4L								
col. 5		2L								
col. 6			2L							
col. 7		3L								
col. 8		2L								
col. 9		4L								
col. 10										
11

NOTE:
CRANE GIRDERS
And columns
IN Good
CONDITION.

REPAIRS REPAIRS REQD.	CONDITION	RECOMMENDED ACTION
R1	LOOSE BOLTS	TIGHTEN BOLTS
R2	MISSING OR SHEARED BOLTS & LOOSE, MISSING, OR SHEARED RIVETS	REPLACE WITH HI-STRENGTH BOLTS
R3	MISSING OR SHEARED SPICE BAR BOLTS	REPLACE WITH PROPERLY SIZED SPICE BAR BOLTS
