Mill Water Discharge Pump Inspection  
Dated: 2000

**Subject:** Chicago Coke Plant  
Mill Water Pumps – Discharge Header  
Inspection & Engineering Services

**Project No. 00-198**

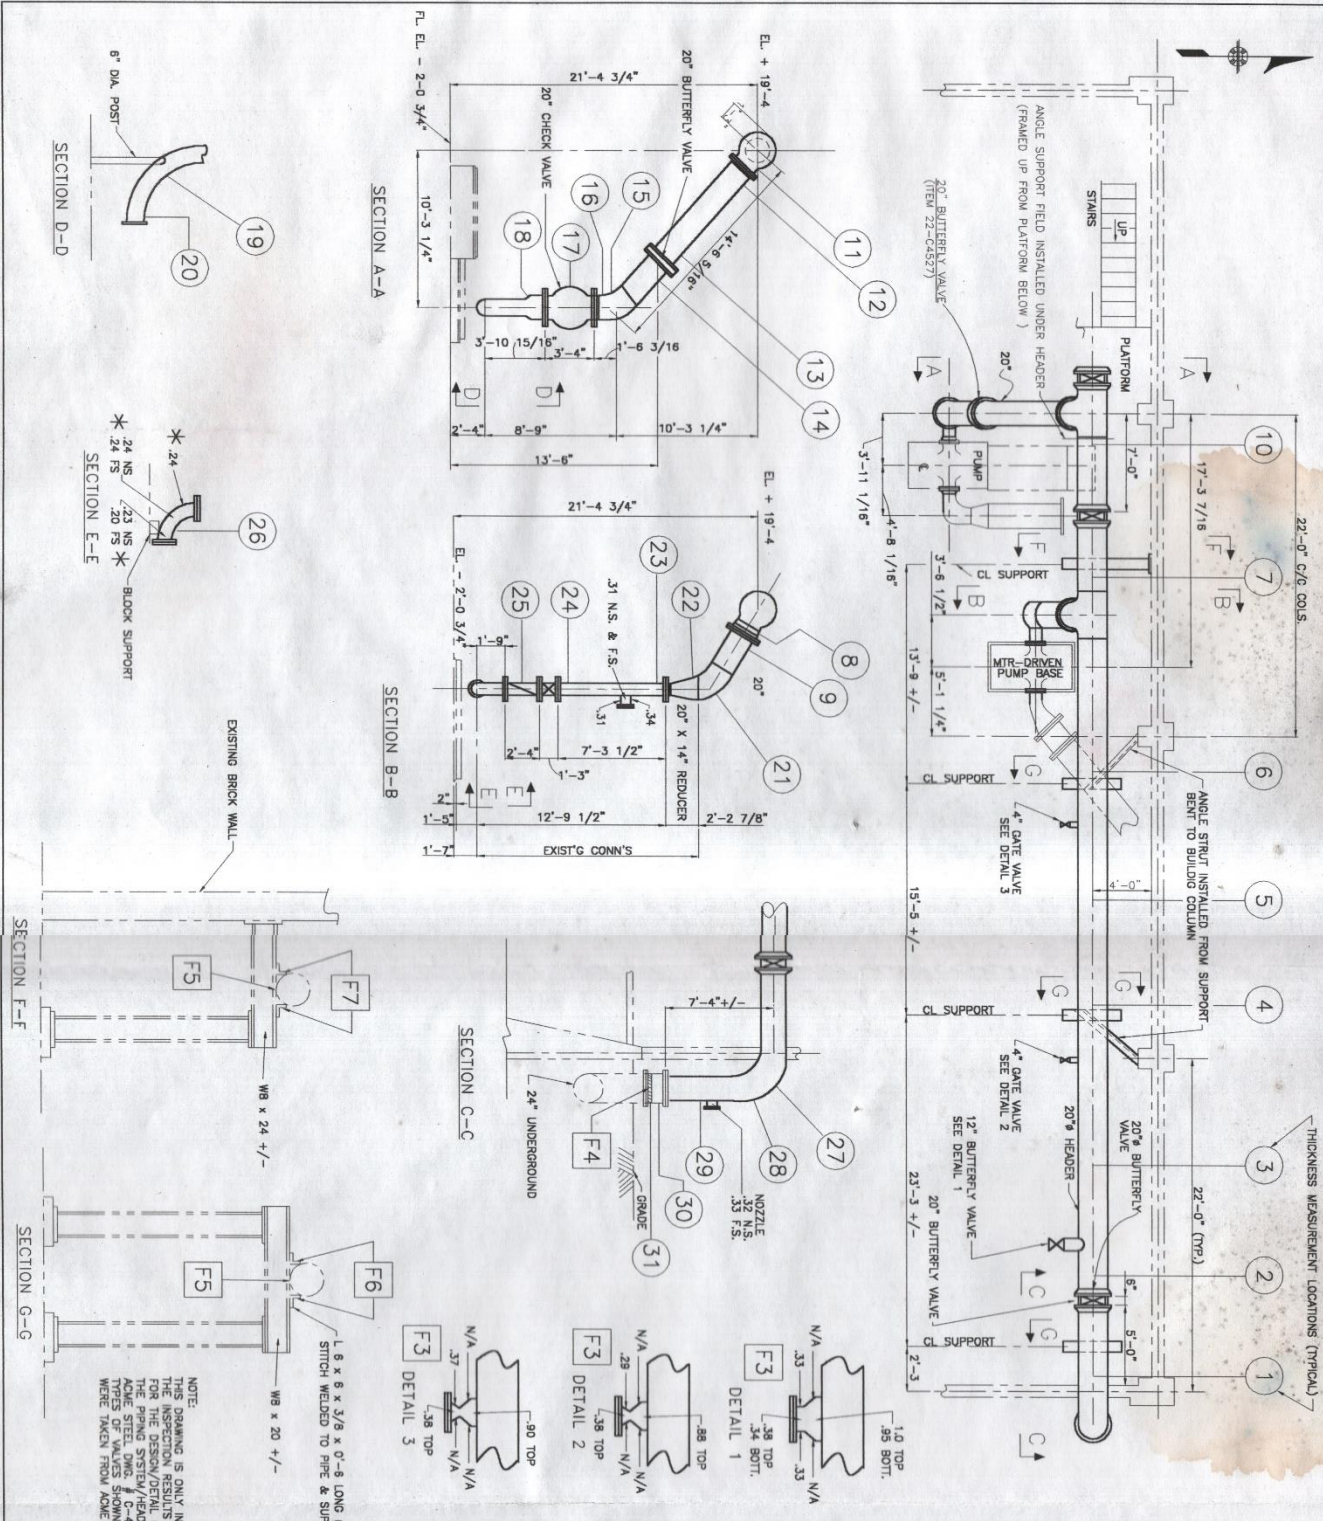
**F1** – The exterior surfaces of the header piping is light to moderately rust layered with surface pitting of 1/16" to 1/8" in depth. This condition exists at approximately 90% of the piping surface area. Only approximately 5% to 10% of the protective coating is intact.

**F2** – Approximately 200 thickness measurements (consisting of 31 stations, plus nozzle locations) were taken on the header piping. The section loss broken down per station, ranged from 0% to 28% section loss, with a calculated overall section loss of 10.58%. The 28% section loss occurs just above the B & S connection to the underground piping (refer to U. T. Station 31). It should be noted that the measurements located at Stations 17 & 26 were erratic and the material is most likely comprised of cast iron. Therefore, these readings were excluded from the section losses noted above.

**F3** – Thickness measurements could only be obtained on the 4" and 12" valve nozzles at isolated areas (See Details 1, 2 & 3).

**F4** – At the exterior of the Powerhouse, a 3" area of the header is heavily rust layered just above the B. & S. connection to the under ground pipe. (Refer to U.T. Station 31).

**F5** – The connection area between the header and support beam is rust packed by 1/8" +/- and the top flange of the support beam between the guide angles is rusted with 33% +/- section loss. This occurs at all 4 supports. At this time, the pipe wall does not appear to be significantly rust gouged at the supports (based on visual inspection).

**F6** – The vertical leg of the header guide angles are deteriorated with approximately 33% section loss (at 3 supports). These 6 x 6 x 3/8 x 0'-6 long angles are stitch welded to the pipe and the support beam, and in most cases the welds to the pipe are cracked.

**F7** – The vertical leg of the header guide angles are deteriorated with approximately 66% section loss (at one support).

STA.	A	B	C	D	E	F	G	H
1	.34	.29	.36	.32	.35	.34	.33	.37
2	.36	.36	.35	.34	.31	.34	.33	.33
3	.38	.36	.30	-	-	-	.36	.35
4	.35	.35	.36	.31	.33	.32	.35	.32
5	.32	.31	.35	.31	.37	.32	.29	.31
6	.33	.34	.34	-	-	.33	.33	.32
7	.37	.37	.26	-	-	.36	.34	-
8	.47	.48	-	-	-	.46	.46	-
9	.36	.33	-	-	-	.34	.33	-
10	.33	.32	.34	.32	.30	.30	.32	.28
11	.45	.40	.46	.38	.27	.39	N/A	.46
12	-	-	.36	.29	.29	.32	.32	-
13	.30	.34	-	.34	.25	.25	.30	.33
14	.35	.34	-	.27	.32	.28	.31	.27
15	.29	.28	-	-	.34	.37	.32	-
16	.28	.29	.33	.30	.36	.32	.28	.28
17	.27	.22	.27	.24	.28	-	.32	-
18	.38	-	.34	.37	.33	.39	.38	.34
19	.33	-	.34	.33	.35	.34	.34	.28
20	.31	-	.30	-	.33	-	.35	-
21	.37	.38	.38	-	-	-	.37	.37
22	.39	.44	.44	-	-	-	.36	.36
23	.33	.34	.34	-	-	-	-	-
24	.30	.33	.31	.31	.30	.31	.31	.32
25	.31	-	.30	-	.30	-	.30	-
26	.23	-	.17	-	-	-	.30	-
27	.43	.40	.39	.39	.38	.38	.37	.39
28	.38	.38	.39	.42	.39	.36	.40	.40
29	.37	.33	.37	.38	.36	.38	.38	.39
30	.32	.32	.32	.33	.31	.32	.30	.34

31	.23	.29	.28	.29	.27	.28	-	.26

\* DENOTES WHERE MEASUREMENTS WERE ERRANT. THE SUBJECT MATERIAL IS MOST LIKELY DISTORTION.

The results of this inspection and engineering review indicate that the mechanical integrity of the pipe is adequate at the present time. The thinned guide angles of the header (finding F6 & F7) should be scheduled for replacement during the year 2001. Based on practical experience, it is recommended that the new guide angles (adjacent to U.T. Station 6) be welded to the header and to the support. All other guide angles should be installed up against the wall of the header and welded to the support only. A cleaning and painting effort of the header and supports should also be implemented to deter further deterioration. This cleaning/coating effort should put special emphasis at the header to support locations along with the top flange of the supports. If a cleaning and painting program is not implemented in the near future, the need to implement additional repairs can be expected.
