Suction Main Inspection

1977 INSPECTION OF 36" DIAMETER  
SUCTION MAIN IN COKE PLANT  
EXHAUSTER BUILDING

Chicago Plant  
Chicago, Illinois

EC-77-2205

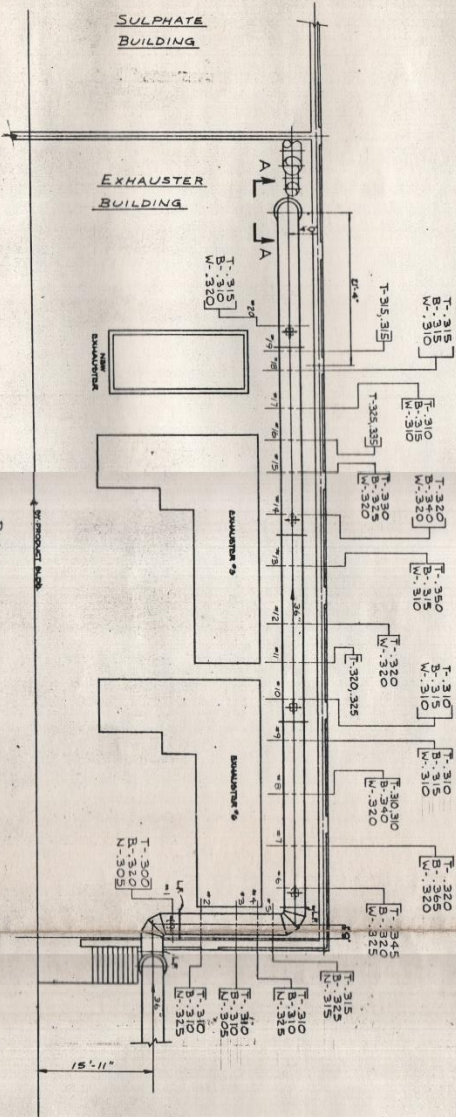
PLAN  
Suction Piping Above  
OPERATING FLOOR

NOTES:  
1. Wagon Plugs Were Found In  
The Top Of The Pipe At Readings  
8, 11, 16, & 19, (For Fire Stream Cleaning)  
2. A DECK WAS FOUND ON THE WEST  
SIDE OF THE PIPING ALONG THE WEST  
SIDE OF THE PLANT BUSTLING ON  
THE WEST SIDE OF PIPE BETWEEN  
READINGS 12 & 13 AND ON THE BOTTOM  
OF PIPE BETWEEN READINGS 14 & 15.

NOTE:  
ORIGINAL PIPE THICKNESS FOR  
READINGS # 21 & # 22 IS 3/8" - 3/125"
