Acme Coke
11236 S. Torrence Ave.
Chicago IL 60617

Bustle Pipe Repairs

Dated: 1975-1977

To: Mr. N. H. Keyser
From: C. Lin
Subject: Investigation of Bustle Pipe Failures
in Chicago "A" Furnace
Reference: D3-002-001

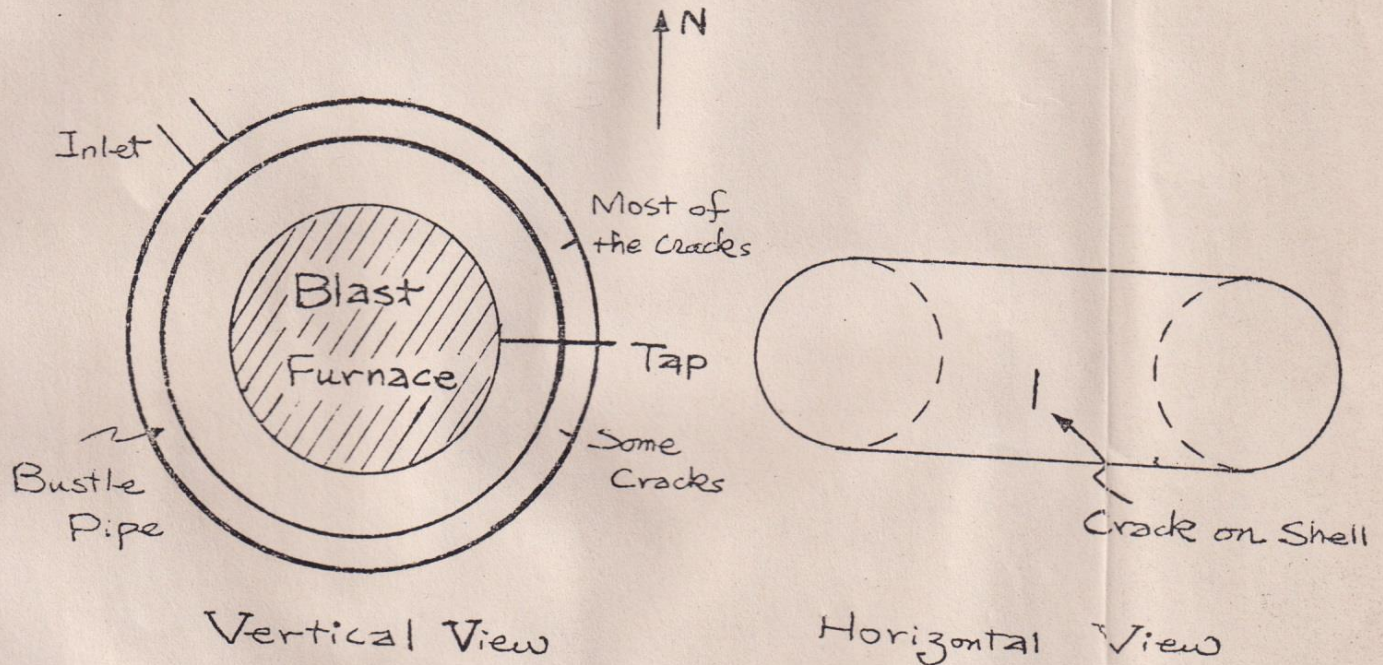
Figure 1: Location of Cracks

1. Nearby the major crack, there were lots of secondary cracks. These secondary cracks, as well as major cracks, were perpendicular to bustle pipe direction (radial direction to the blast furnace). (Figure 1).

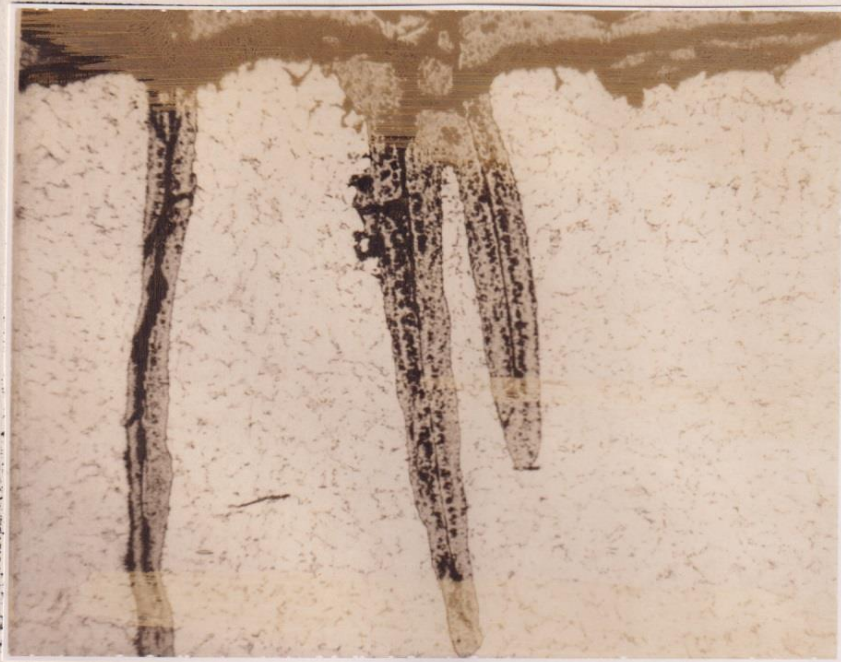
Figure 2. Secondary Cracks on Bustle Pipe (X80).

2. All these secondary cracks were straight and transgranular. They were perpendicular to the maximum tension stress direction, and tell us that the bustle wall had no strength at all under that service circumstance. (Figure 2)

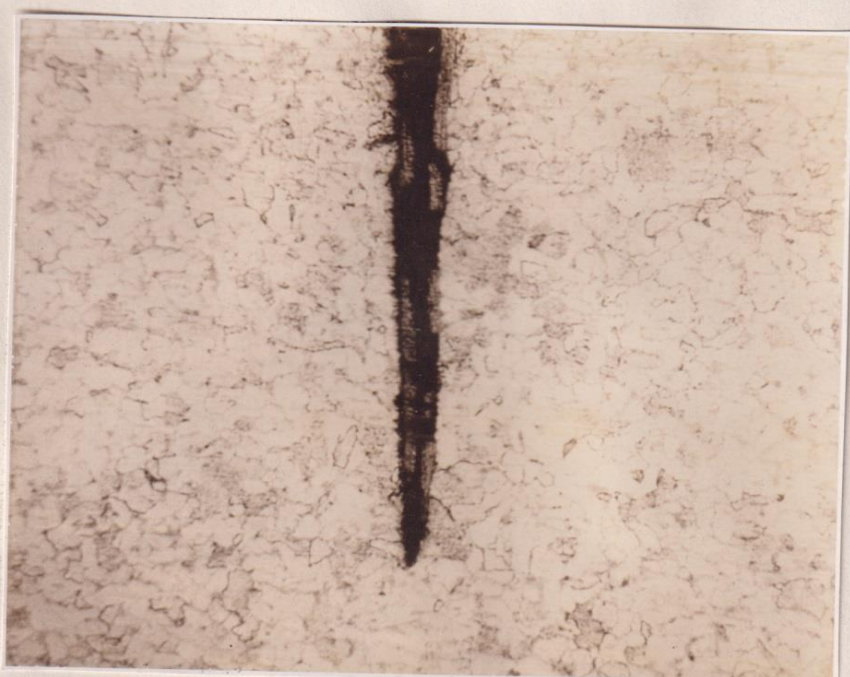
Figure 3. Typical Bustle Pipe Secondary Crack (X80).

3. Thicker iron oxide at the beginning of the crack (near the surface) than the end of crack indicated that the entire cracking process was a time-consuming process. This process might take months or years just like creep test at elevated temperature (Figure 3).

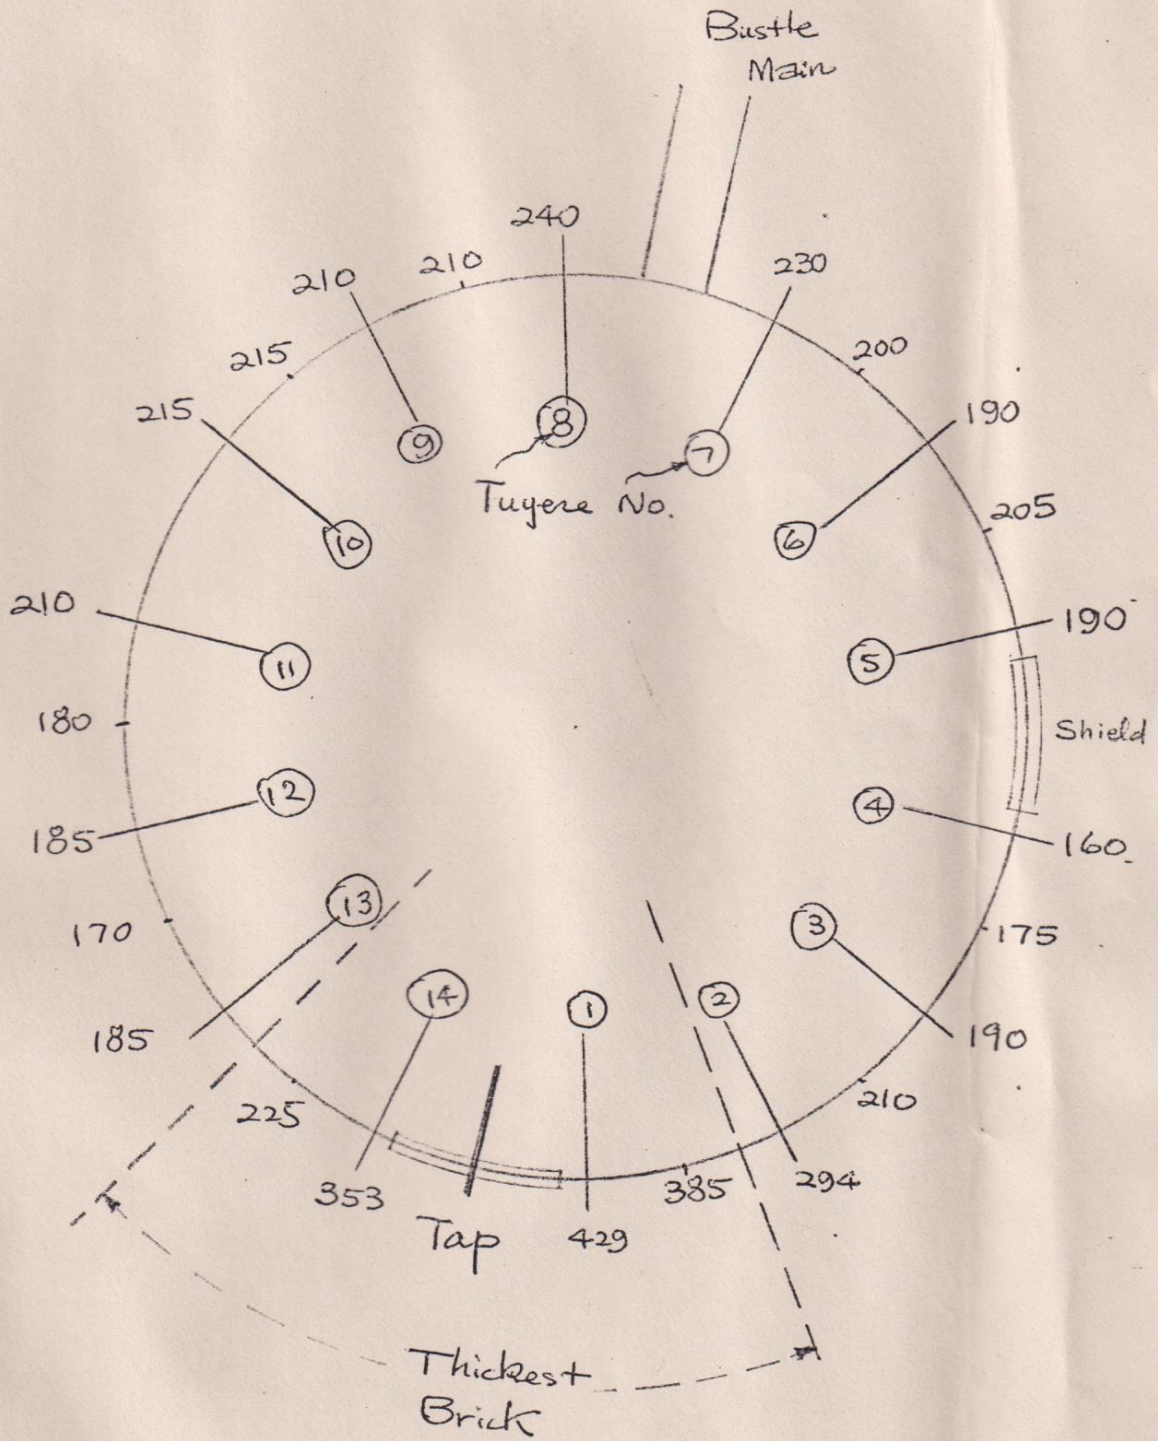
Fig. 1 Chicago "A" Furnace Bustle Pipe Temperature, °F. 12-2-75

2. Temperature measurements taken along the bottom of "A" bustle pipe on December 2, 1975 showed the pipe to be hottest along the 30 foot span of thickest refractory, the area where it should have been coolest (Figure 1). This indicates that the entire 30 foot span of refractory had apparently sustained damage prior to that date.

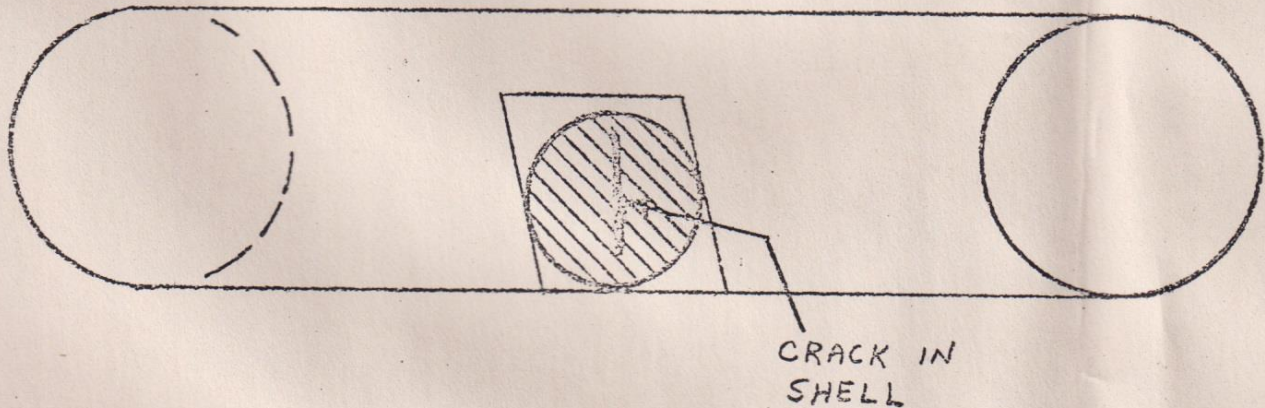
Figure 1. Orientation of Temperatures

Figure 1 illustrates the orientation of the series of temperatures measured.

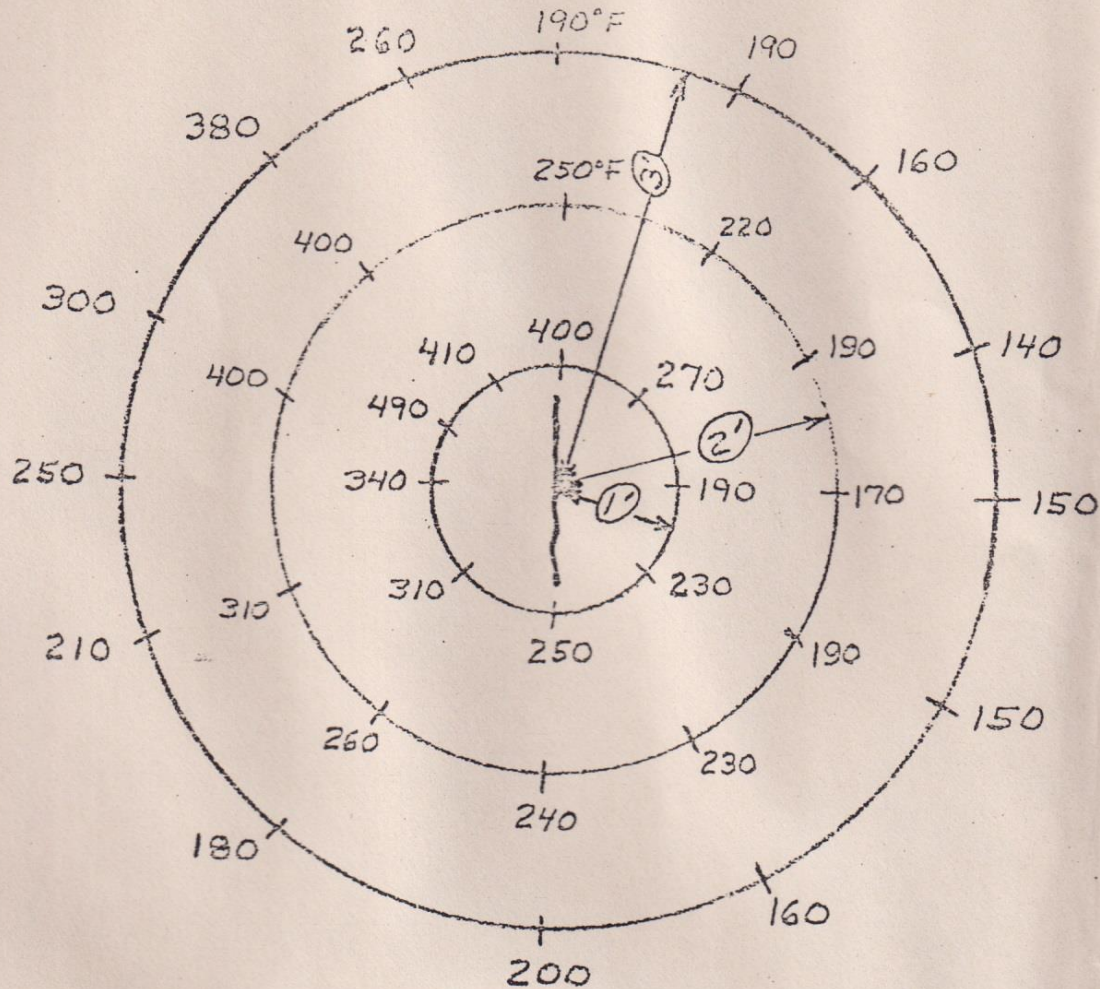
Figure 2. Measured Temperatures

The temperature gradient indicates that the hot air may be channeling behind the brickwork from the 9 to 11 o'clock position. Therefore, grouting of the main in this region may patch up any existing channels.

If the crack reopens again, the pipe will be checked with the Thermovision (if available). Possibly, a hot spot line through the brickwork will be visible. Seeing this hot spot, grout could then be pumped into the main at the locations of the hot spot. This grouting should close off any channeling of hot air from the interior of the main out to the crack in the shell.

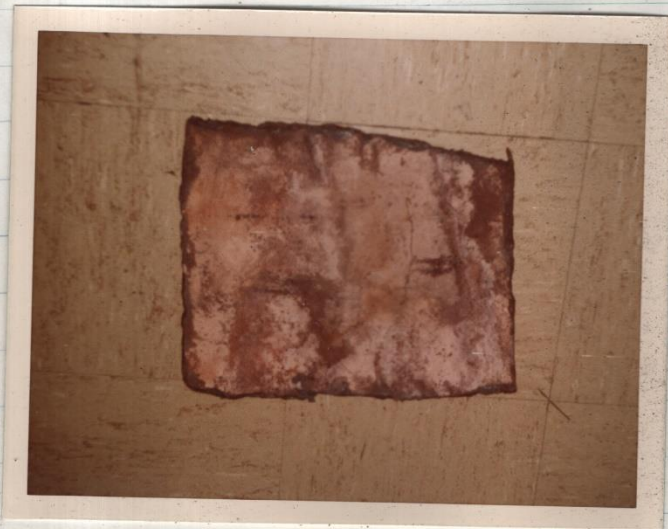
Fig. 2 The Cracks on Bustle Pipe

The first appearance of the cracks on that bustle pipe was similar to the crack of mud pie due to shrinkage after drying.

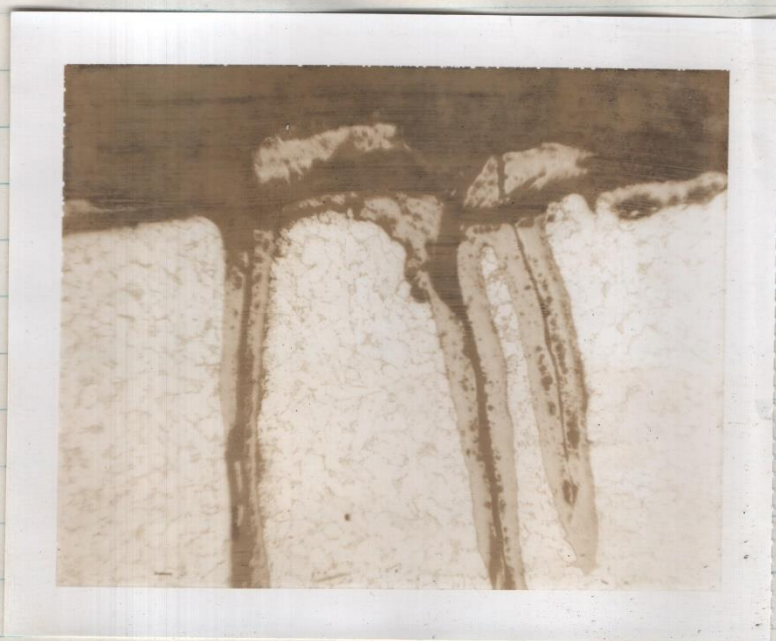
Fig. 5 Secondary Cracks on Bustle Pipe

Sample No. 1 through No. 4 were in the vicinity of the major crack. No. 5 and No. 6 were away from the major crack. All secondary cracks were found to be straight, ~~and~~ transgranular, perpendicular to maximum tensile direction and 6 and containing iron oxide. (Fig. 5)

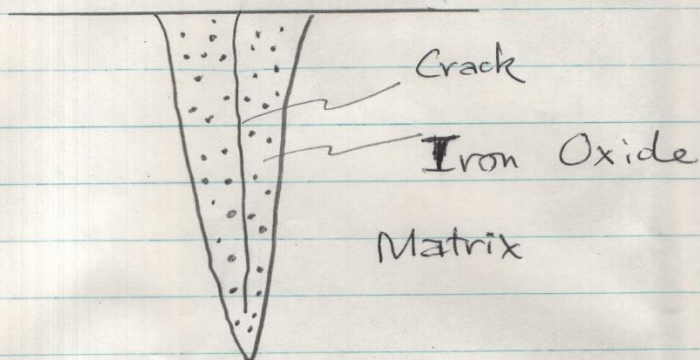
Fig. 7 Typical Secondary Crack on Bustle Pipe

They looked the same as these of creep test sample at elevated temperature. In addition, more iron oxide at the beginning of the crack than in the end indicated that the entire cracking process was a time-consuming process (Fig. 7). The cracking process

might take months or years.

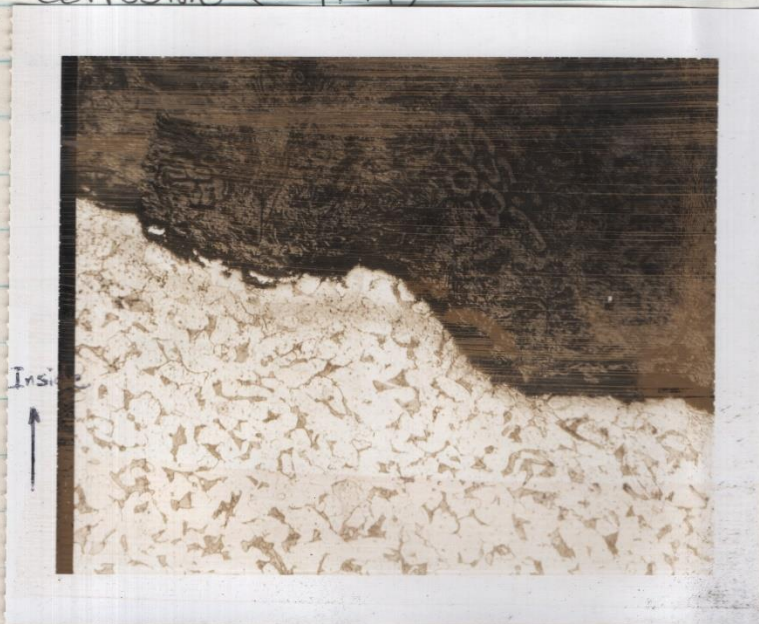
Fig. 14 ^{Uniform} General Corrosion on COG Inner Wall

The inner wall usually was corroded by Uniform General Corrosion. (Fig. 14)

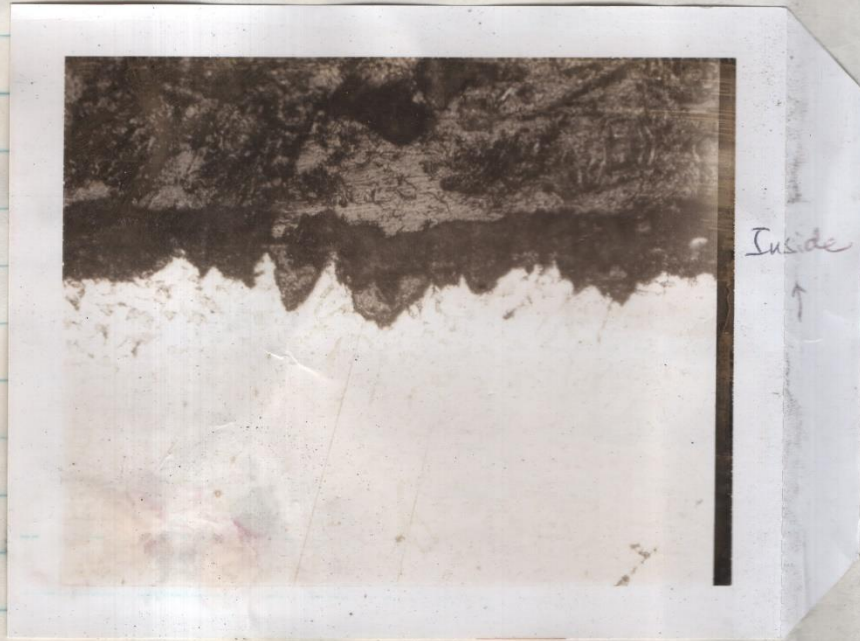
Fig. 16 Some ~~of the~~ pitting Corrosion with
Less Severe Stress Concentration.

On the Origin, two defects, one defect
and river pattern
on each surface, were found. These defects,
I believe, ^{were} is originated from the pitting

Corrosion. The wall thickness along the rupture path had been greatly thin-down by ^{Uniform} ~~General~~ corrosion. Few pitting corrossions, relatively sensitiveless of pit notch on mild steel, and the lack of stress corrosion cracks is the reason why this COG line could last for 12 years.

(except 316 or 321) are out of question too, since there is few Oxygen in the coke oven gas and naphthalene can aggregate crevice or pitting corrosion. Cast iron will not fit ^{either} ~~how~~ too, since it could not be bended. Finally, ^{Stainless} ~~321~~ ³¹⁶ and Carpenter ^{are} ~~2000~~ are too expensive. That is the reason, I believe, to increase the wall thickness and use the same material (mild steel) will be the best answer.
