Acme Coke
11236 S. Torrence Ave.
Chicago IL 60617

acmecoke.com

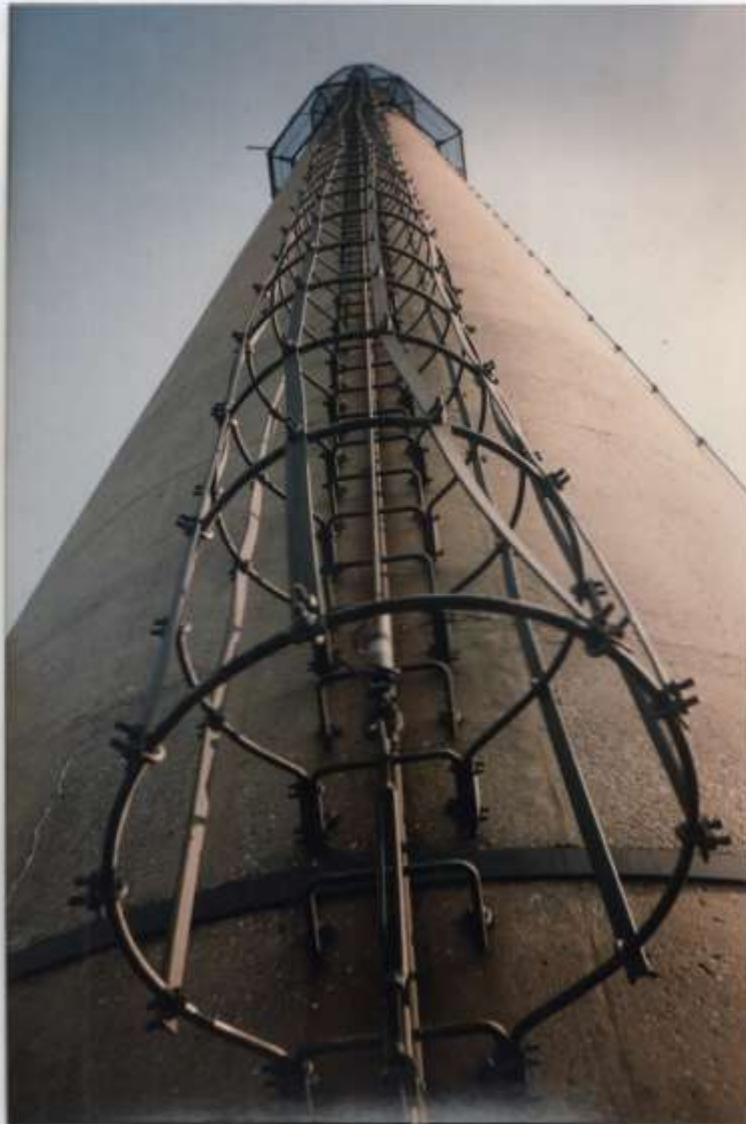
Photo #3 - View
looking up the
caged step irons.
The entire system
was found to be
safe & sound.

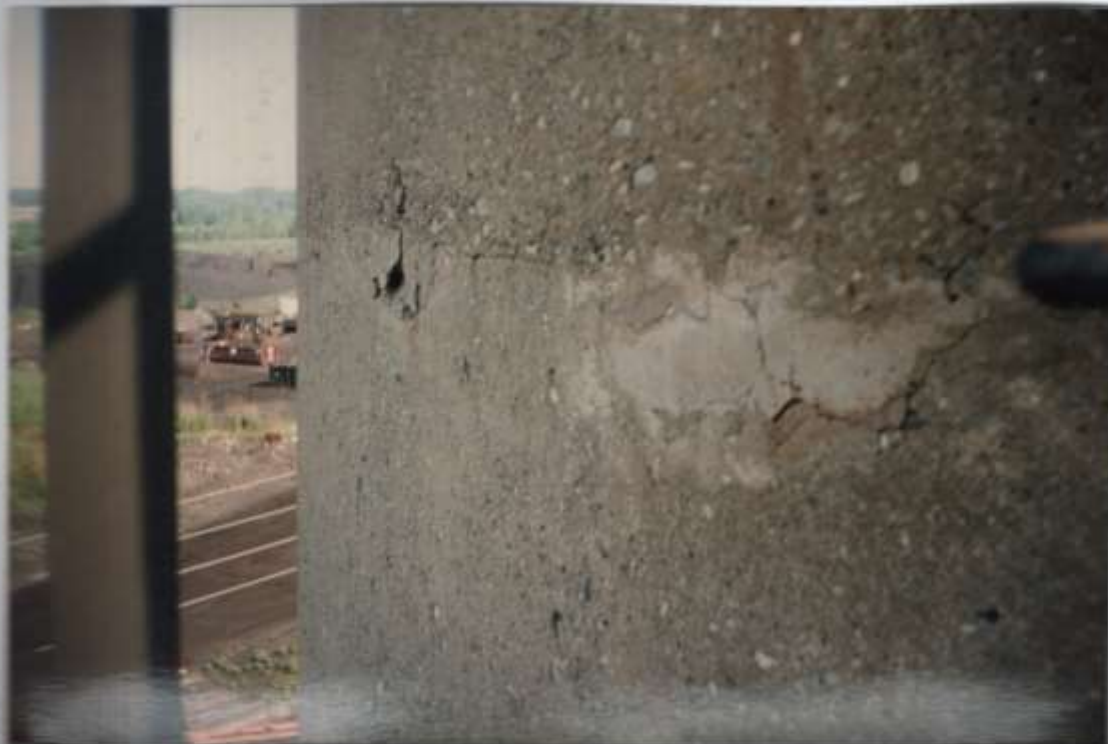
Photo #5 - View of cement patches at 50' above grade elevation. Note fractures and spalling of patch material.

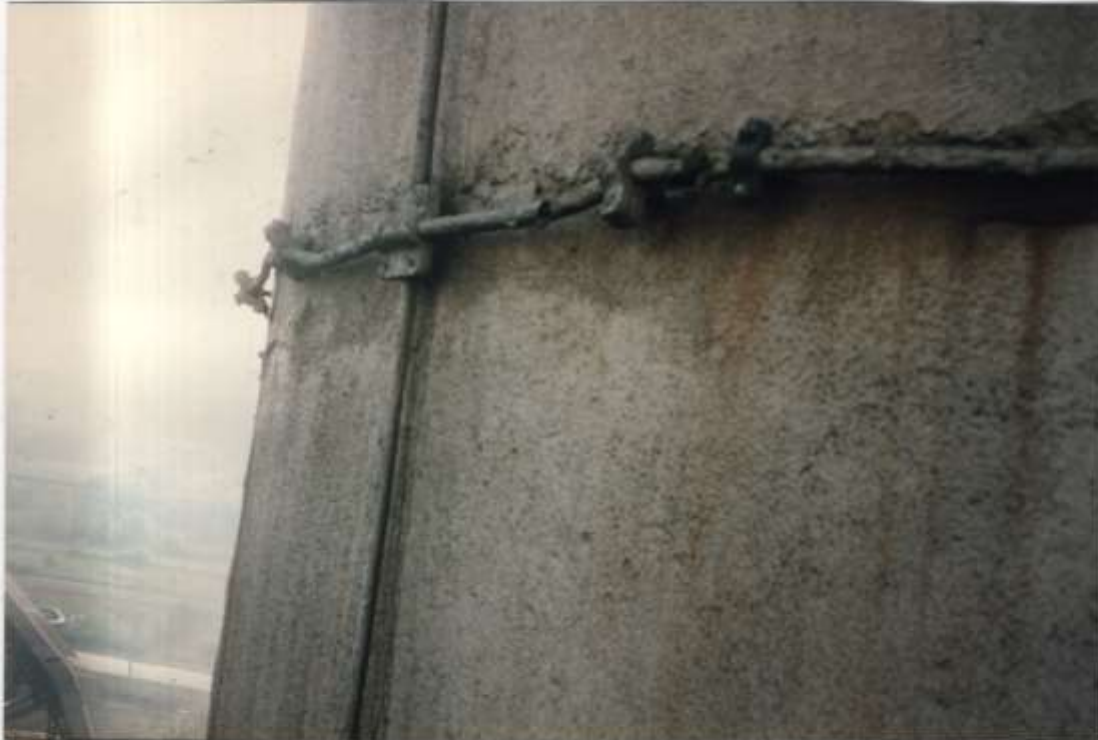
Photo #8 -
Midpoint circular
cable at
connection to
downlead, west
quadrant. Note
broken anchors.

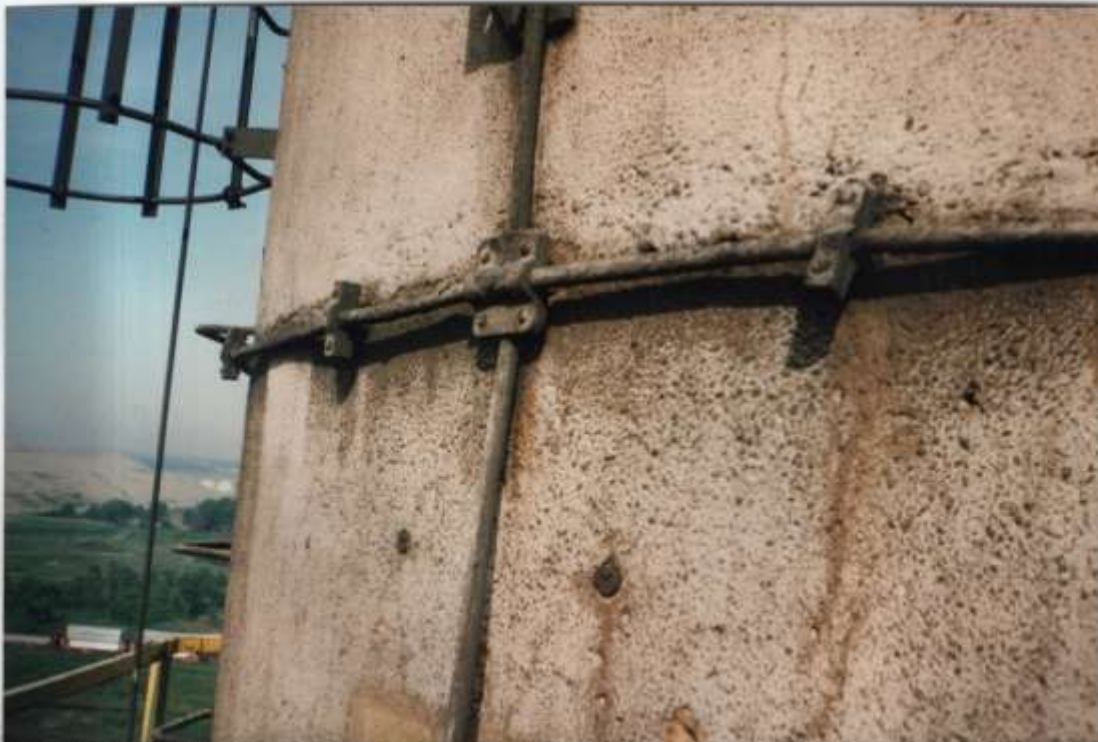
Photo #9 -
Midpoint circular
cable at
connection to
downlead, east
quadrant. Note
broken anchors.

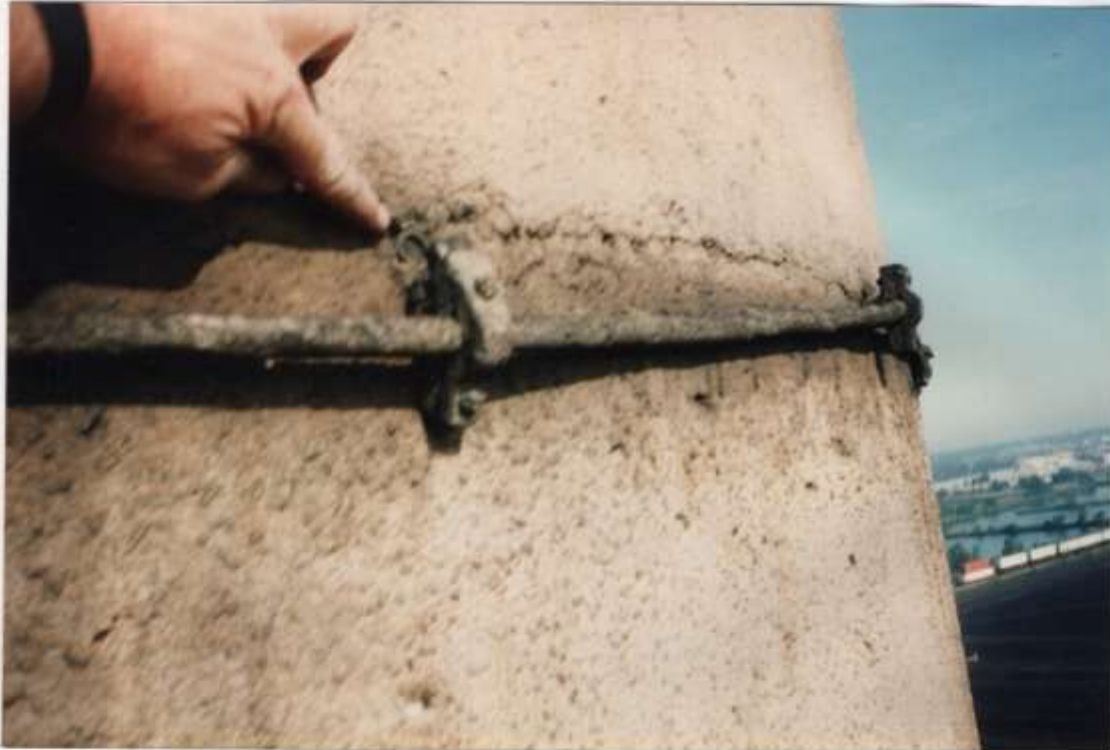
Photo #10 - Close view of the broken anchor, east quadrant, on midpoint of circular cable.

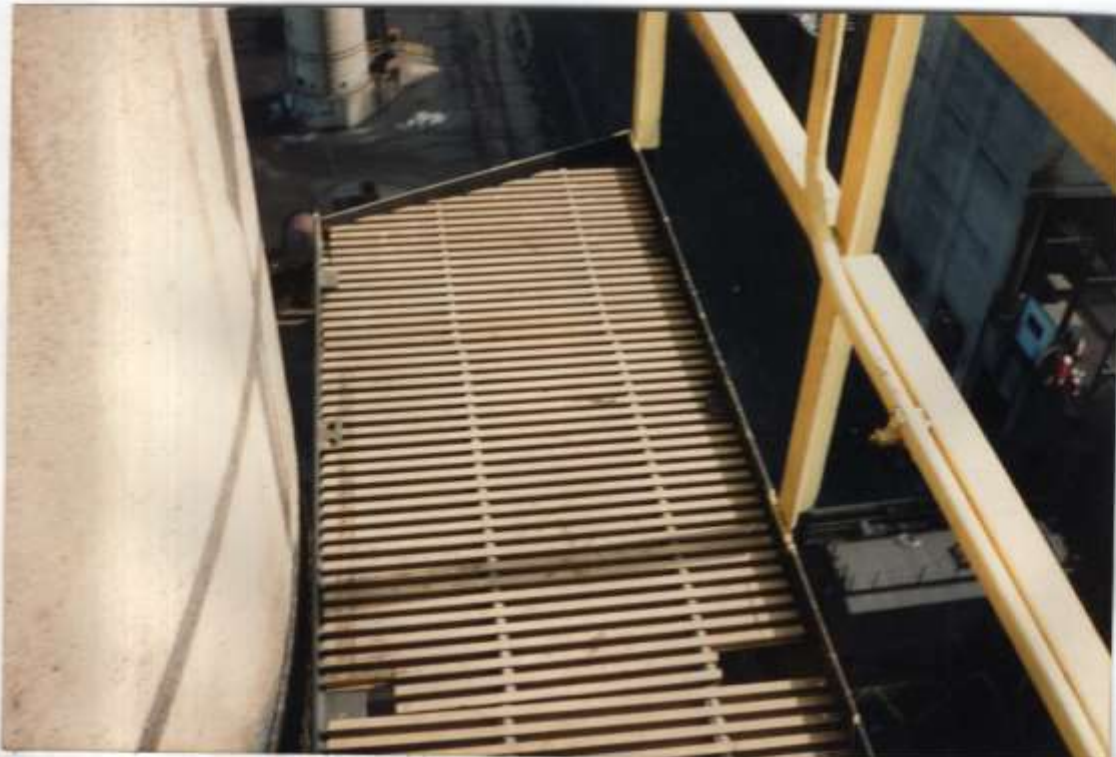
Photo #11 - Typical condition of platform at midpoint of chimney on the east quadrant. Platform is safe & sound.

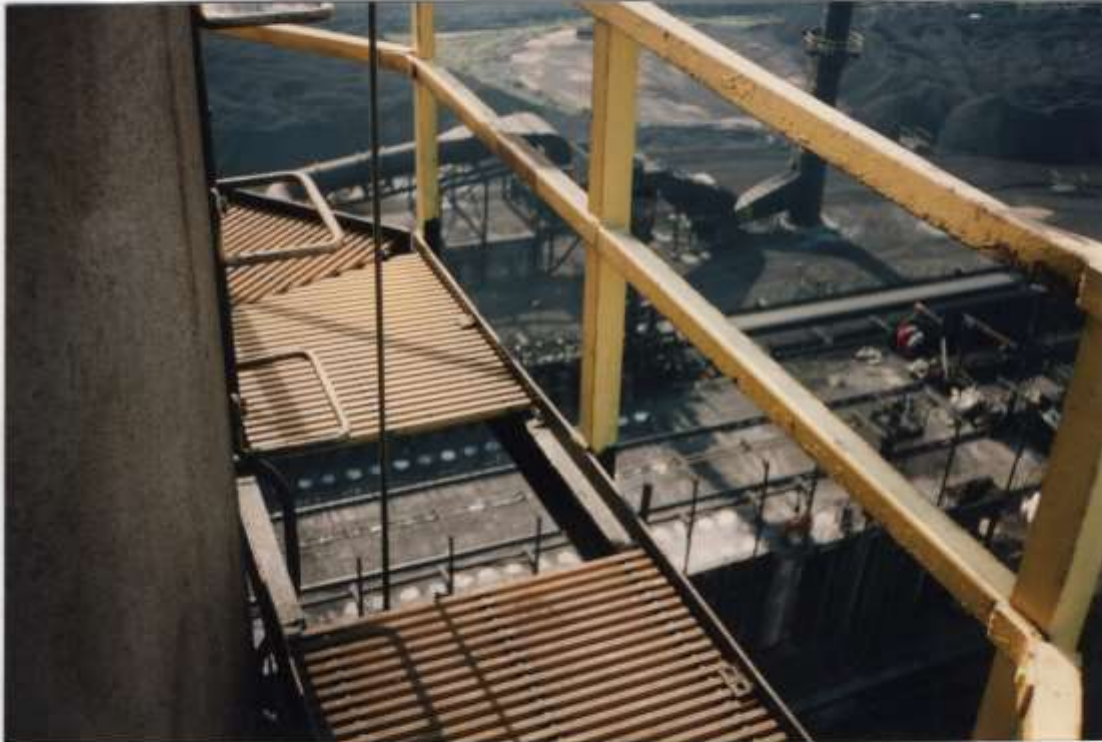
Photo #12 - South quadrant, typical condition of platform at midpoint of chimney. Minor rusting of hand rails noted.

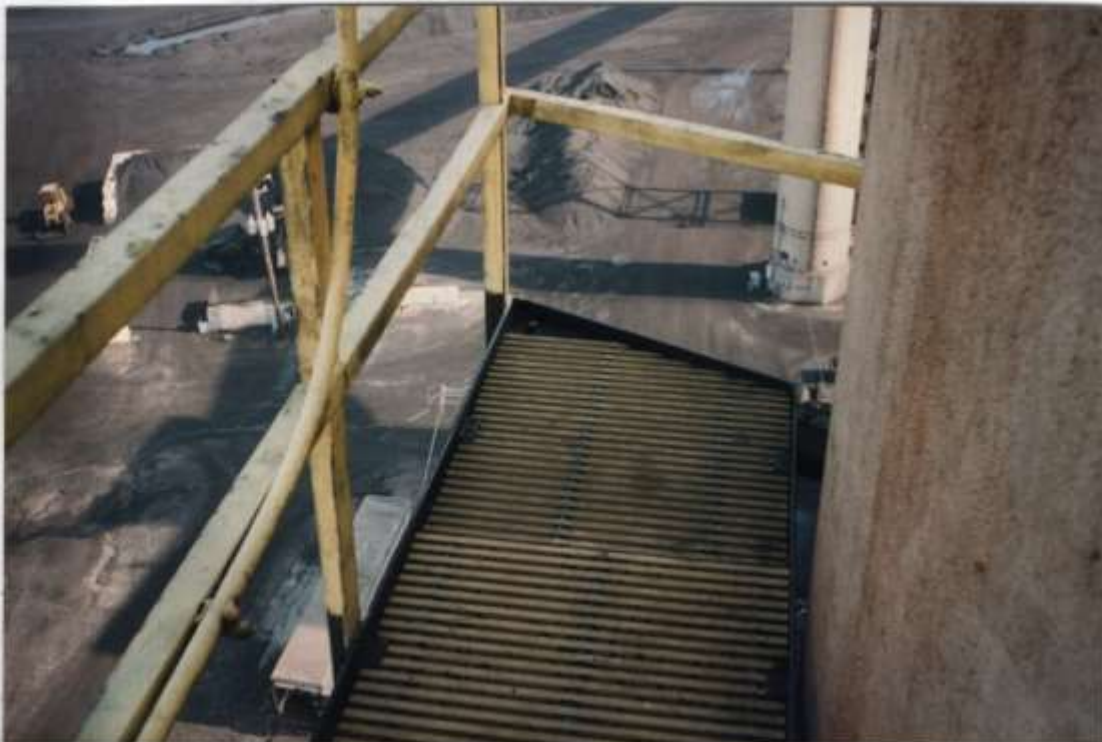
Photo #13 - Typical condition of platform at midpoint of chimney, west quadrant. Minor rusting of hand rails noted.

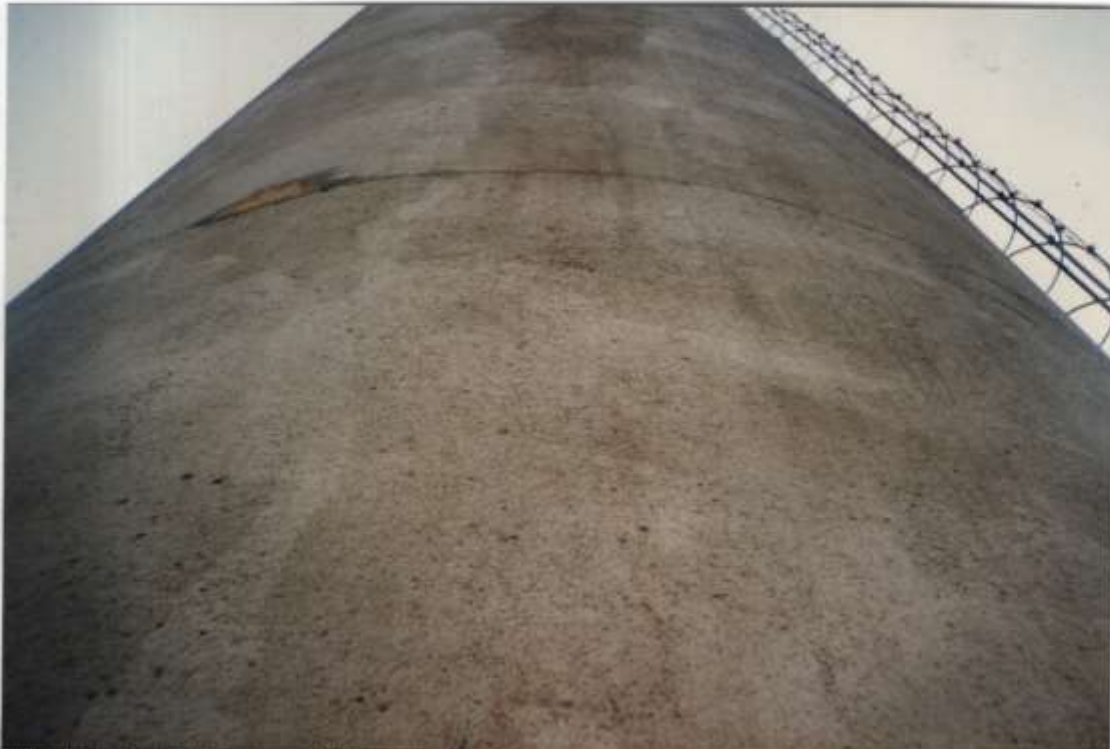
Photo #15 -
Typical condition
of concrete
column, east
quadrant.
Concrete is solid
& sound.

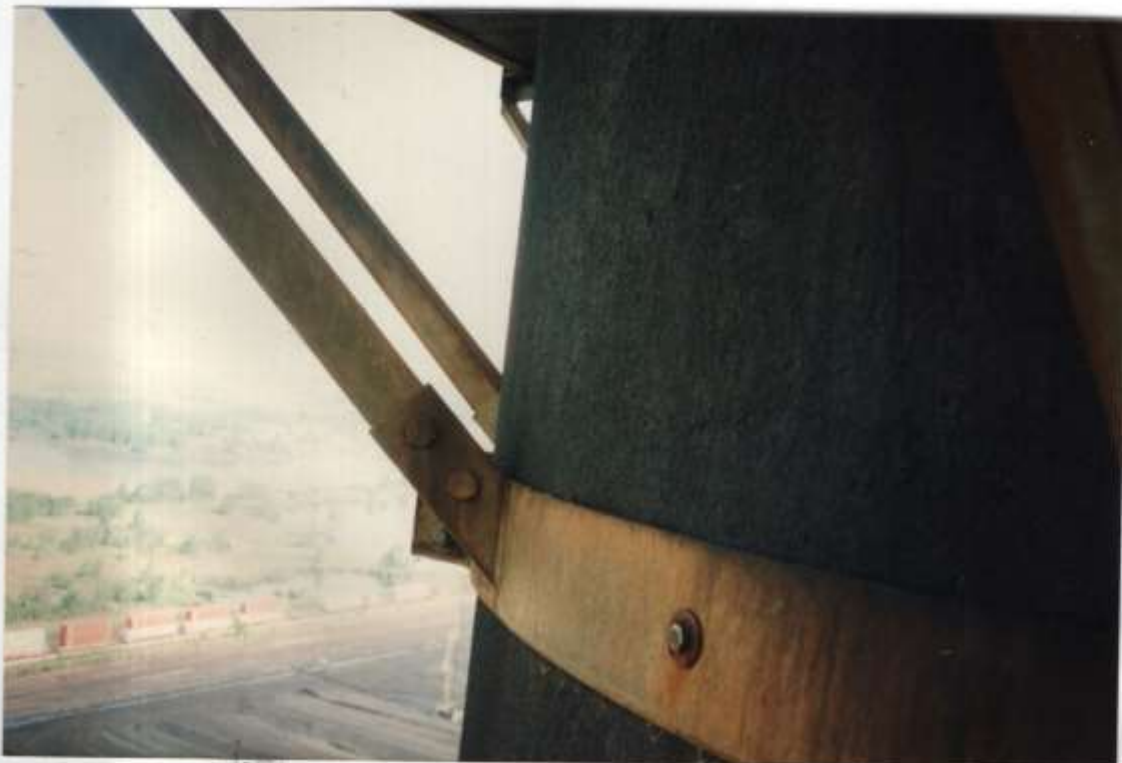
Photo #17 - The support band and bottom support angles for the top platform are all solid & sound. Minor rusting noted.

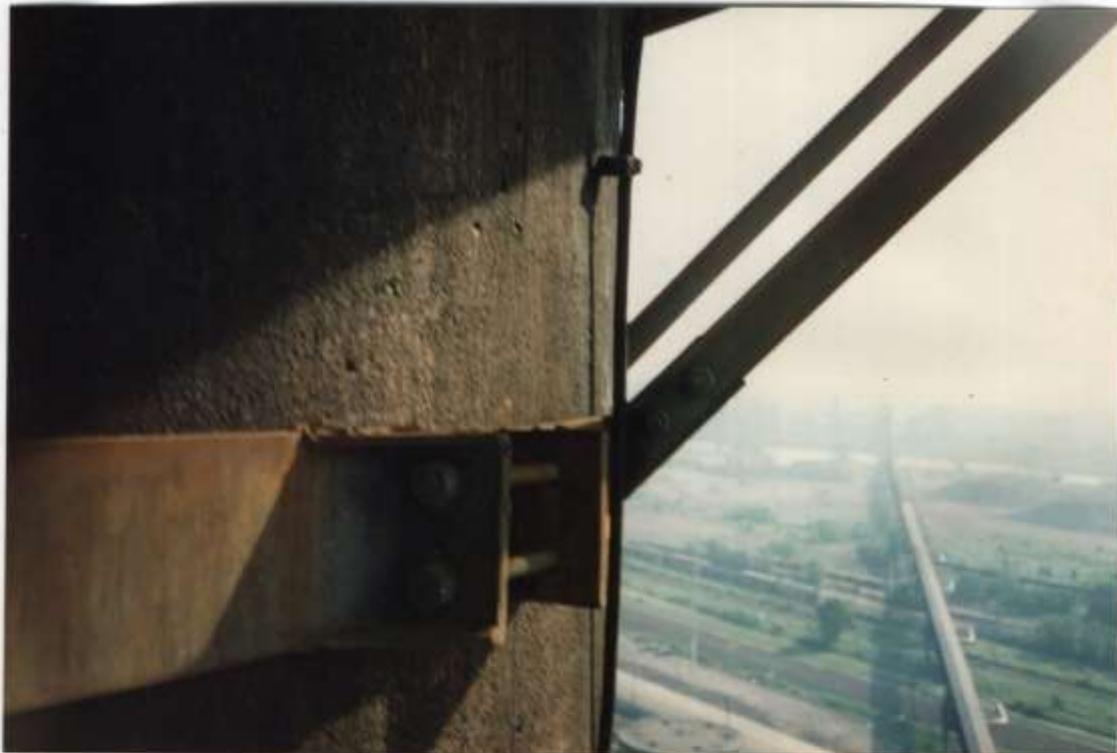
Photo # 18- The support band and bottom support angles for the top platform are all solid & sound. Minor rusting noted.

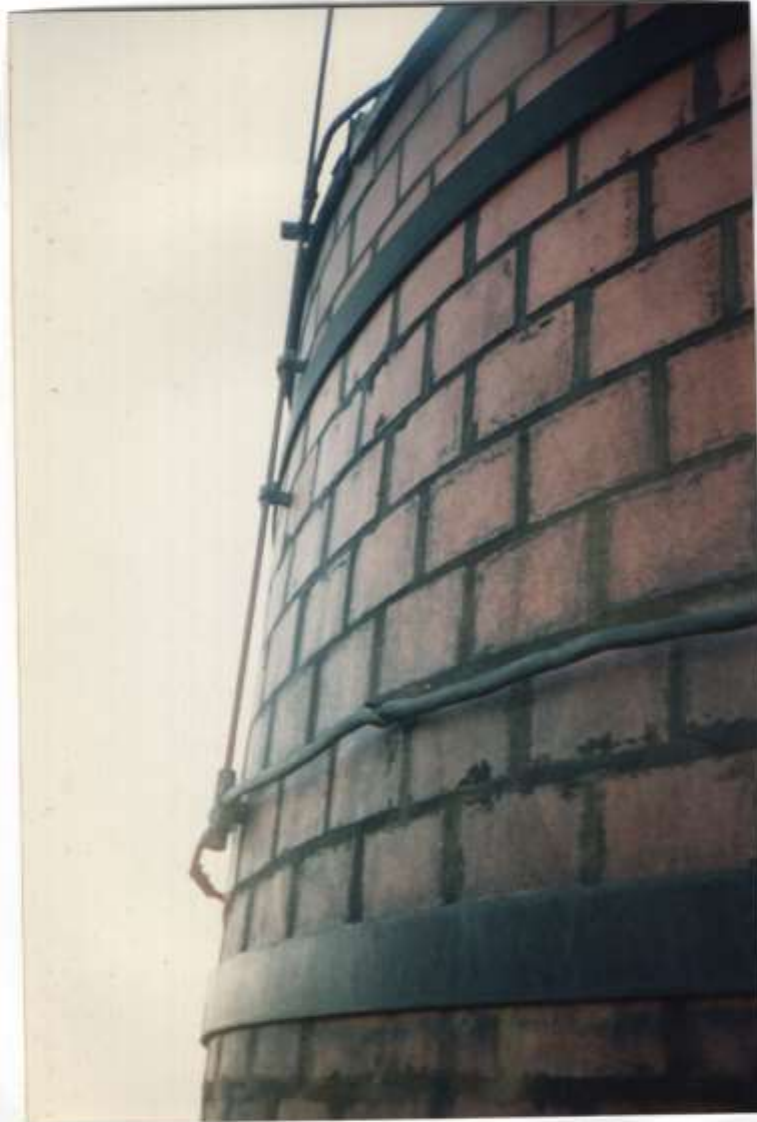
Photo # 19-
Typical condition
of brickwork
throughout the
top 5' of the
chimney. All
brickwork is
solid & sound.

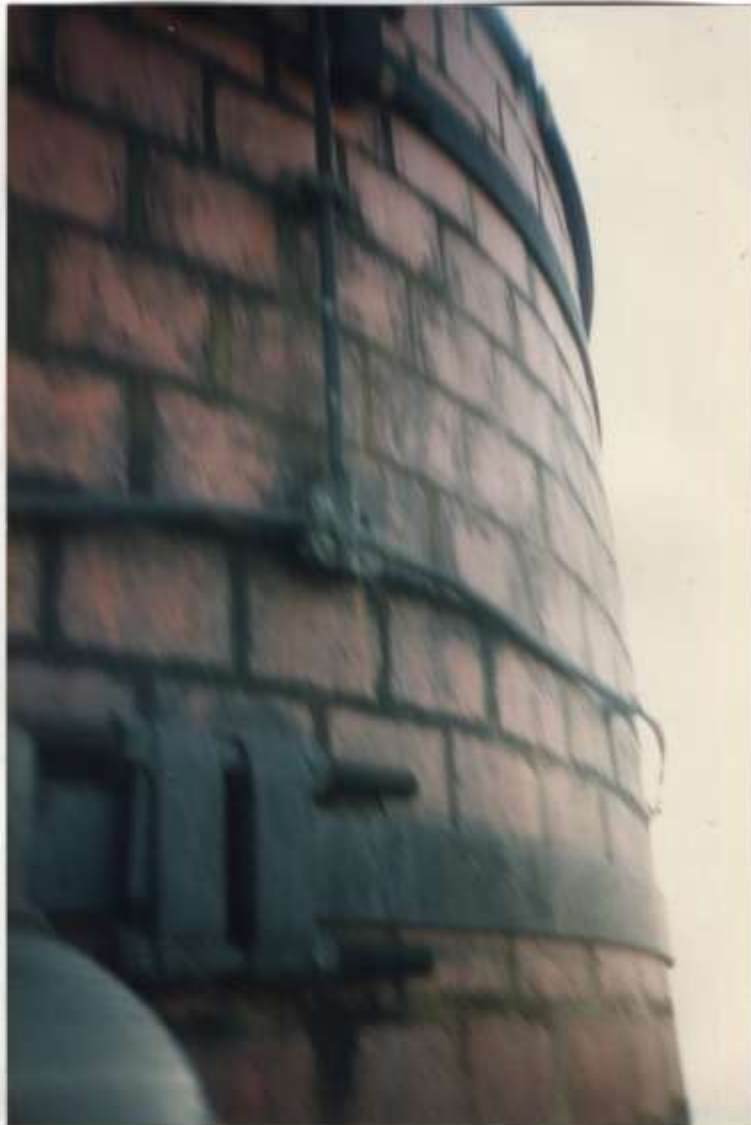
Photo # 20-
Typical condition
of brickwork
throughout the
top 5' of the
chimney. All
brickwork is
solid & sound.

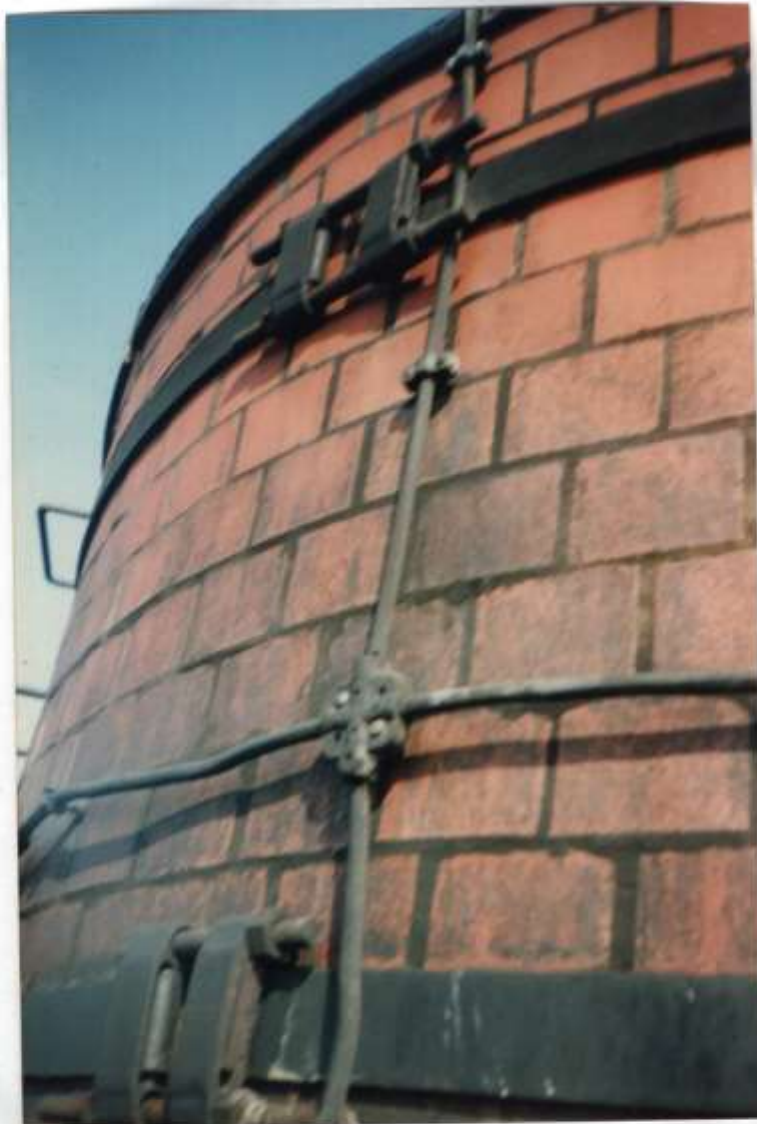
Photo # 21- The bands and the Lightning Protection system were found to be intact throughout the top 5' of the chimney.

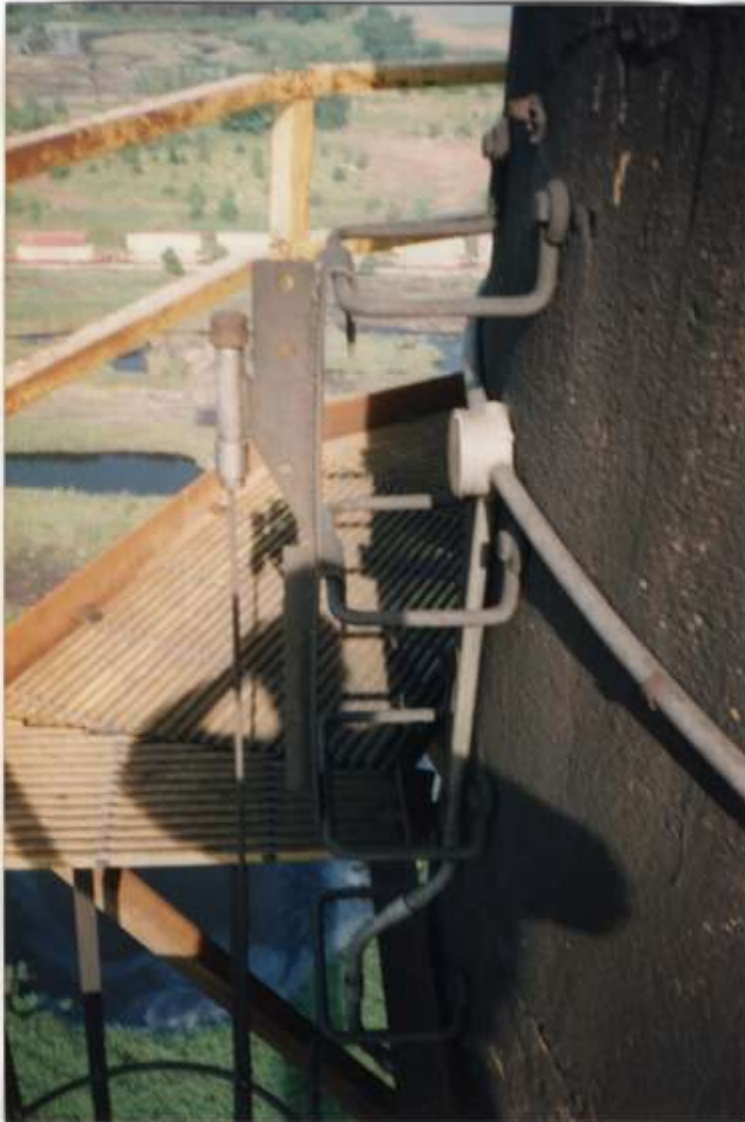
Photo # 22-
Typical condition
of the step irons
at the top of the
stack.

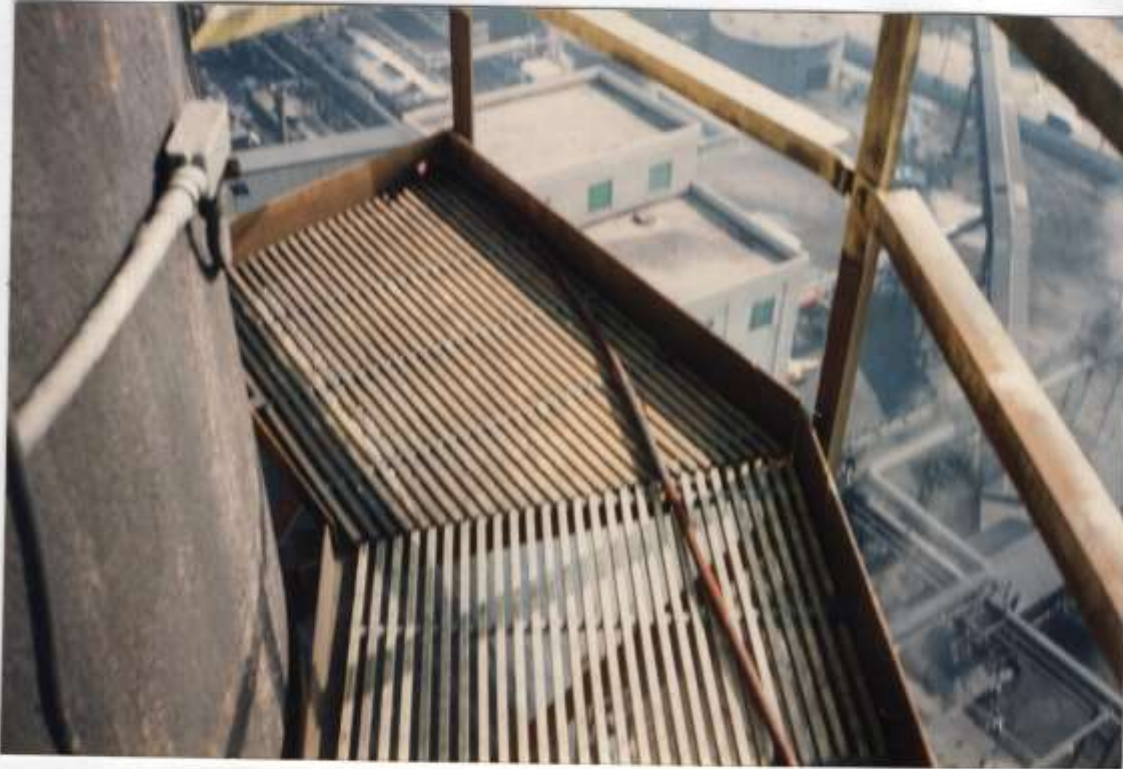
Photo # 24 View of the top platform. Minor rusting was noted.

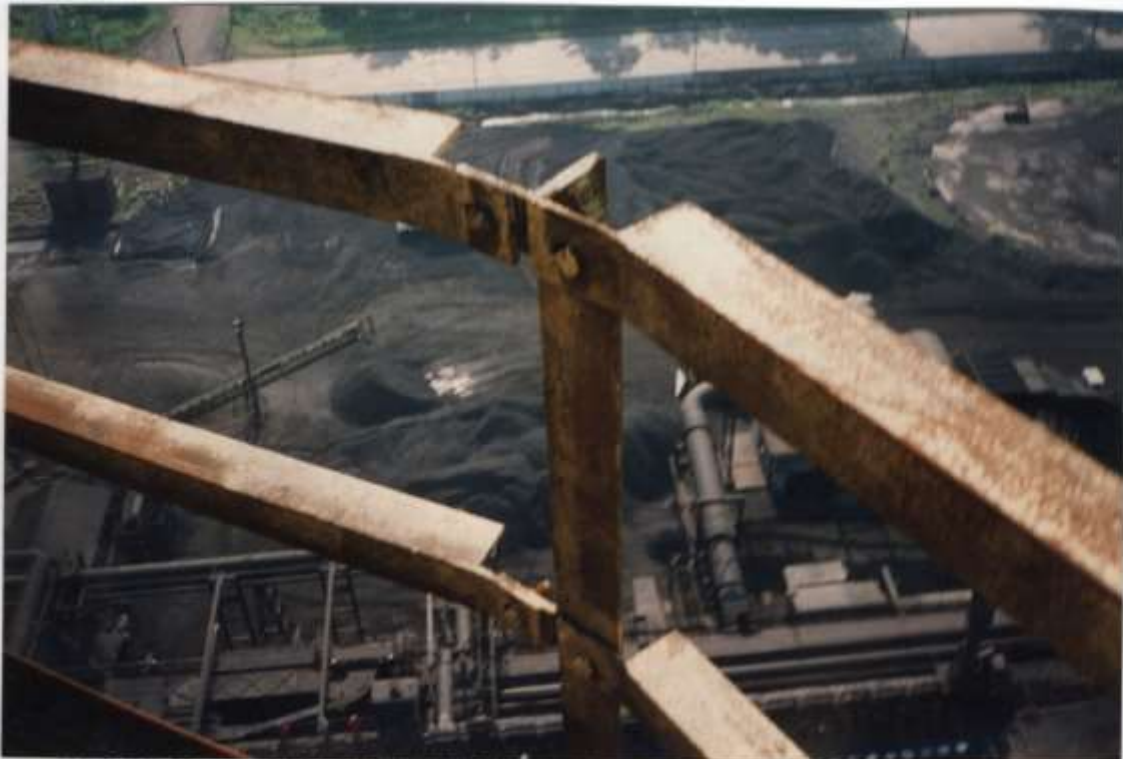
Photo #25 - Close up view of the top platform handrail. Note the steel is rusting freely.

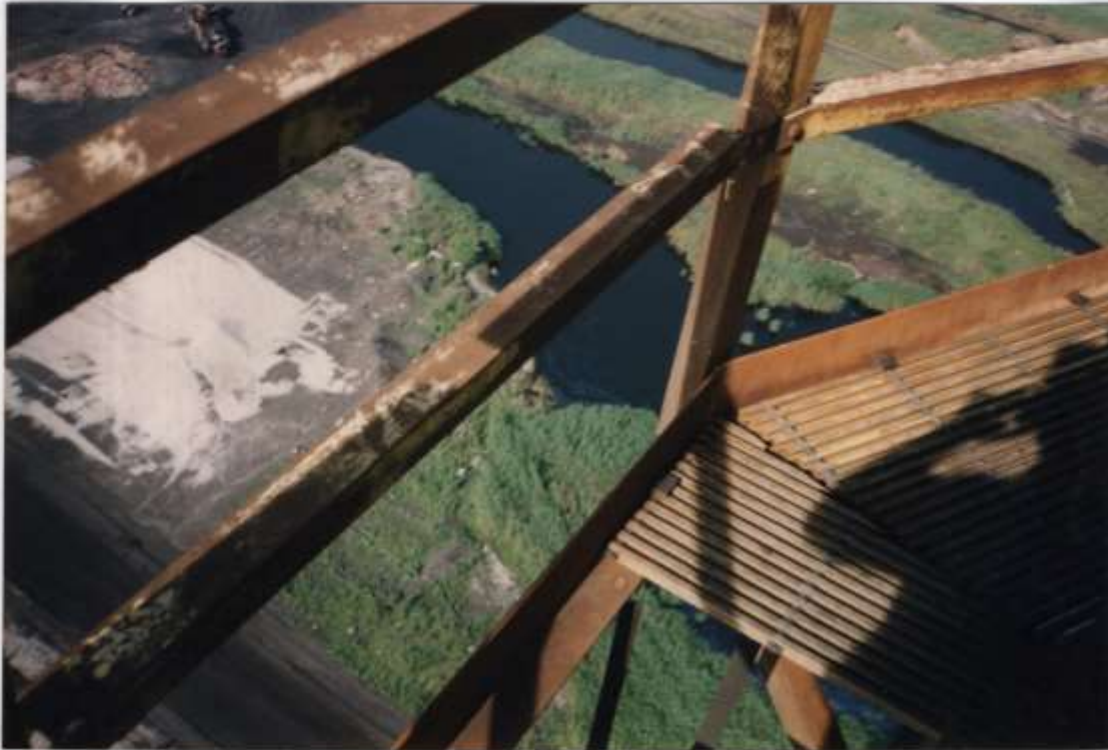
Photo #26 - Close up view of the top platform handrail. Note the steel is rusting freely.

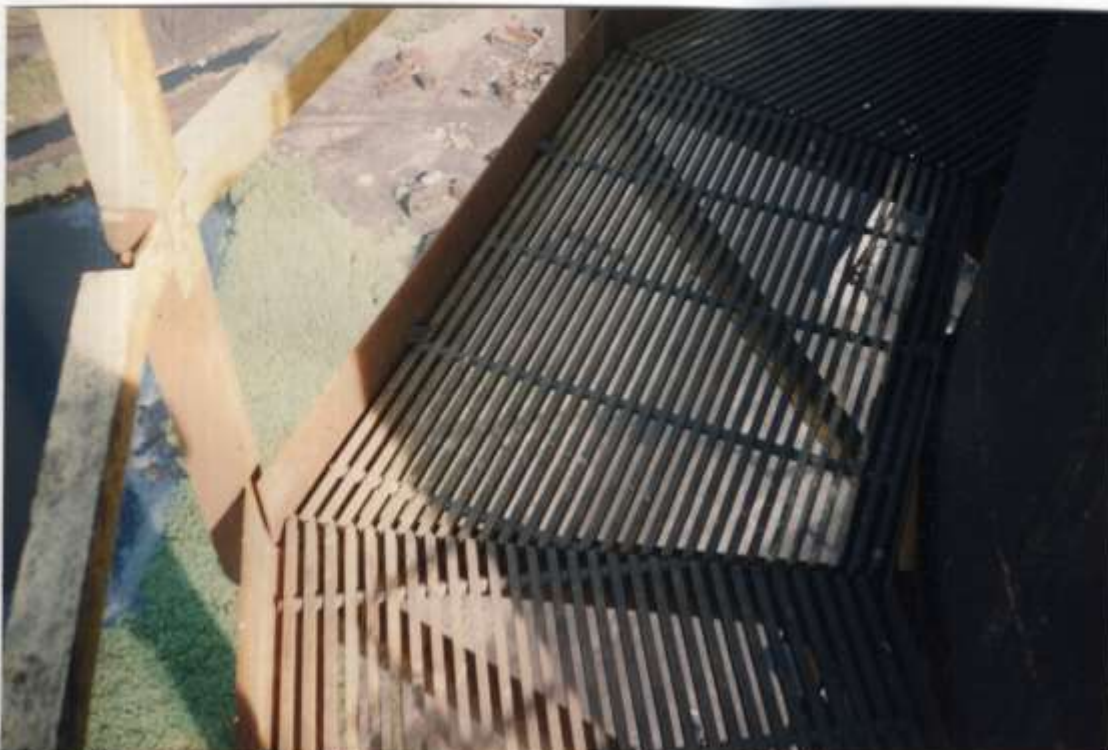
Photo #27 - The grating on the top platform is safe & sound.

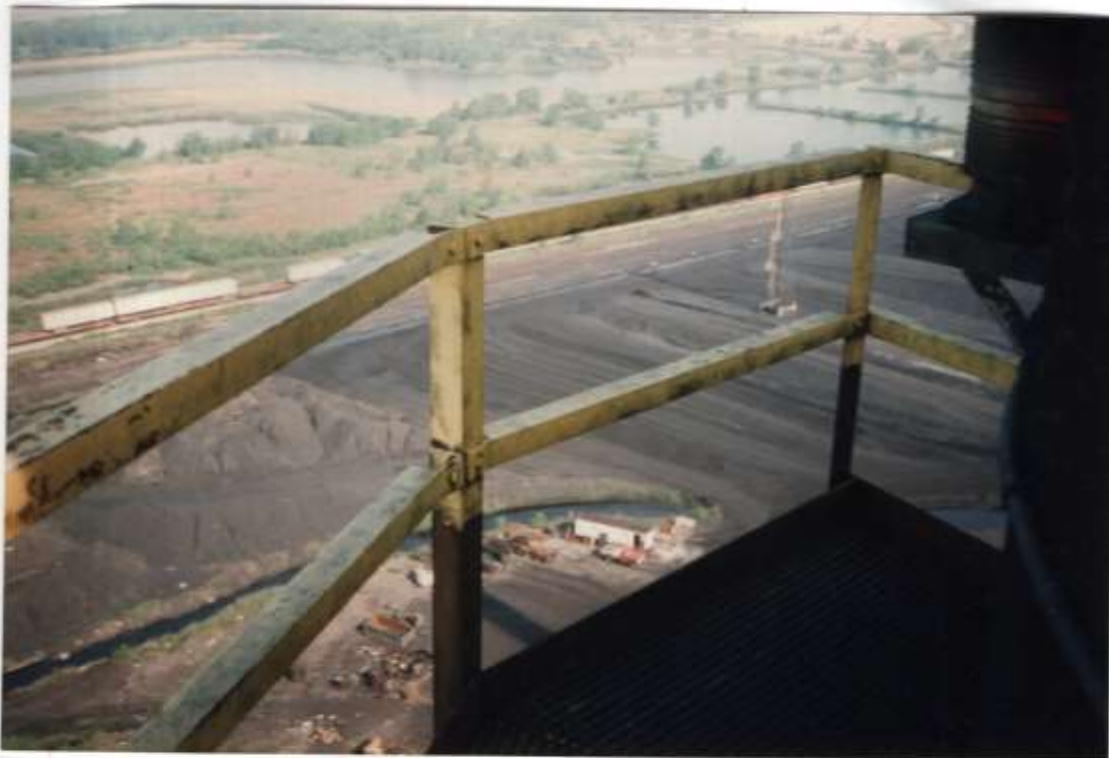
Photo #28 - Minor rusting of handrails on the top platform was noted.

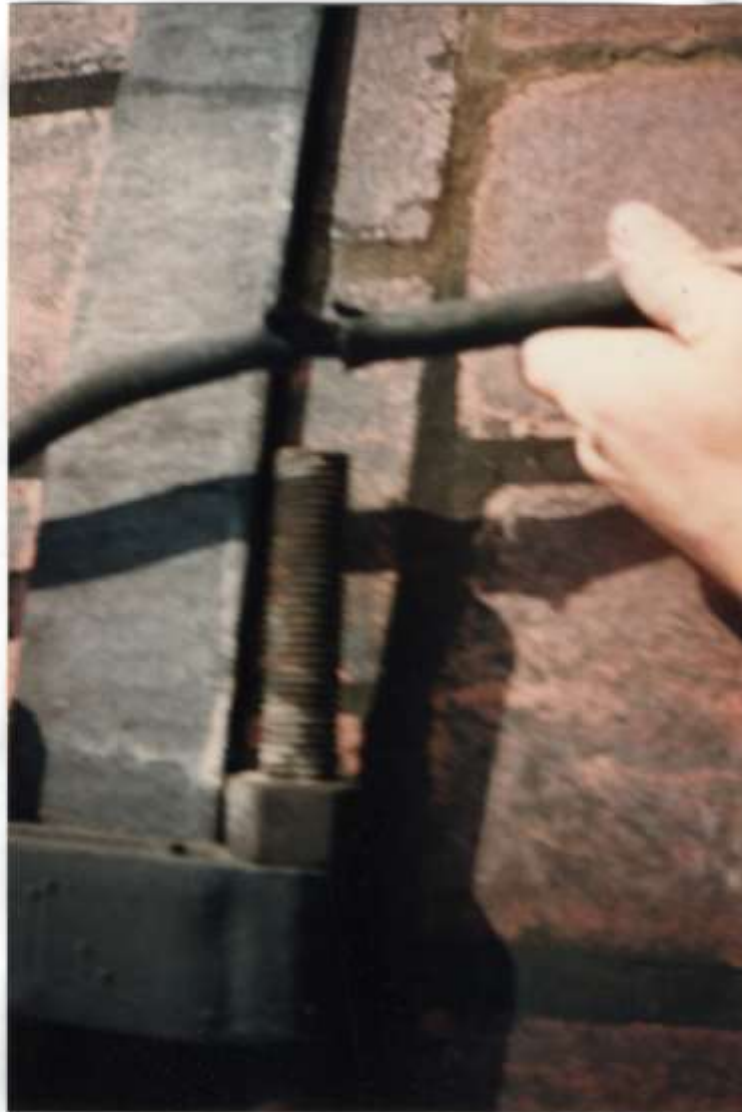
Photo #31 - The lead coating covering the Lightning Protection system cable was found cracked and split open in several areas throughout the top of the chimney.

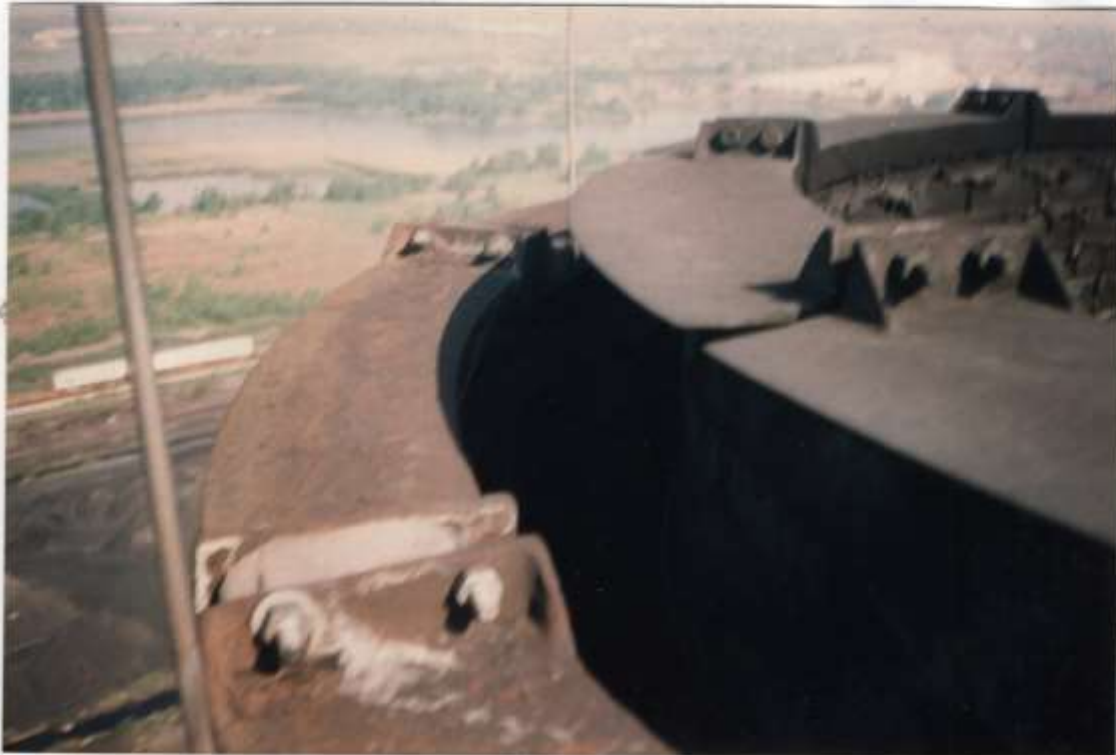
Photo #32 -
Column & liner
caps are intact.
Note minor
corrosion &
rusting
conditions.

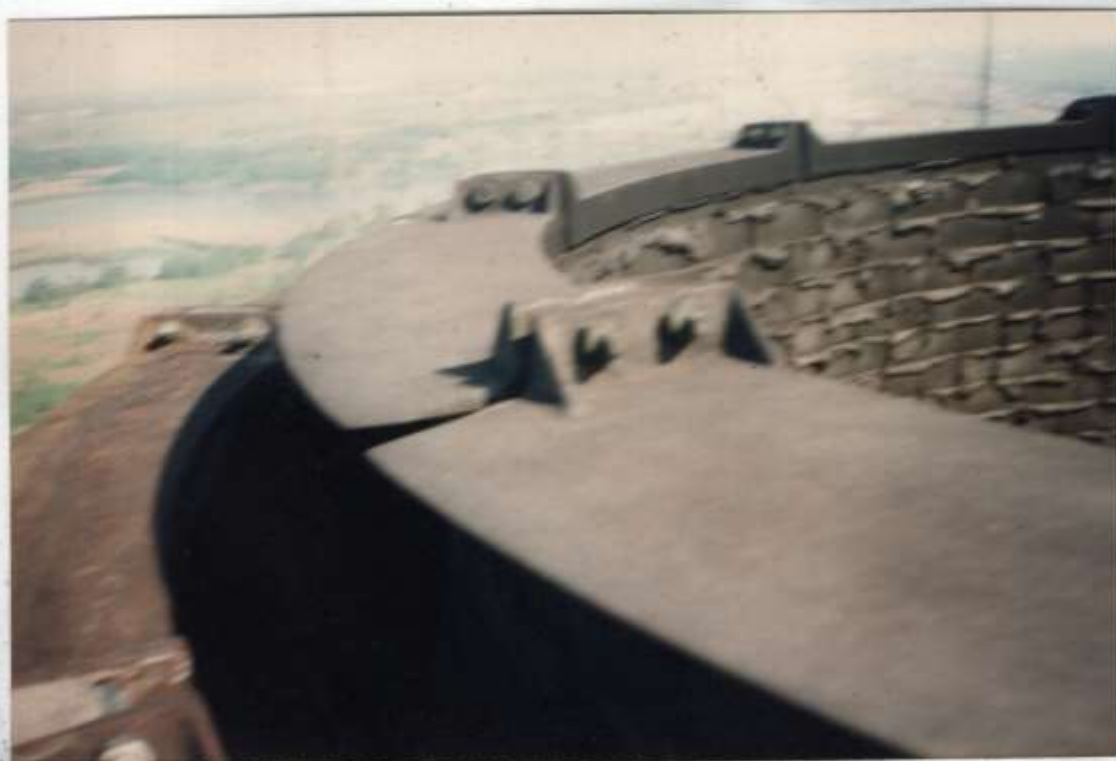
Photo #33 -
Column & liner
caps are intact.
Note minor
corrosion &
rusting
conditions.

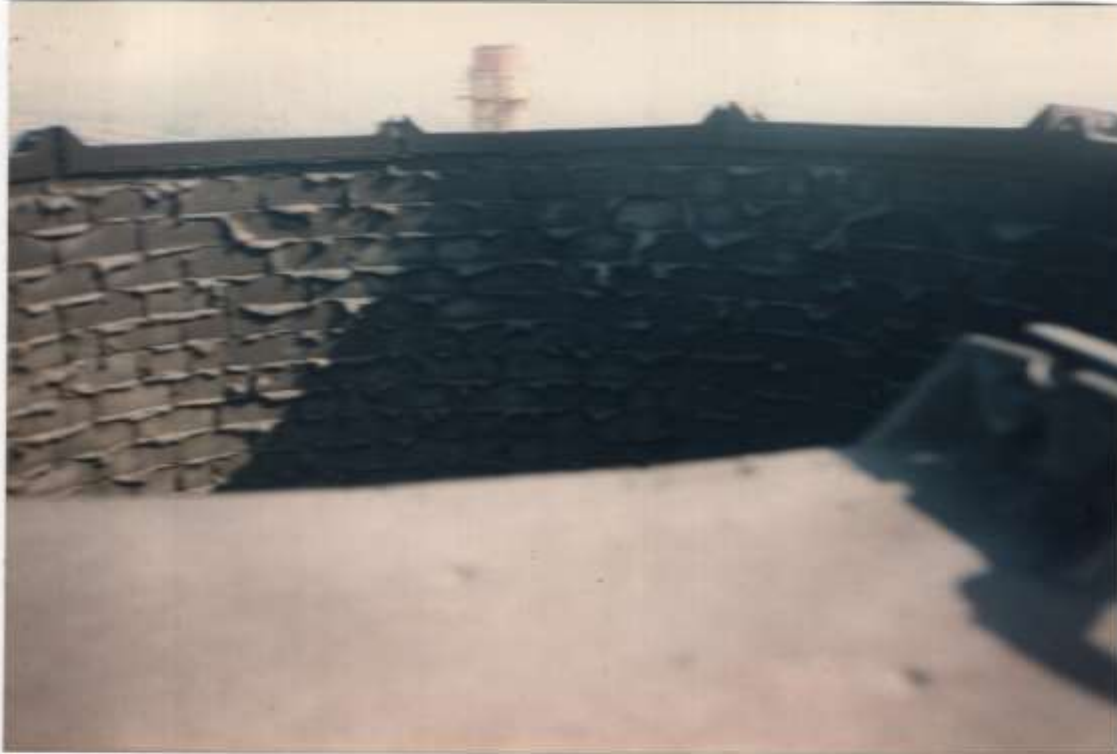
Photo #34 -
Column & liner
caps are intact.
Note minor
corrosion &
rusting
conditions.

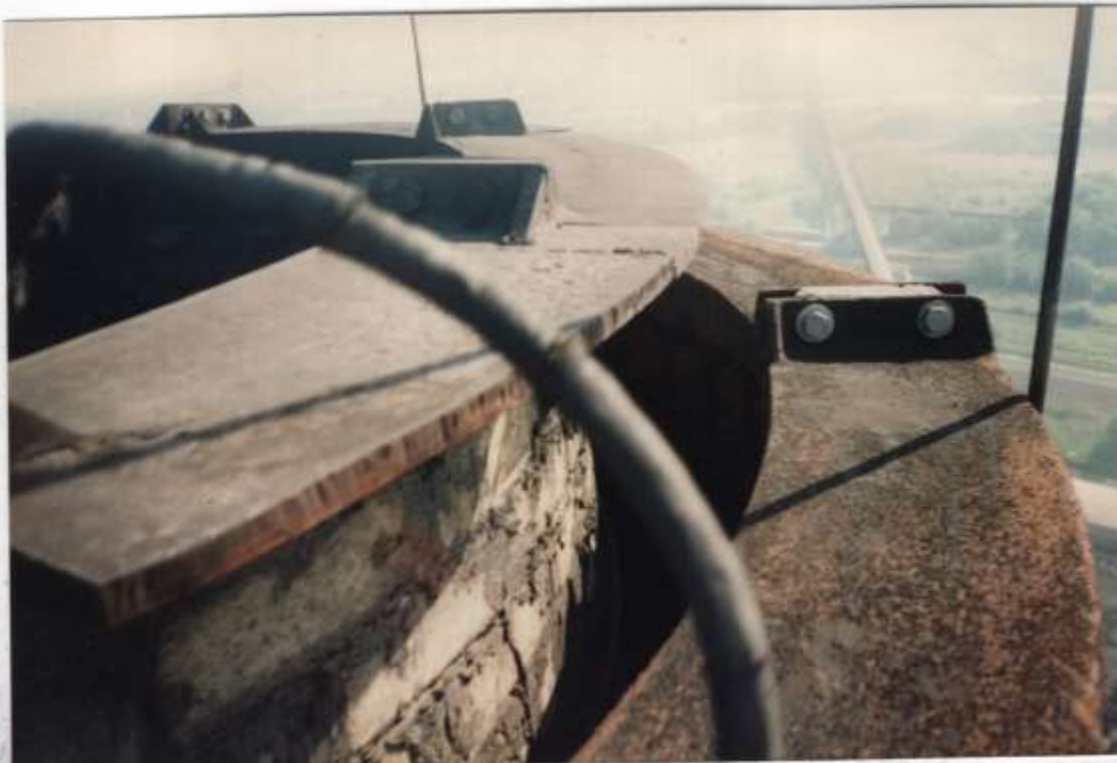
Photo #35 -
Column & liner
caps are intact.
Note minor
corrosion &
rusting
conditions.

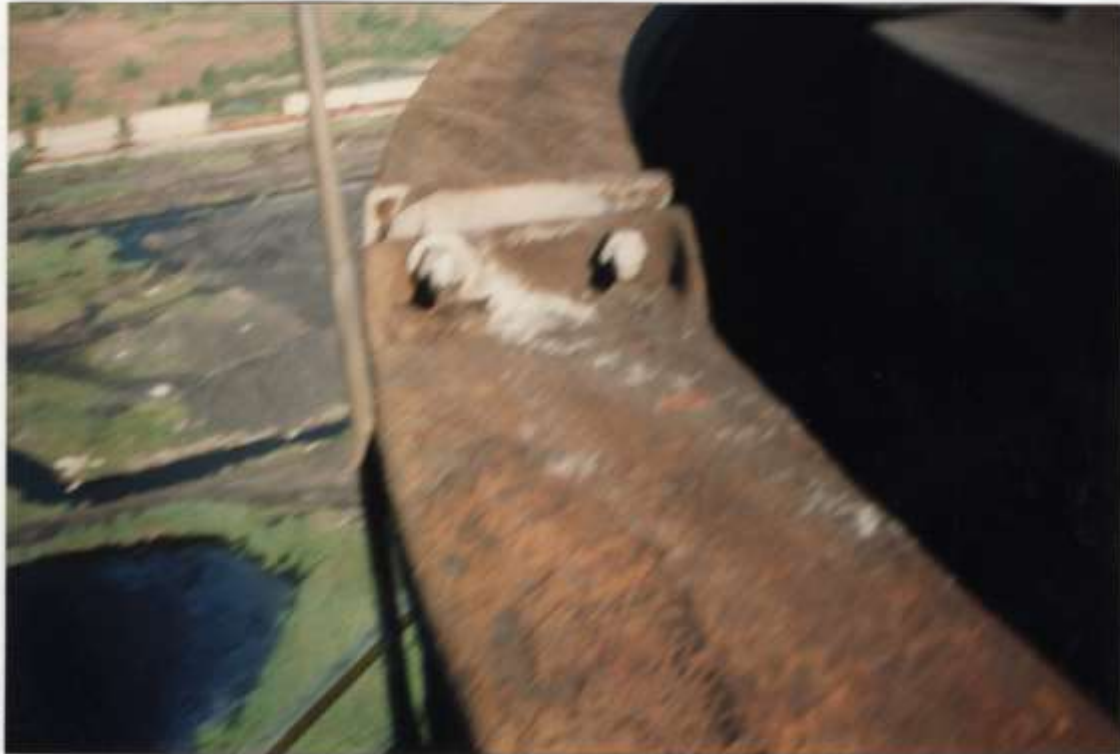
Photo #36 -
Column & liner
caps are intact.
Note minor
corrosion &
rusting
conditions.

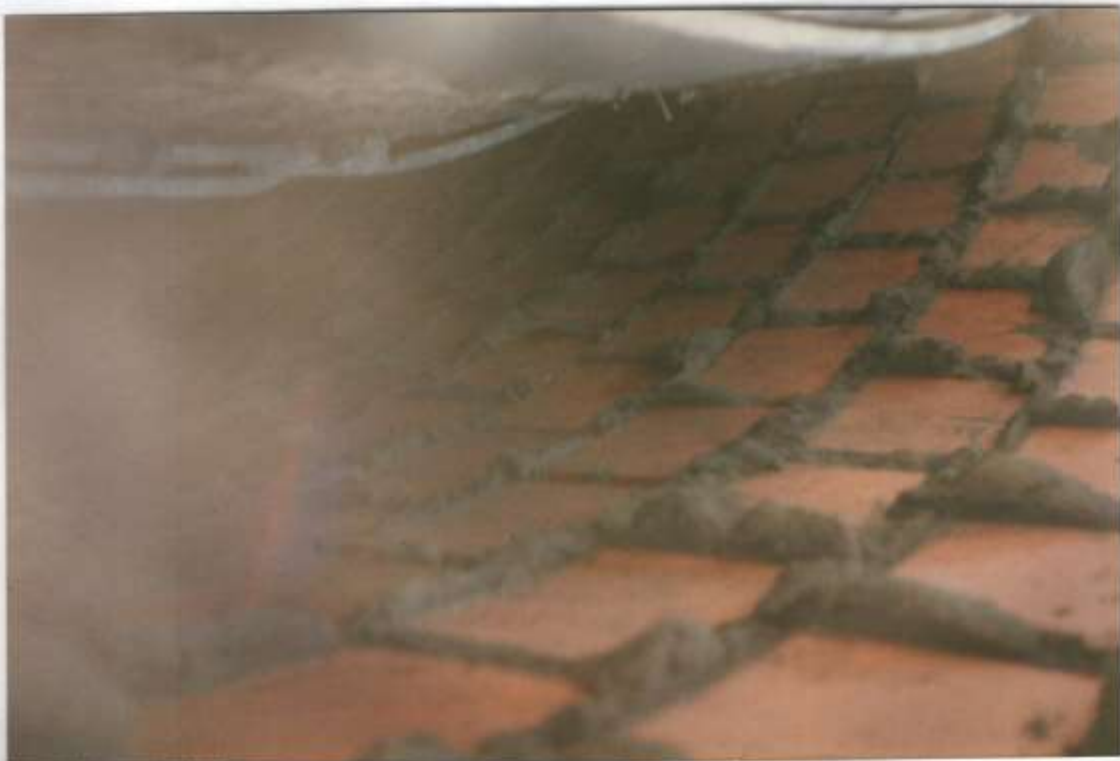
Photo #37 - View
into the air
space between the
liner and the
column interior.
Brickwork is
solid & sound.
