**ACME STEEL COMPANY**  
 DATE: 12-13-96 Last Edit: Jan. 10, 1997

ACME STEEL - CHICAGO  
 COKE PLANT  
 PUSHING EMISSION DUCT  
 SECTION, DETAILS, & GENERAL INSPECTION FINDINGS  
 1996 INSPECTION

JOB No. 05-7672-01 SHT. No. 2

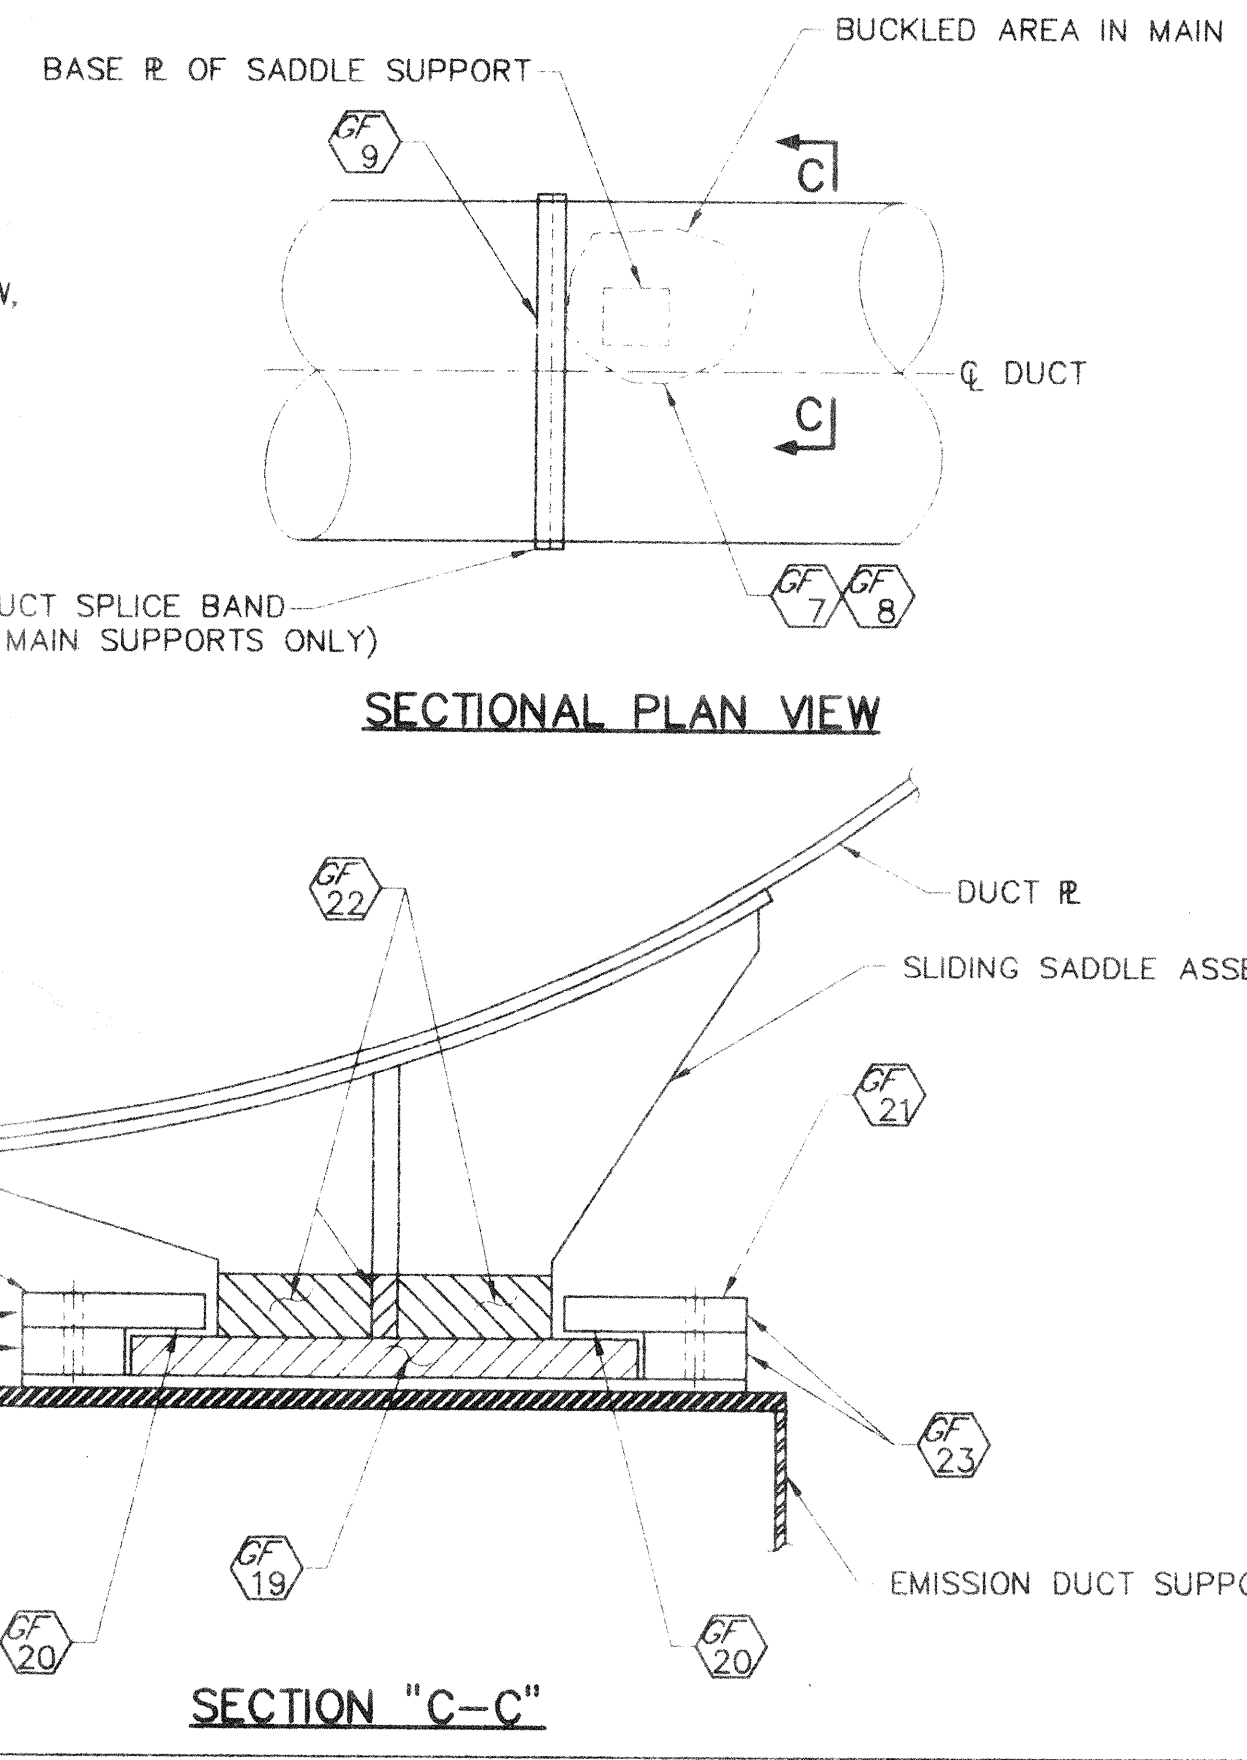
GENERAL INSPECTION FINDINGS OF EMISSION DUCT SADDLE SUPPORTS. FOR SPECIFIC LOCATIONS OF THE DEFICIENCIES REFER TO THE SUMMARY CHART, SECTIONAL PLAN VIEW, SECTION "C-C", & FIELD SKETCHES FS-1 TO FS-15.

NOTE: ALL SUPPORTS APPEAR TO BE FROZEN WITH NO VISIBLE MOVEMENT.

- GF 19 THERE IS HEAVY RUST LAYERING OF THE LOWER HORIZONTAL R OF THE SADDLE ASSEMBLY, WITH 10% - 25% APPARENT SECTION LOSS.
- GF 20 THERE IS 3/8" ± RUST PACKING AND SEPARATION AT THE HORIZONTAL SADDLE R TO GUIDE R.
- GF 21 THERE IS HEAVY RUST LAYERING ON THE GUIDE R'S AND THEIR CONNECTION BOLTS, WITH UP TO 25% SECTION LOSS.
- GF 22 THE LOWER 3" ± OF THE VERTICAL SADDLE R'S EXHIBIT HEAVY RUST LAYERING & ARE THINNED TO 3/16" ±, WHICH IS APPROXIMATELY 63% SECTION LOSS.
- GF 23 THE GUIDE R BOLTS HAVE BEEN REMOVED AND R'S MOVED WEST AND THEN WELDED IN PLACE, MOVEMENT WAS TYPICALLY 1" - 2", DEPENDING ON THE DEPTH OF BUCKLING IN THE MAIN.
