Acme Coke
11236 S. Torrence Ave.
Chicago IL 60617

Bustle Pipe Repairs

Dated: 1975-1977

To: Mr. N. H. Keyser
From: C. Lin
Subject: Investigation of Bustle Pipe Failures
in Chicago "A" Furnace
Reference: D3-002-001

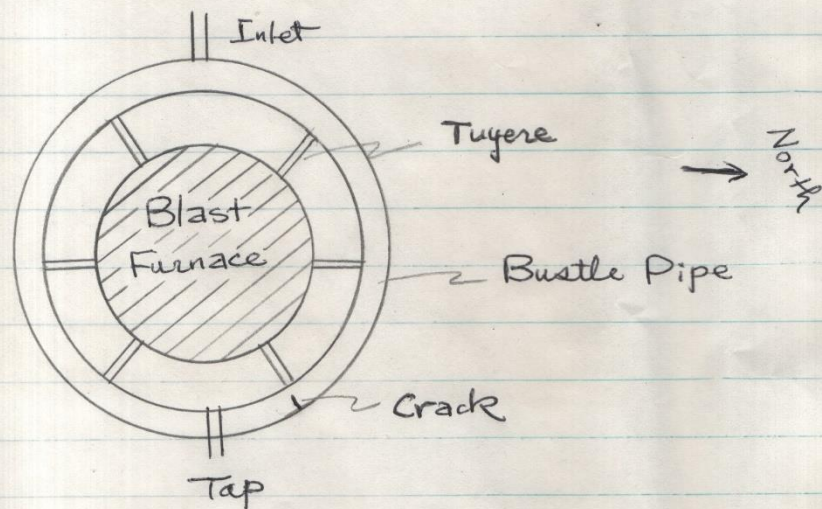
Fig. 1 Location of Bustle Pipe related to Blast Furnace

Bustle pipe provided the necessary air or oxygen for blast furnace. According to ASTM specification, bustle pipe is made of $A285_{\text{Grade C}}$ ^{which} is similar to 1025 Carbon steel. The

location of bustle pipe related to blast furnace is shown in Fig. 1. The cracking area was cut up and brought to the laboratory for further investigation. The shape of cracks is shown in Fig. 2

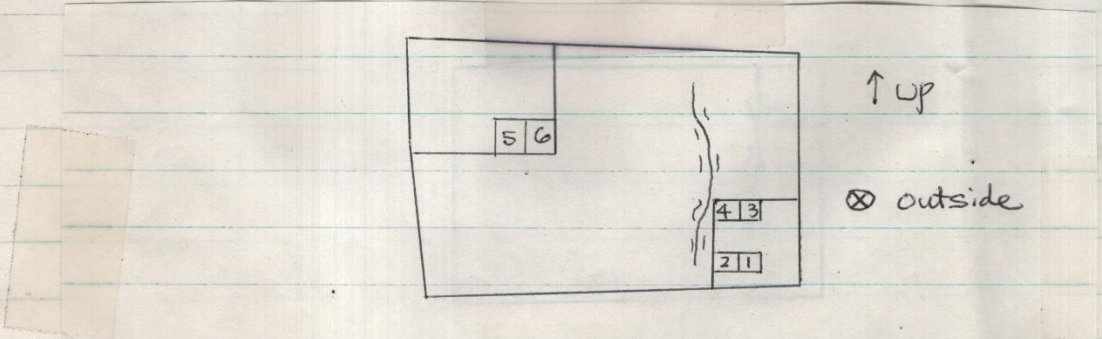
Fig. 4 Locations of ~~Cut up~~ Sampler for Bustle Pipe

Sampler from different locations were cut-up, mounted, and ready for metallographic study (Fig. 4).

Sample No. 1 through No. 4 were in the vicinity of the major crack. No. 5 and No. 6 were away from the major crack. All secondary cracks were found to be straight, ~~and~~ transgranular, perpendicular to maximum tensile direction and 6 and containing iron oxide. (Fig. 5)

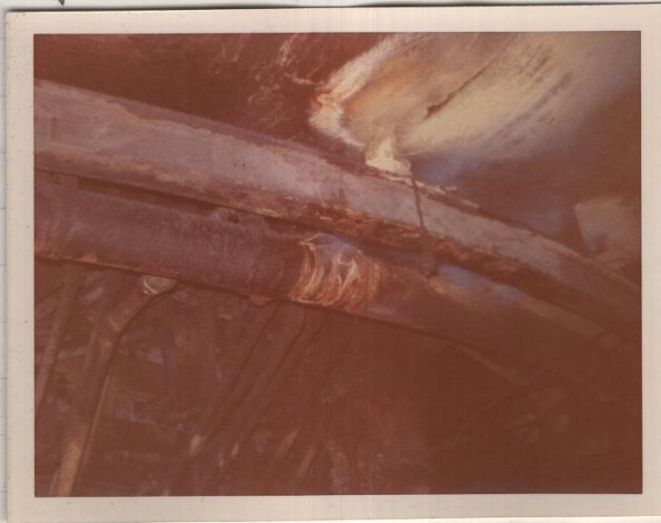
The location of coke oven gas line in relation to blast furnace & bustle pipe is shown in Fig. 11, and

Fig. 12. COG Pipe is underneath the Bustle Pipe.

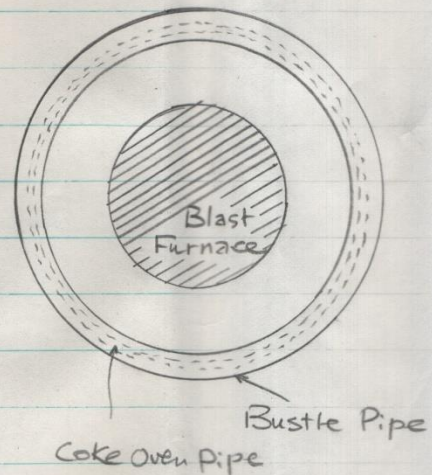
Fig. 11. Vertical View of COG Pipe, Bustle Pipe & Blast Furnace. COG Pipe is underneath the Bustle Pipe.

This gas line, originally purchased from U.S. Steel during 1964, was a type of 6" diameter seamless pipe. Material specification was not able to obtain. However, judging from metallographic study, it should be made of low-alloy steel or carbon steel with 0.2%-0.3% Carbon. Whether it is low alloy steel or carbon steel, it is the same from fractographical point of view. The hardness of this pipe line is pretty soft, $R_B \approx 80$.
